Niagara Gorge Corridor Project

Draft Scoping Report

Appendix G - Visual Pavement Condition Assessment

Robert Moses Parkway-North Segment

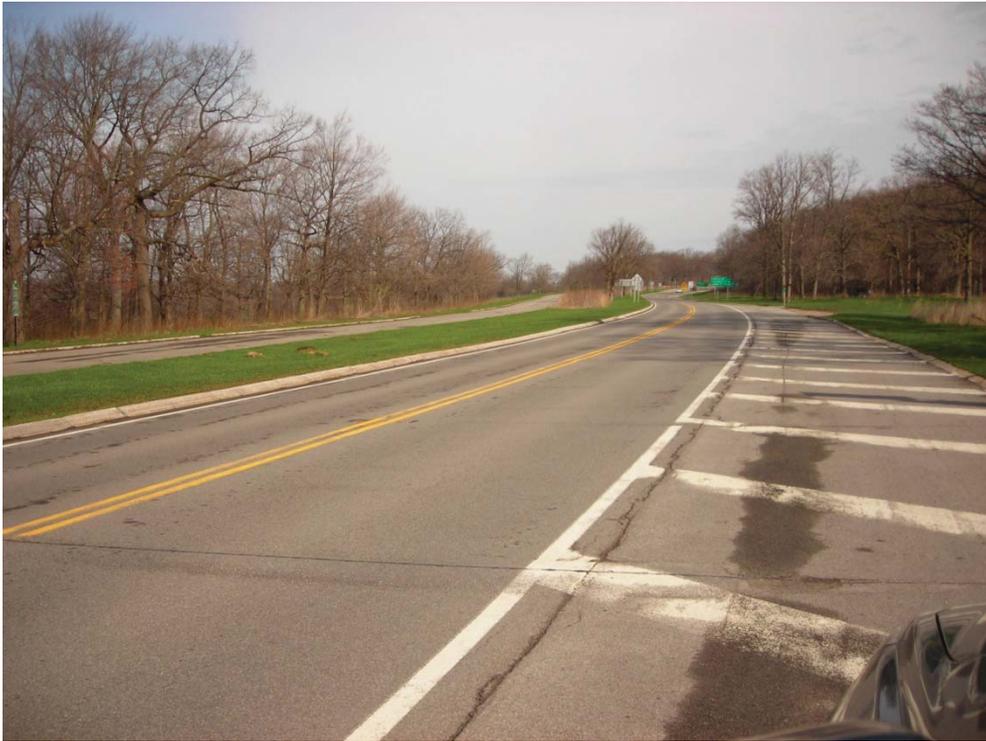
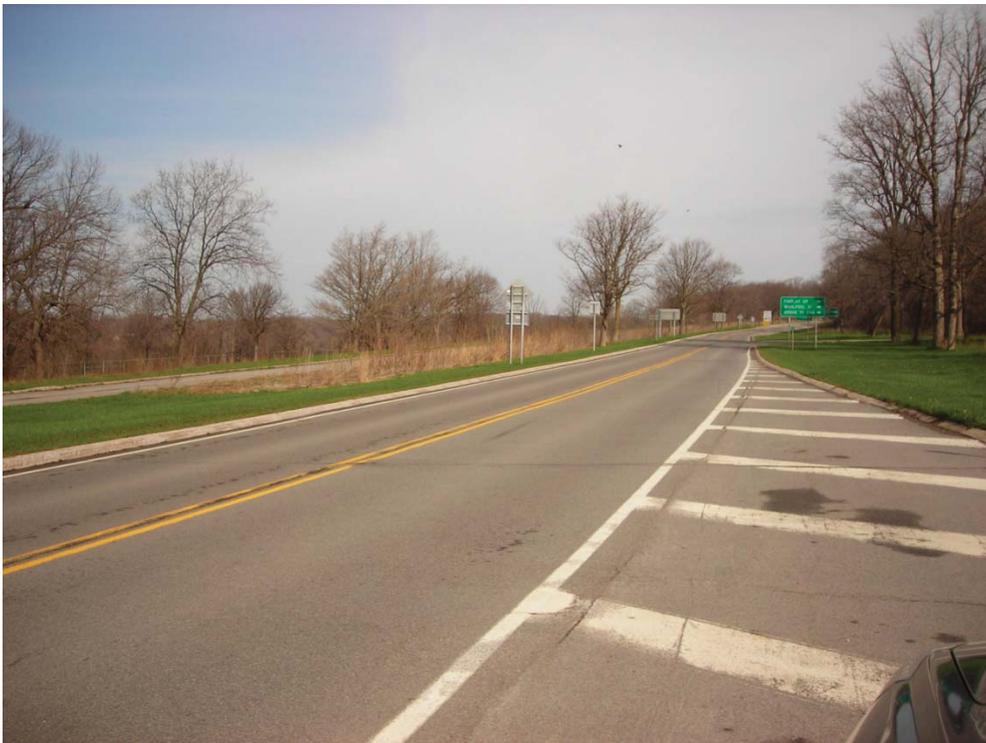
Robert Moses Parkway
Segment 4 - MP 1.7 Top Photo, MP 1.8 Bottom Photo

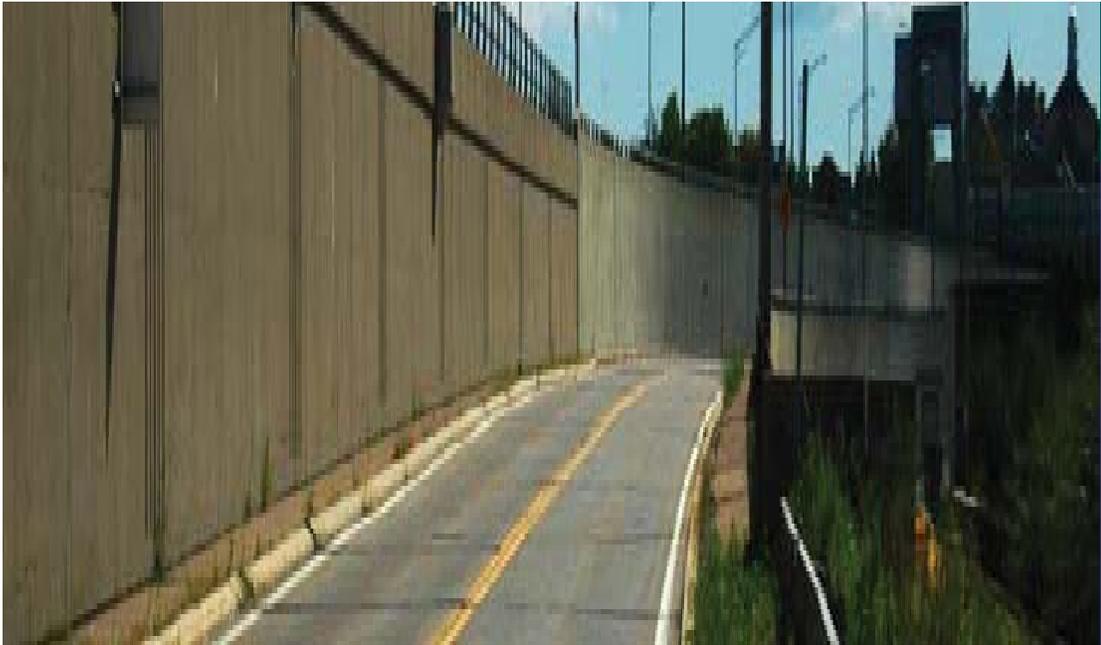
Robert Moses Parkway

Segment 6 Photo courtesy of NYPA (photo is a few years old, pavement is in worse condition now)

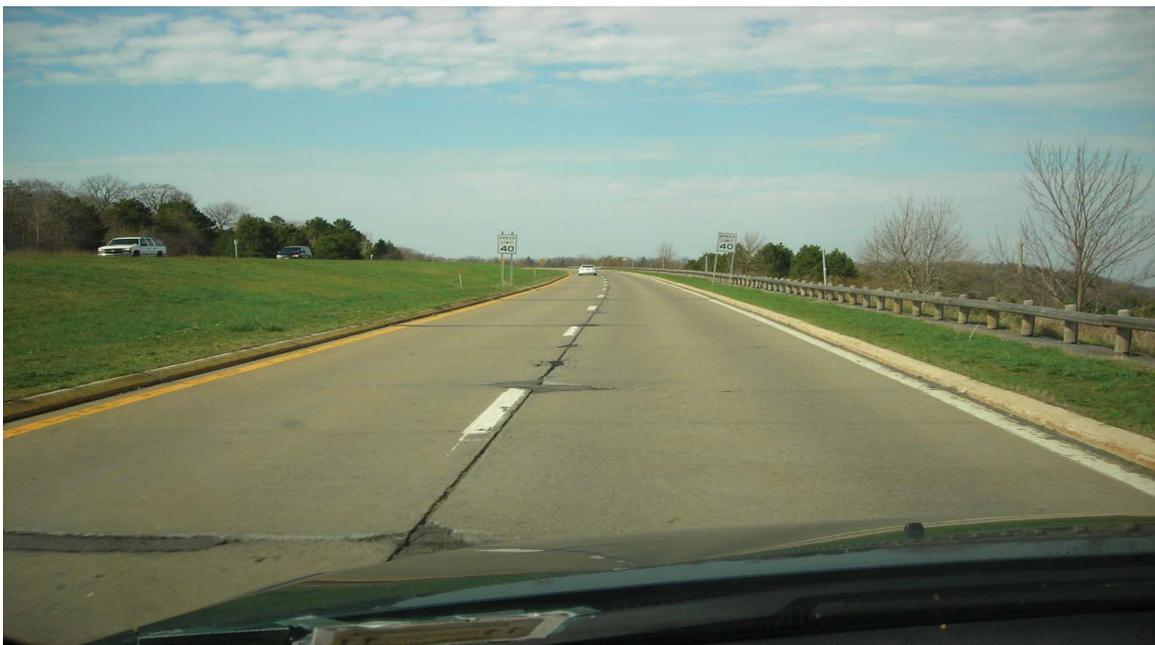
Robert Moses Parkway

Segment 8 Photo courtesy of NYPA (photo is a few years old, pavement is in worse condition now)

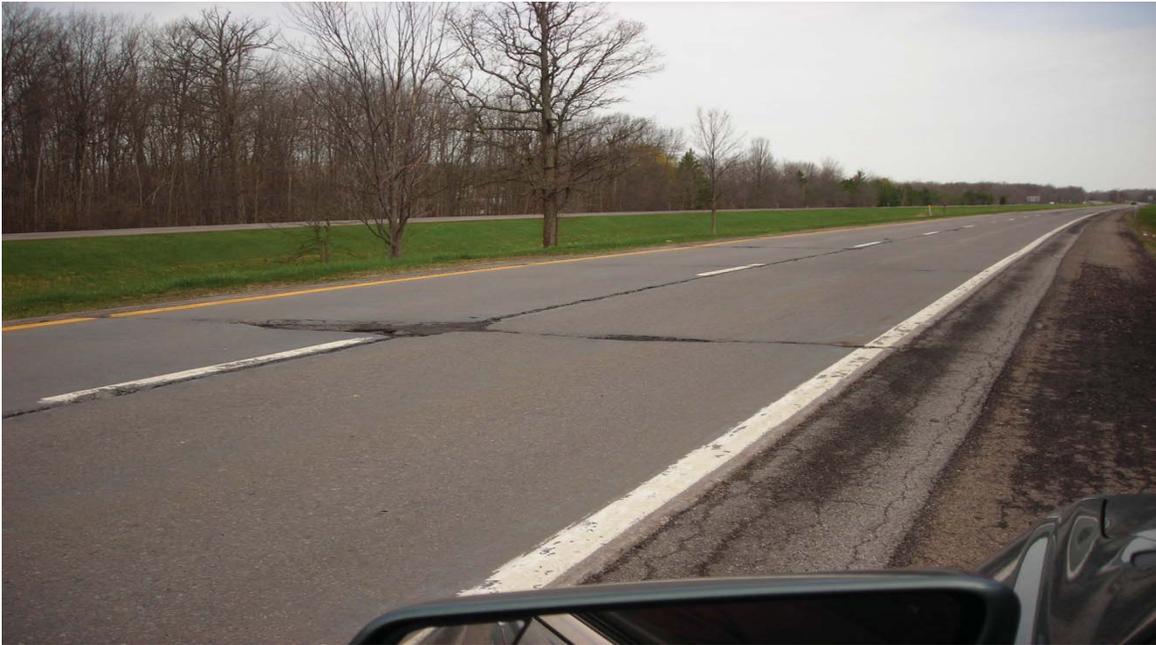
Robert Moses Parkway

Segment 10 - Divided highway section heading North out of Lewiston

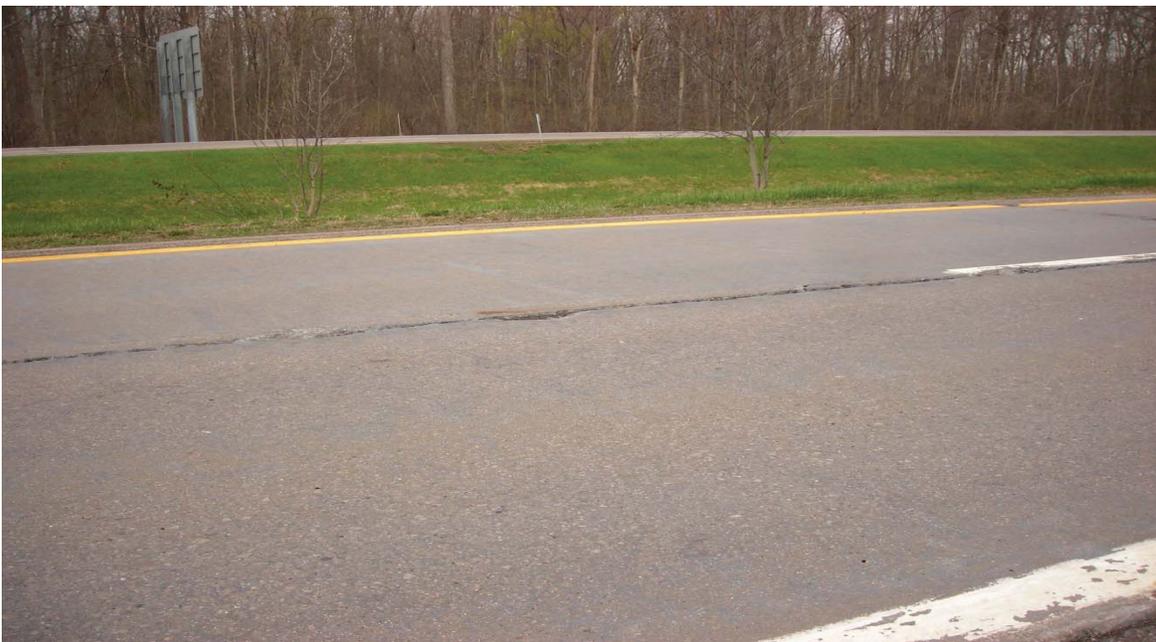
Robert Moses Parkway

**Segment 10 - Divided highway section - typical conditions
(Note this section with shoulders I north of the project limits but pavement is similar)**
