**Sanitary Survey
for the
Buffalo Harbor State Park –
Gallagher Beach
Erie County
Buffalo, New York**

Contract Number D003773

September 2015

ECOLOGY AND ENVIRONMENT ENGINEERING, P.C.
368 Pleasant View Drive
Lancaster, New York 14086

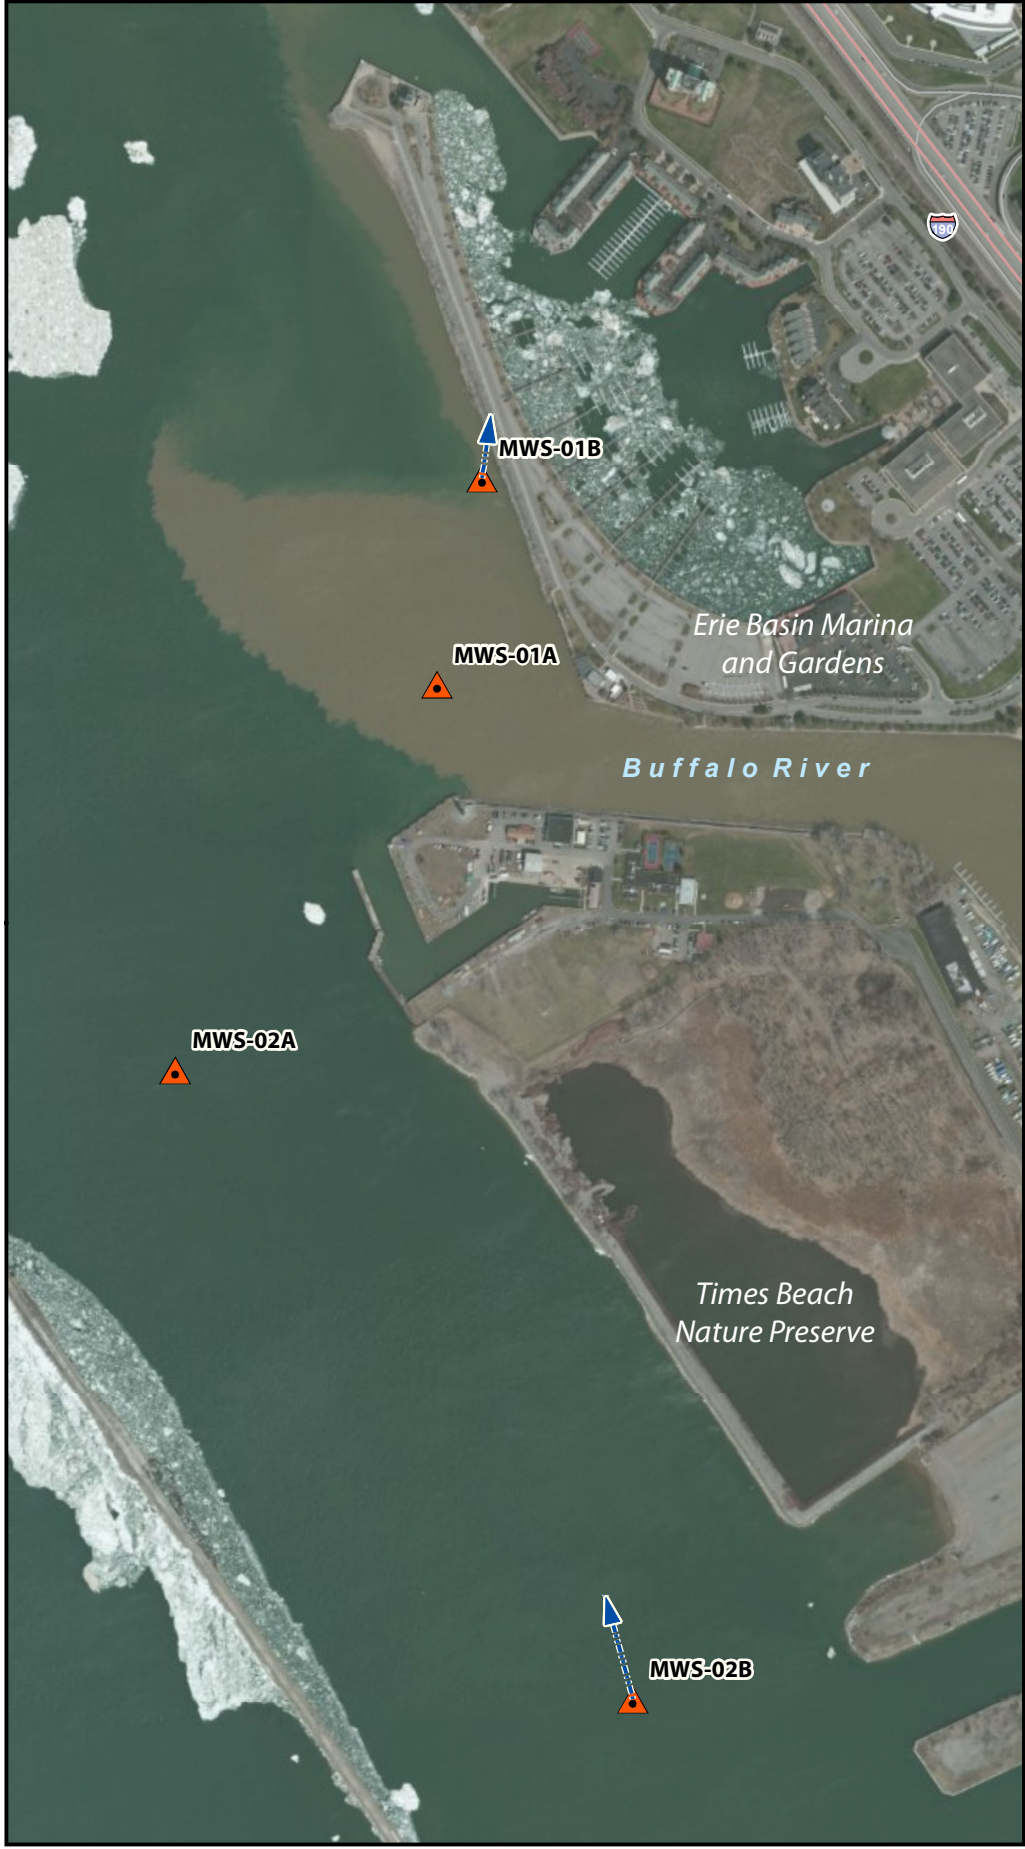
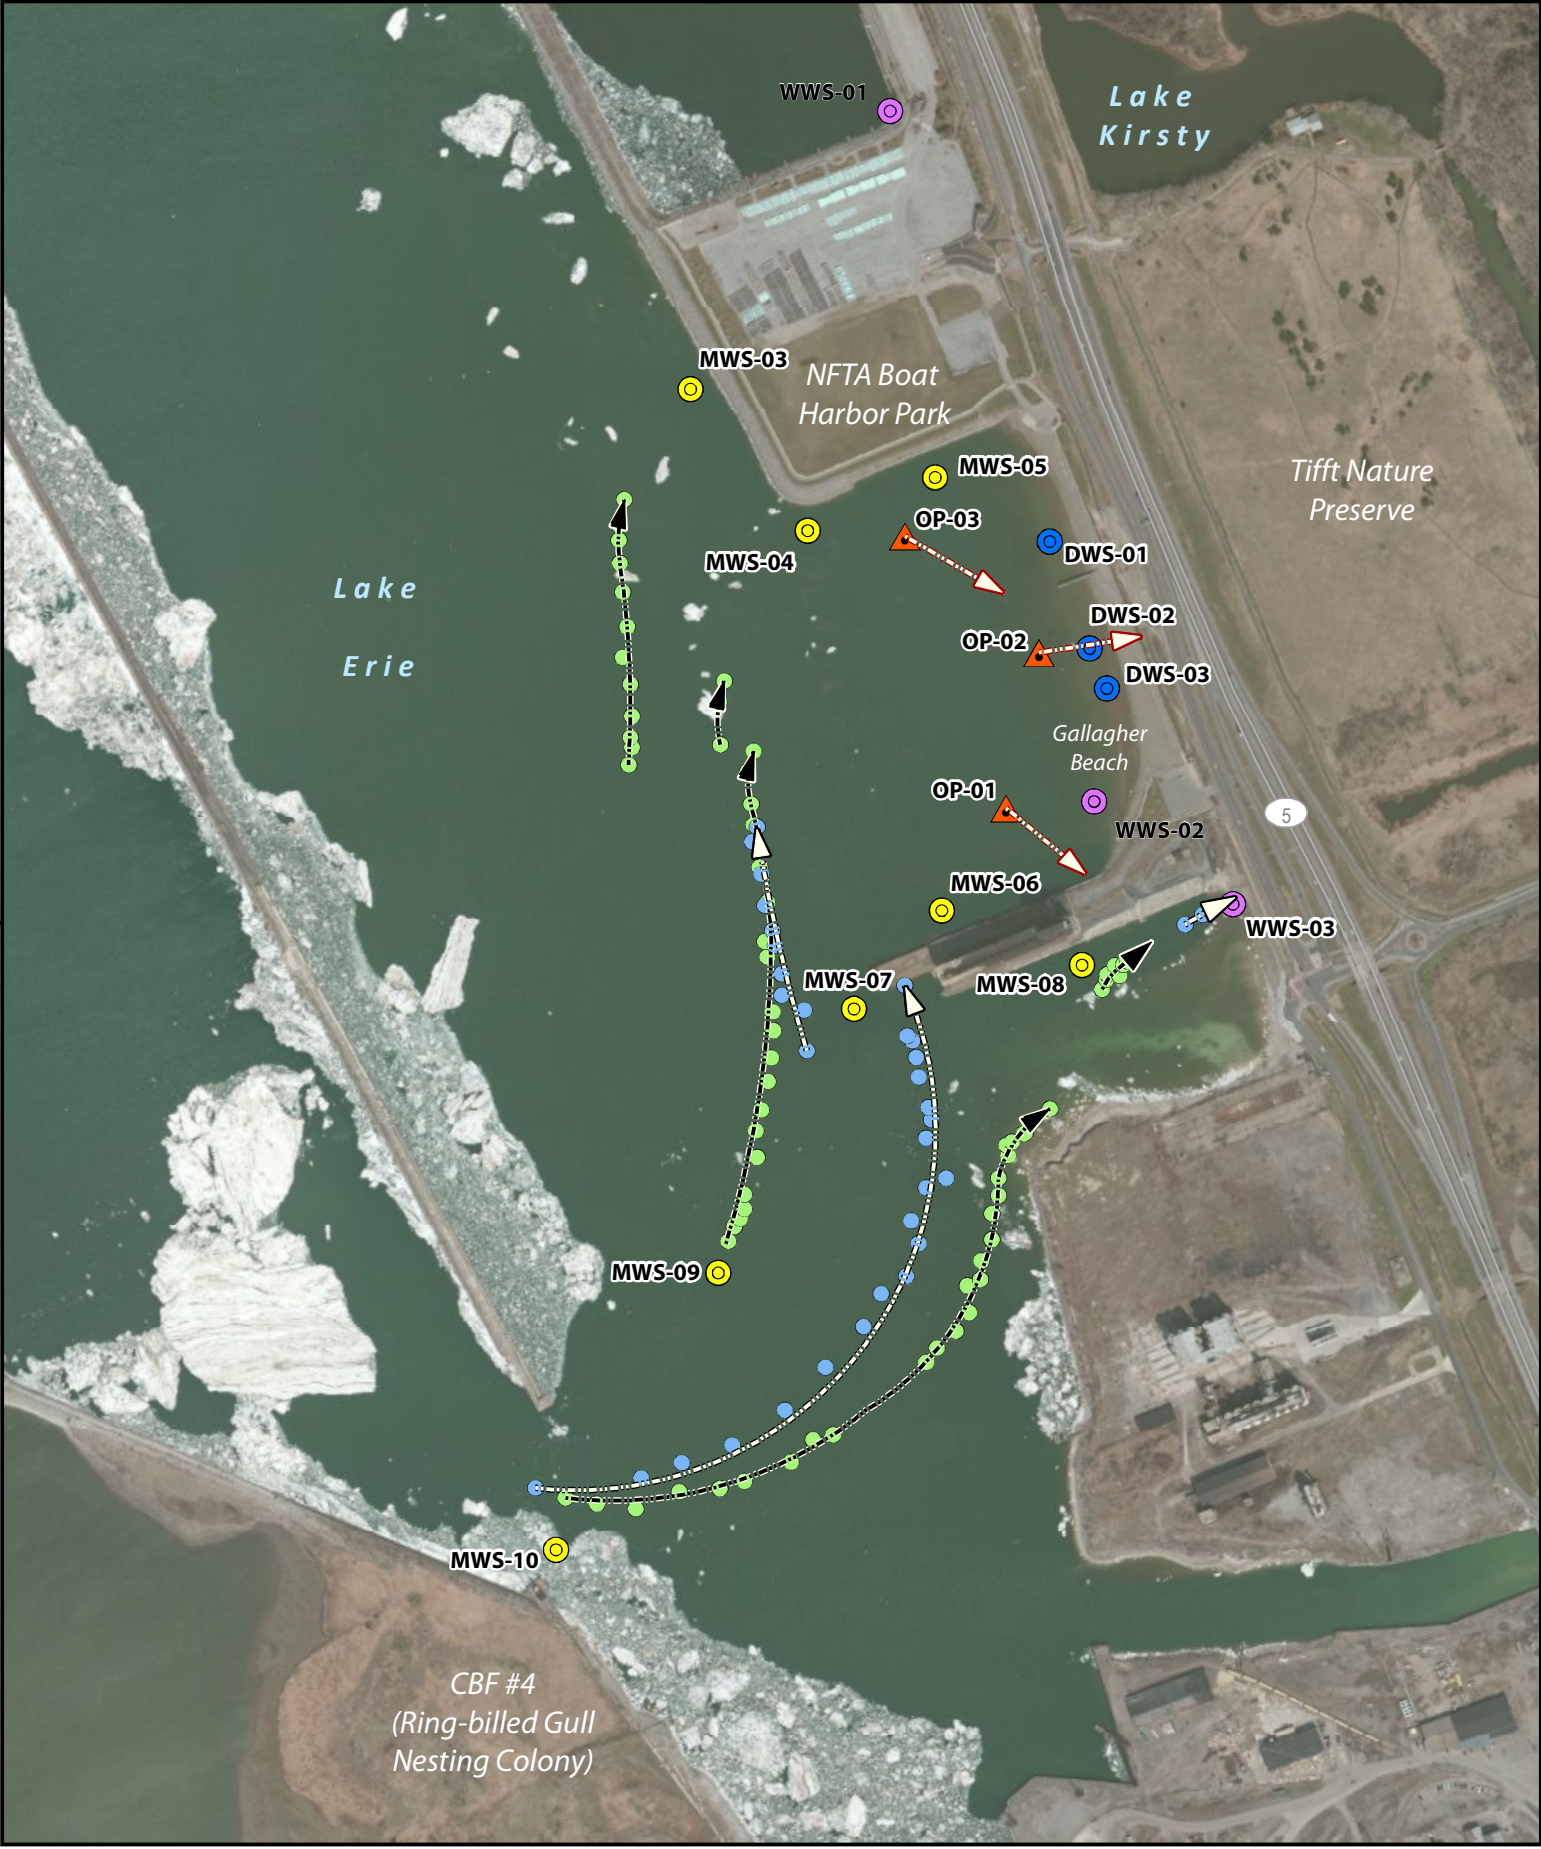
Figure 2-1
Sanitary Survey
Water Flow Direction Tracking
Buffalo Harbor State Park
Buffalo, New York

The flow monitoring indicates that the general flow direction within the breakwater is from the south to the north. Significant movement was observed. The flow monitoring at the location adjacent to CDF No. 4 and the ring-billed gull nesting colony indicated that water flow was toward the Gallagher Beach embayment and the outside of the embayment to the south.

EEEPC performed flow tracking on two occasions during the summer of 2014: once after a 0.77-inch rainfall event on June 4 and 6, 2014; and once on July 30, 2014, a dry, calm day with no rain (see Figure 2-1). Three locations were tracked on June 4. These three locations were tracked again on July 30 along with two additional locations. Three locations were tracked near the shore at the additional flow direction measurement locations (OP-01, OP-02, and OP-03) during the sample event on June 6. The flow tracking was done by recording the location of

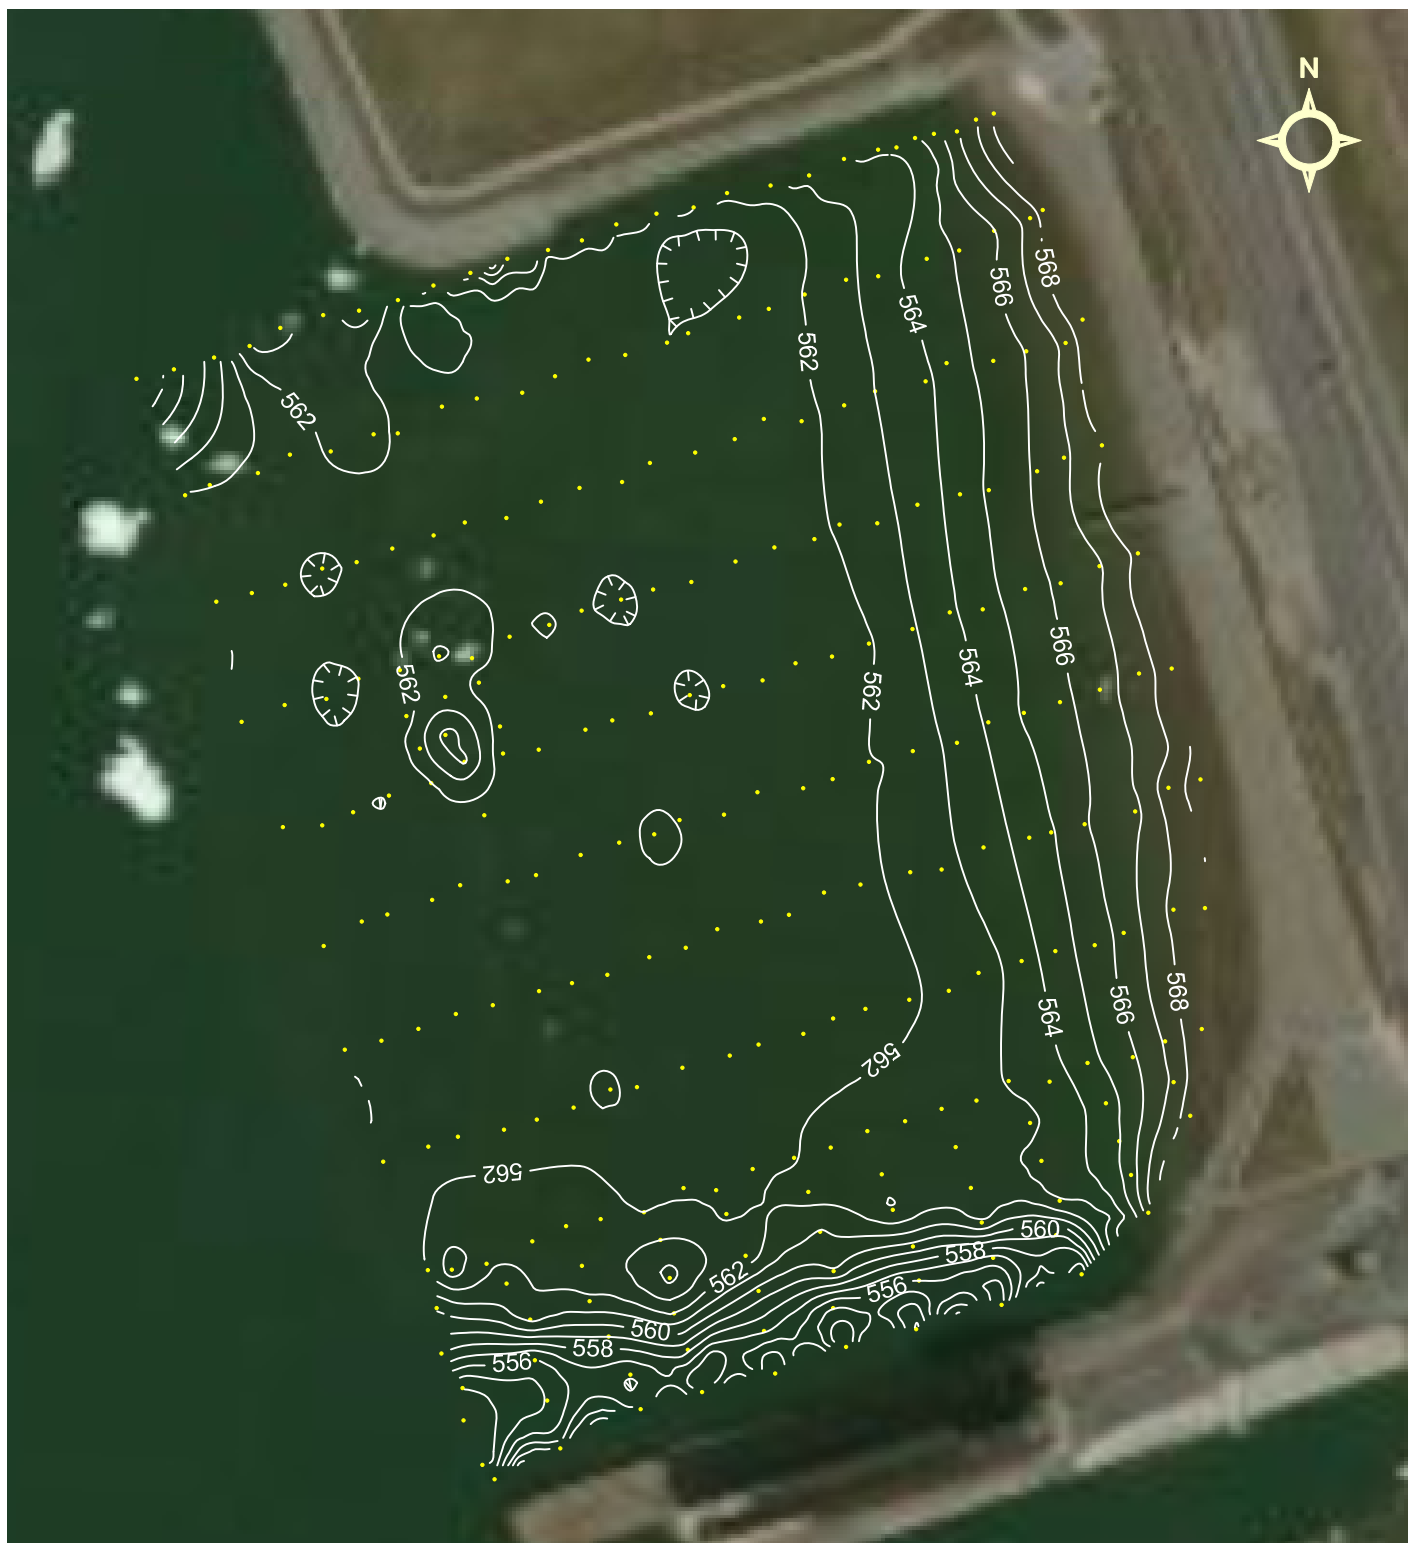
Figure 2-3
Bathymetric Elevations
Buffalo Harbor State Park - Gallagher Beach
Buffalo, New York

Note:
Elevation datum is North American Vertical Datum 1988, feet.

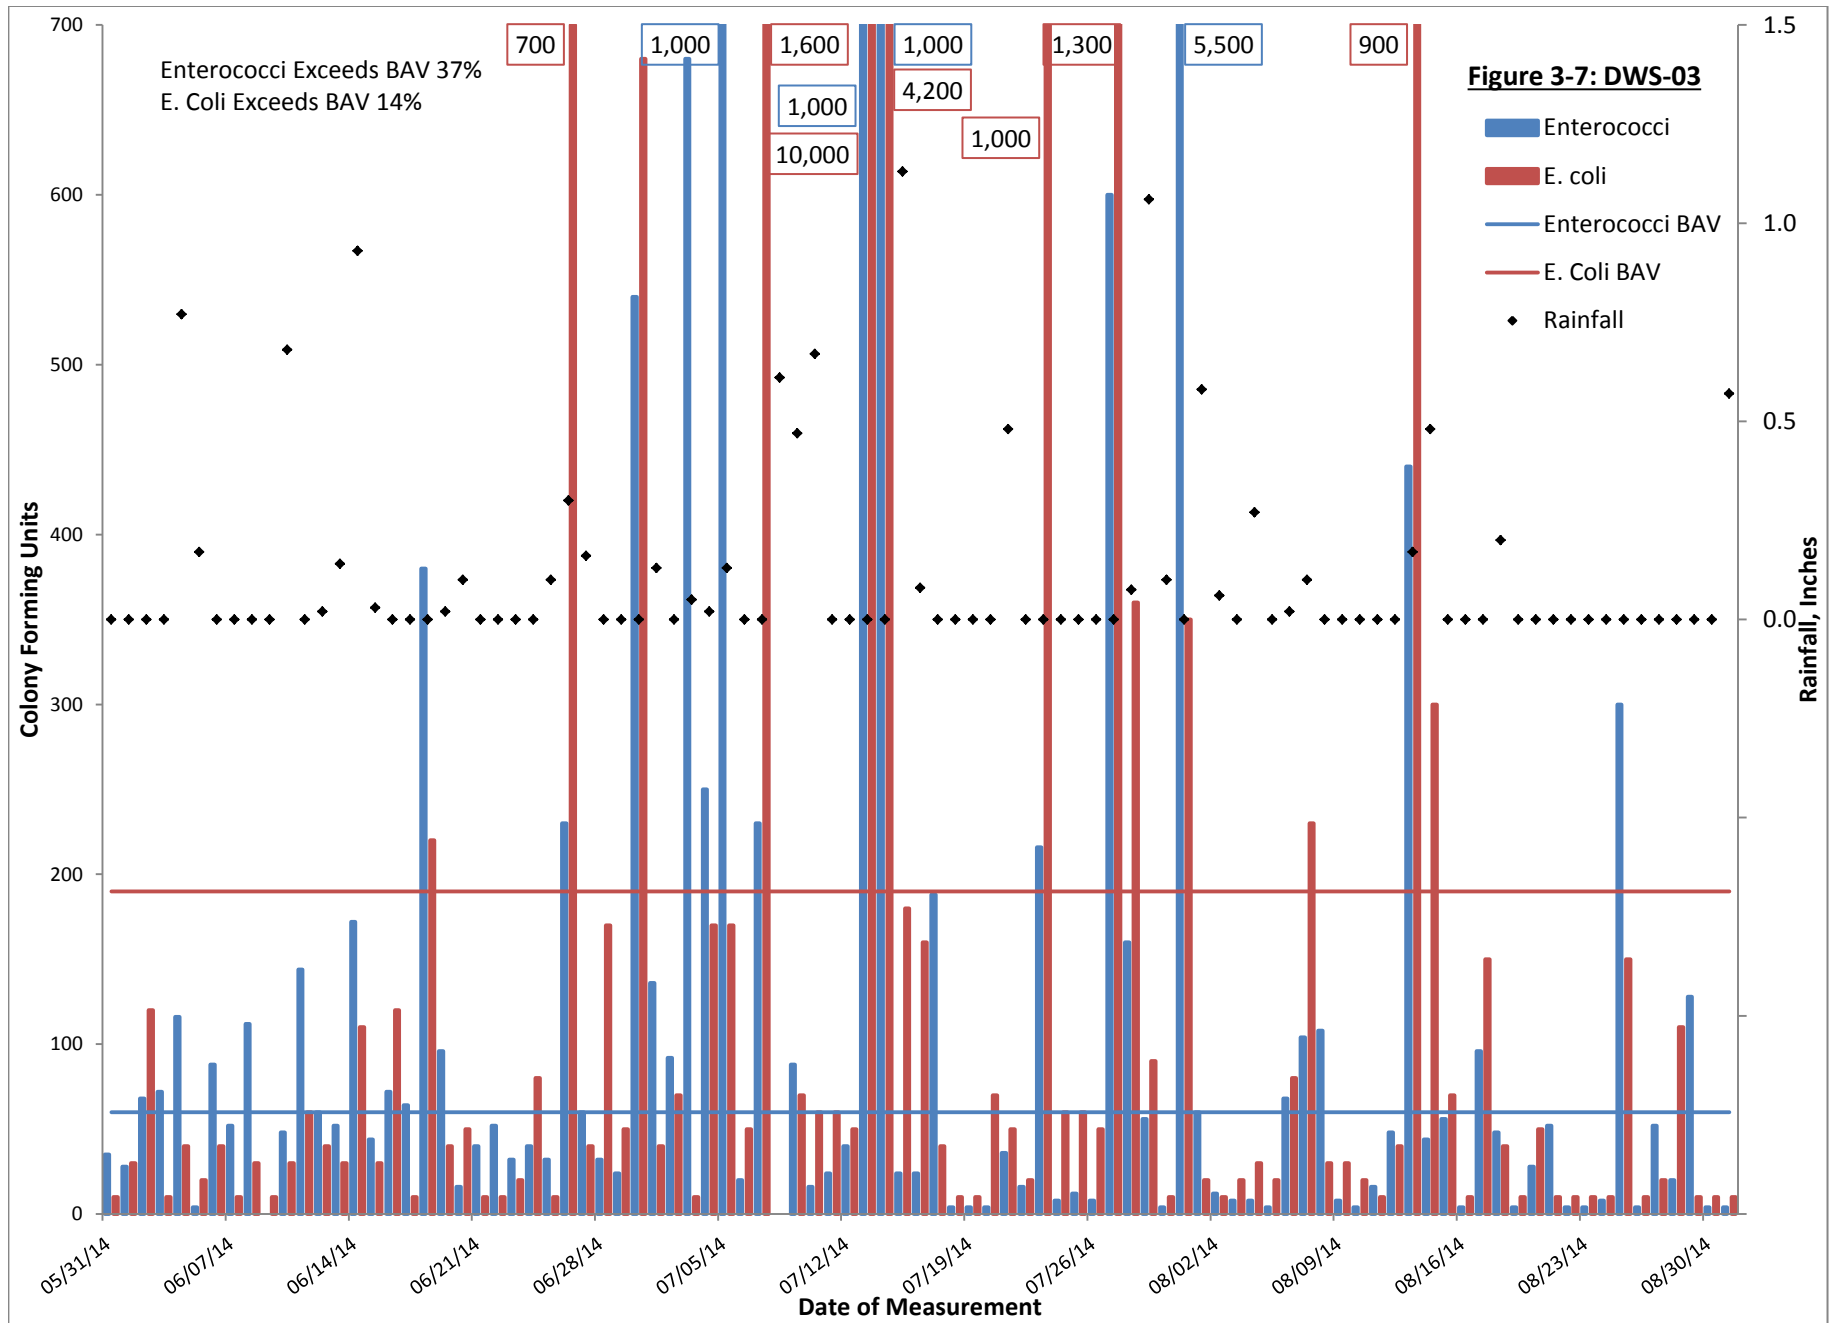
Figure 3-7: Daily Water Sample (DWS-03), Bacteriological Results and Rainfall

The DWS-03 sample location had the single sample maximum for *Enterococci* at 5,500 CFU/100 mL, and for *E. coli* at 10,000 CFU/100 mL. While location DWS-03 had the single sample maximum, it was also the location that had the lowest amount of samples exceeding the *Enterococci* and *E. coli* BAVs at only 37% and 14% exceedance, respectively.

The *E. coli* concentration on July 12, 2014 (i.e., the July 13, 2014 maximum result of 10,000 CFU/100 mL) was 50 CFU/100 mL, while the July 14, 2014, sample resulted in 4,200 CFU/100 mL. There was 1.13 inches of rainfall recorded on July 14, 2014. The *Enterococci* results at this location in chronological order over this time period was 40, 1,000, and 1,000 CFU/100 mL, respectively. The samples at DWS-01, DWS-02, and WWS-02 from July 12 and 13 also greatly exceeded the BAVs.

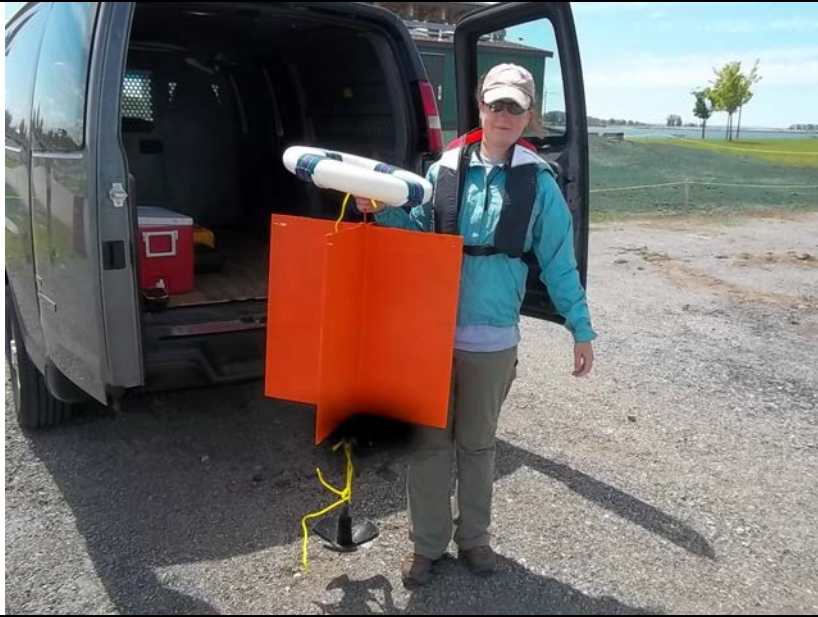
Photo No.:	013	Direction:	South
Date:	June 2014	Subject:	Current tracking device

Water flow direction (current) tracking was also performed in the vicinity of the beach. Flow direction was observed twice during the summer at two locations: one adjacent to the ring-billed gull nesting colony (MWS-10), and the second adjacent to the stormwater outfall south of Gallagher Beach (WWS-03). Additional smaller tracking runs were also conducted to help evaluate the water movement in the Gallagher Beach embayment and off shore from the WWS-03 sample location (see Section 2.3.3). Water flow direction tracking was conducted once on July 30, 2014, a dry, calm day with no rain; and once after a 0.77-inch rainfall event on June 4, 2014. The path of the flow/current was monitored by dropping a floating object (device designed for tracking water flow) in the water and following it, while tracking and recording its location with a global positioning system (GPS) unit (see Appendix A, Photos 13 through 16).

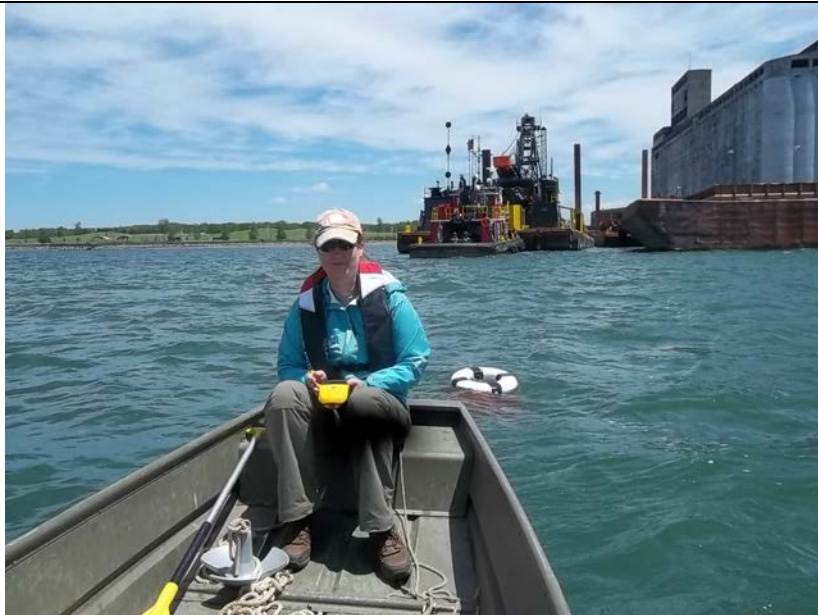
Photo No.:	014	Direction:	East
Date:	June 2014	Subject:	Current tracking west of Gallagher Beach

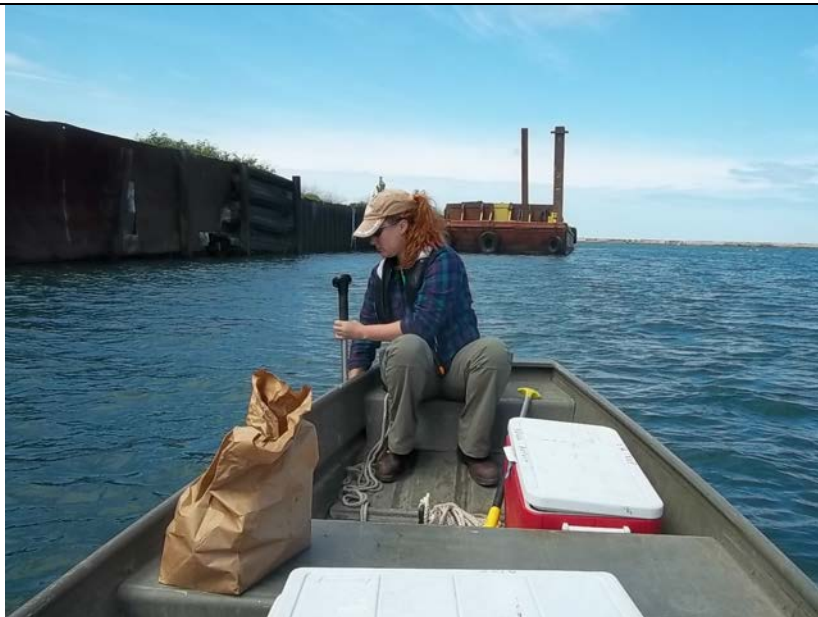
Photo No.:	015	Direction:	West
Date:	June 2014	Subject:	Flow measurement near Gallagher Beach

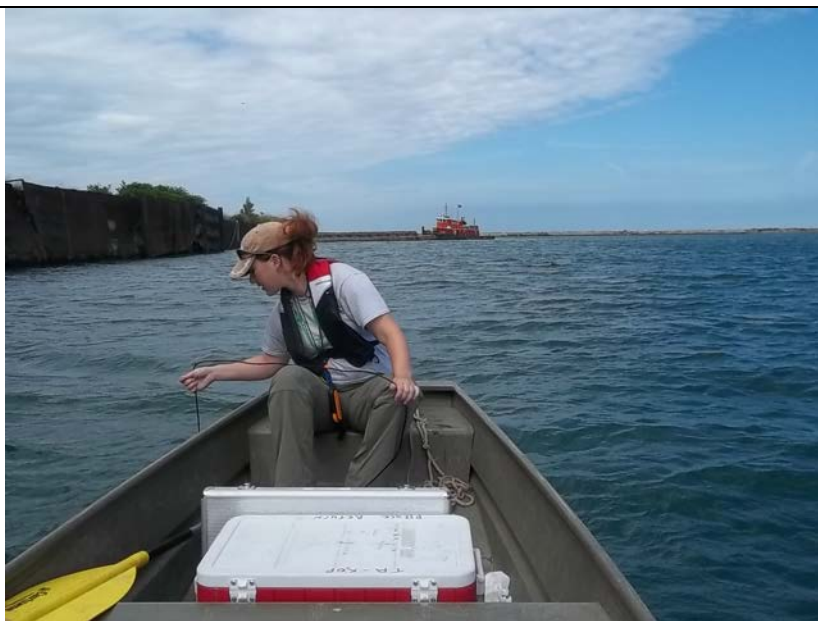
Photo No.:	016	Direction:	West
Date:	July 2014	Subject:	Flow measurement at Gallagher Beach

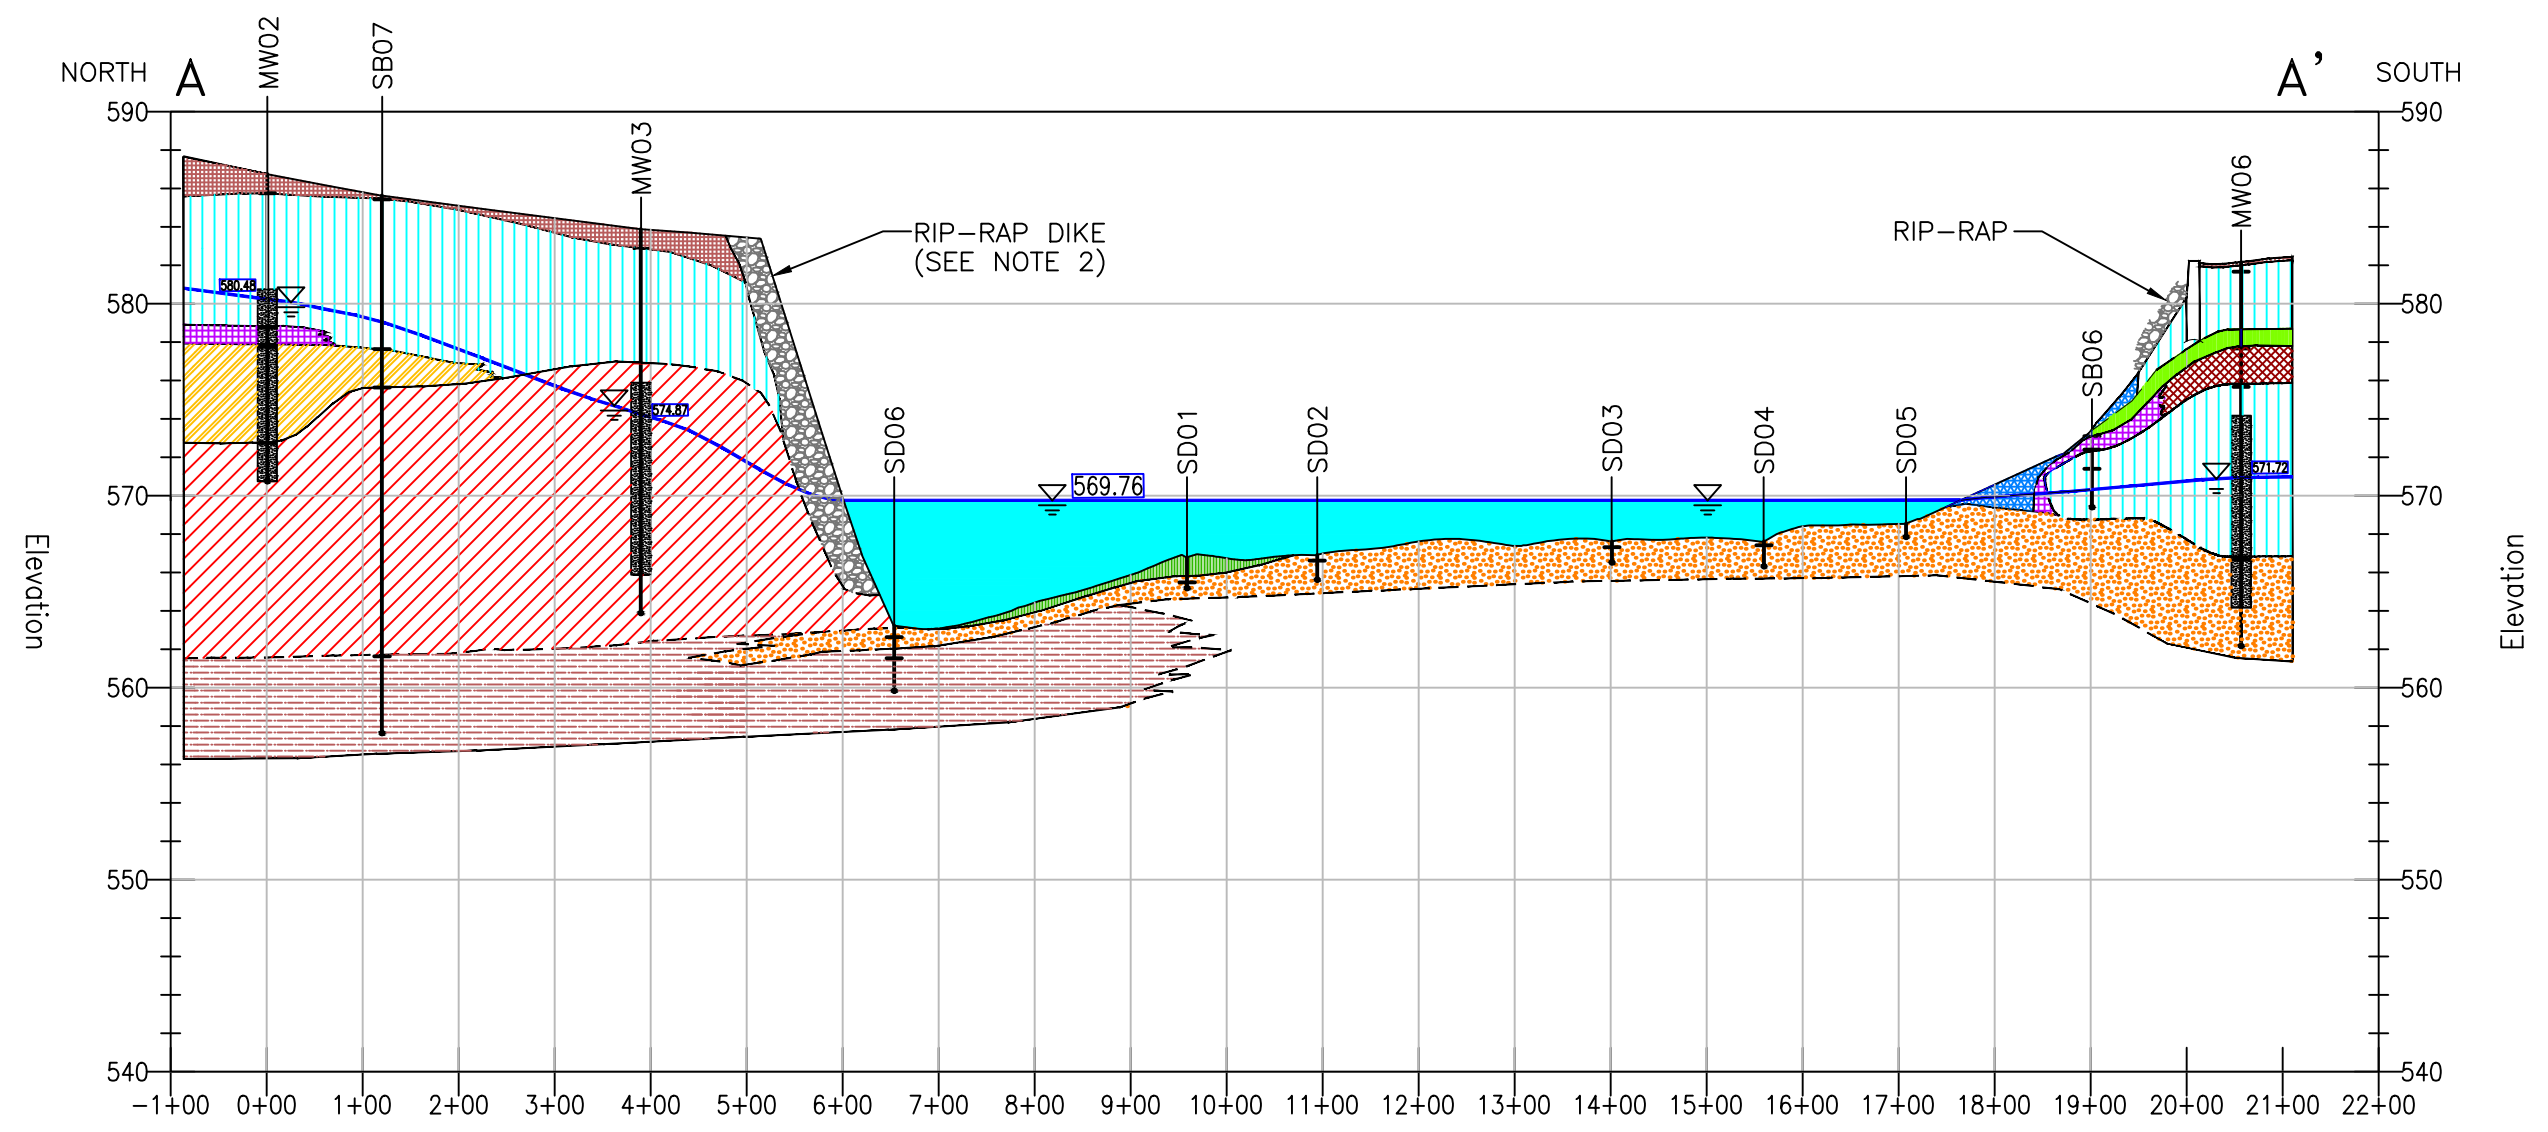
FIGURE 3

GEOLOGIC CROSS SECTION, PROFILE LINE A-A'
BUFFALO HARBOR STATE PARK
BUFFALO, NEW YORK

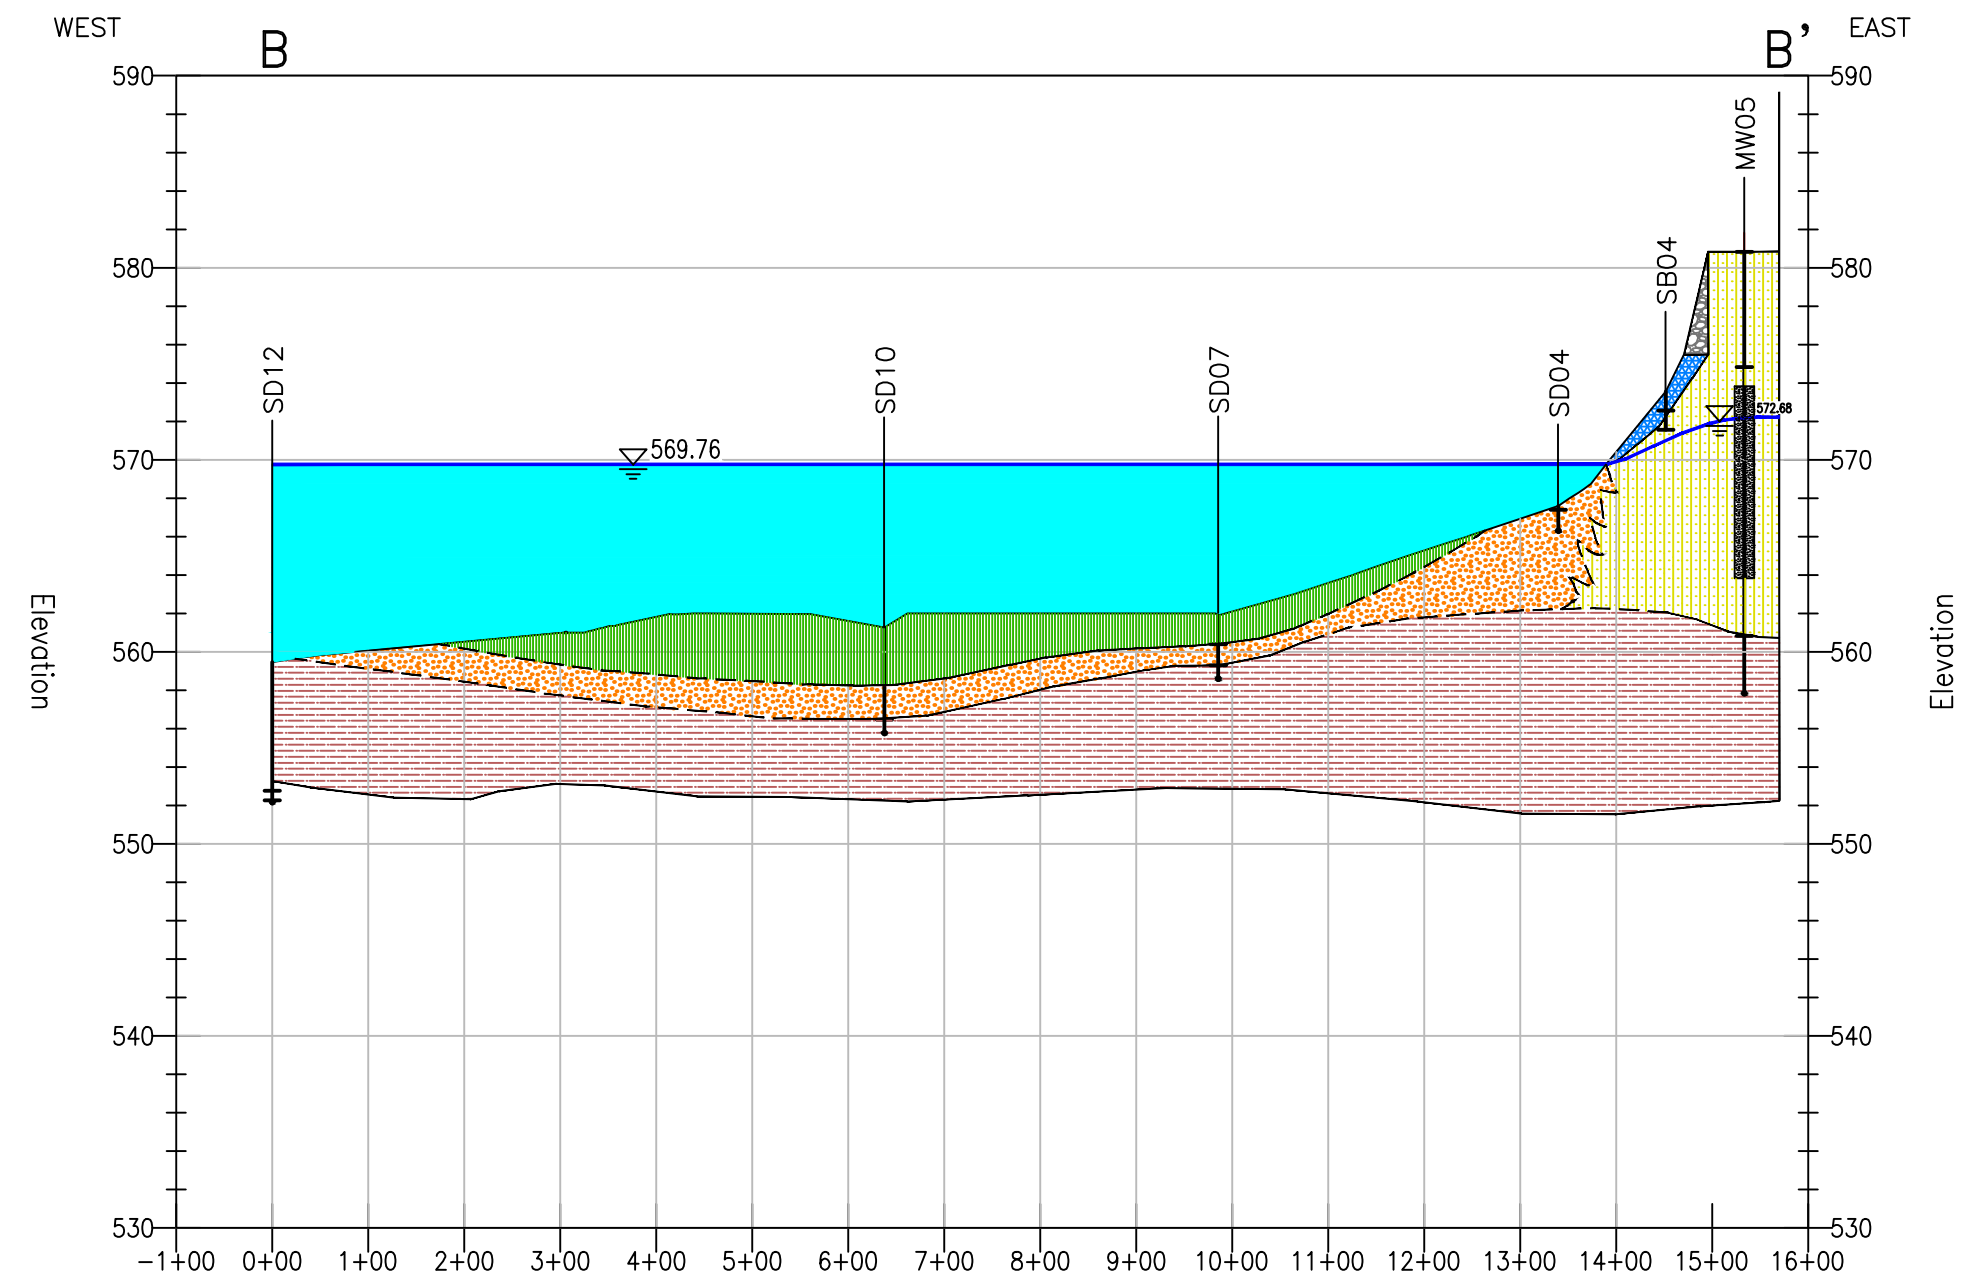
FIGURE 4

GEOLOGIC CROSS SECTION, PROFILE LINE B-B'
BUFFALO HARBOR STATE PARK
BUFFALO, NEW YORK

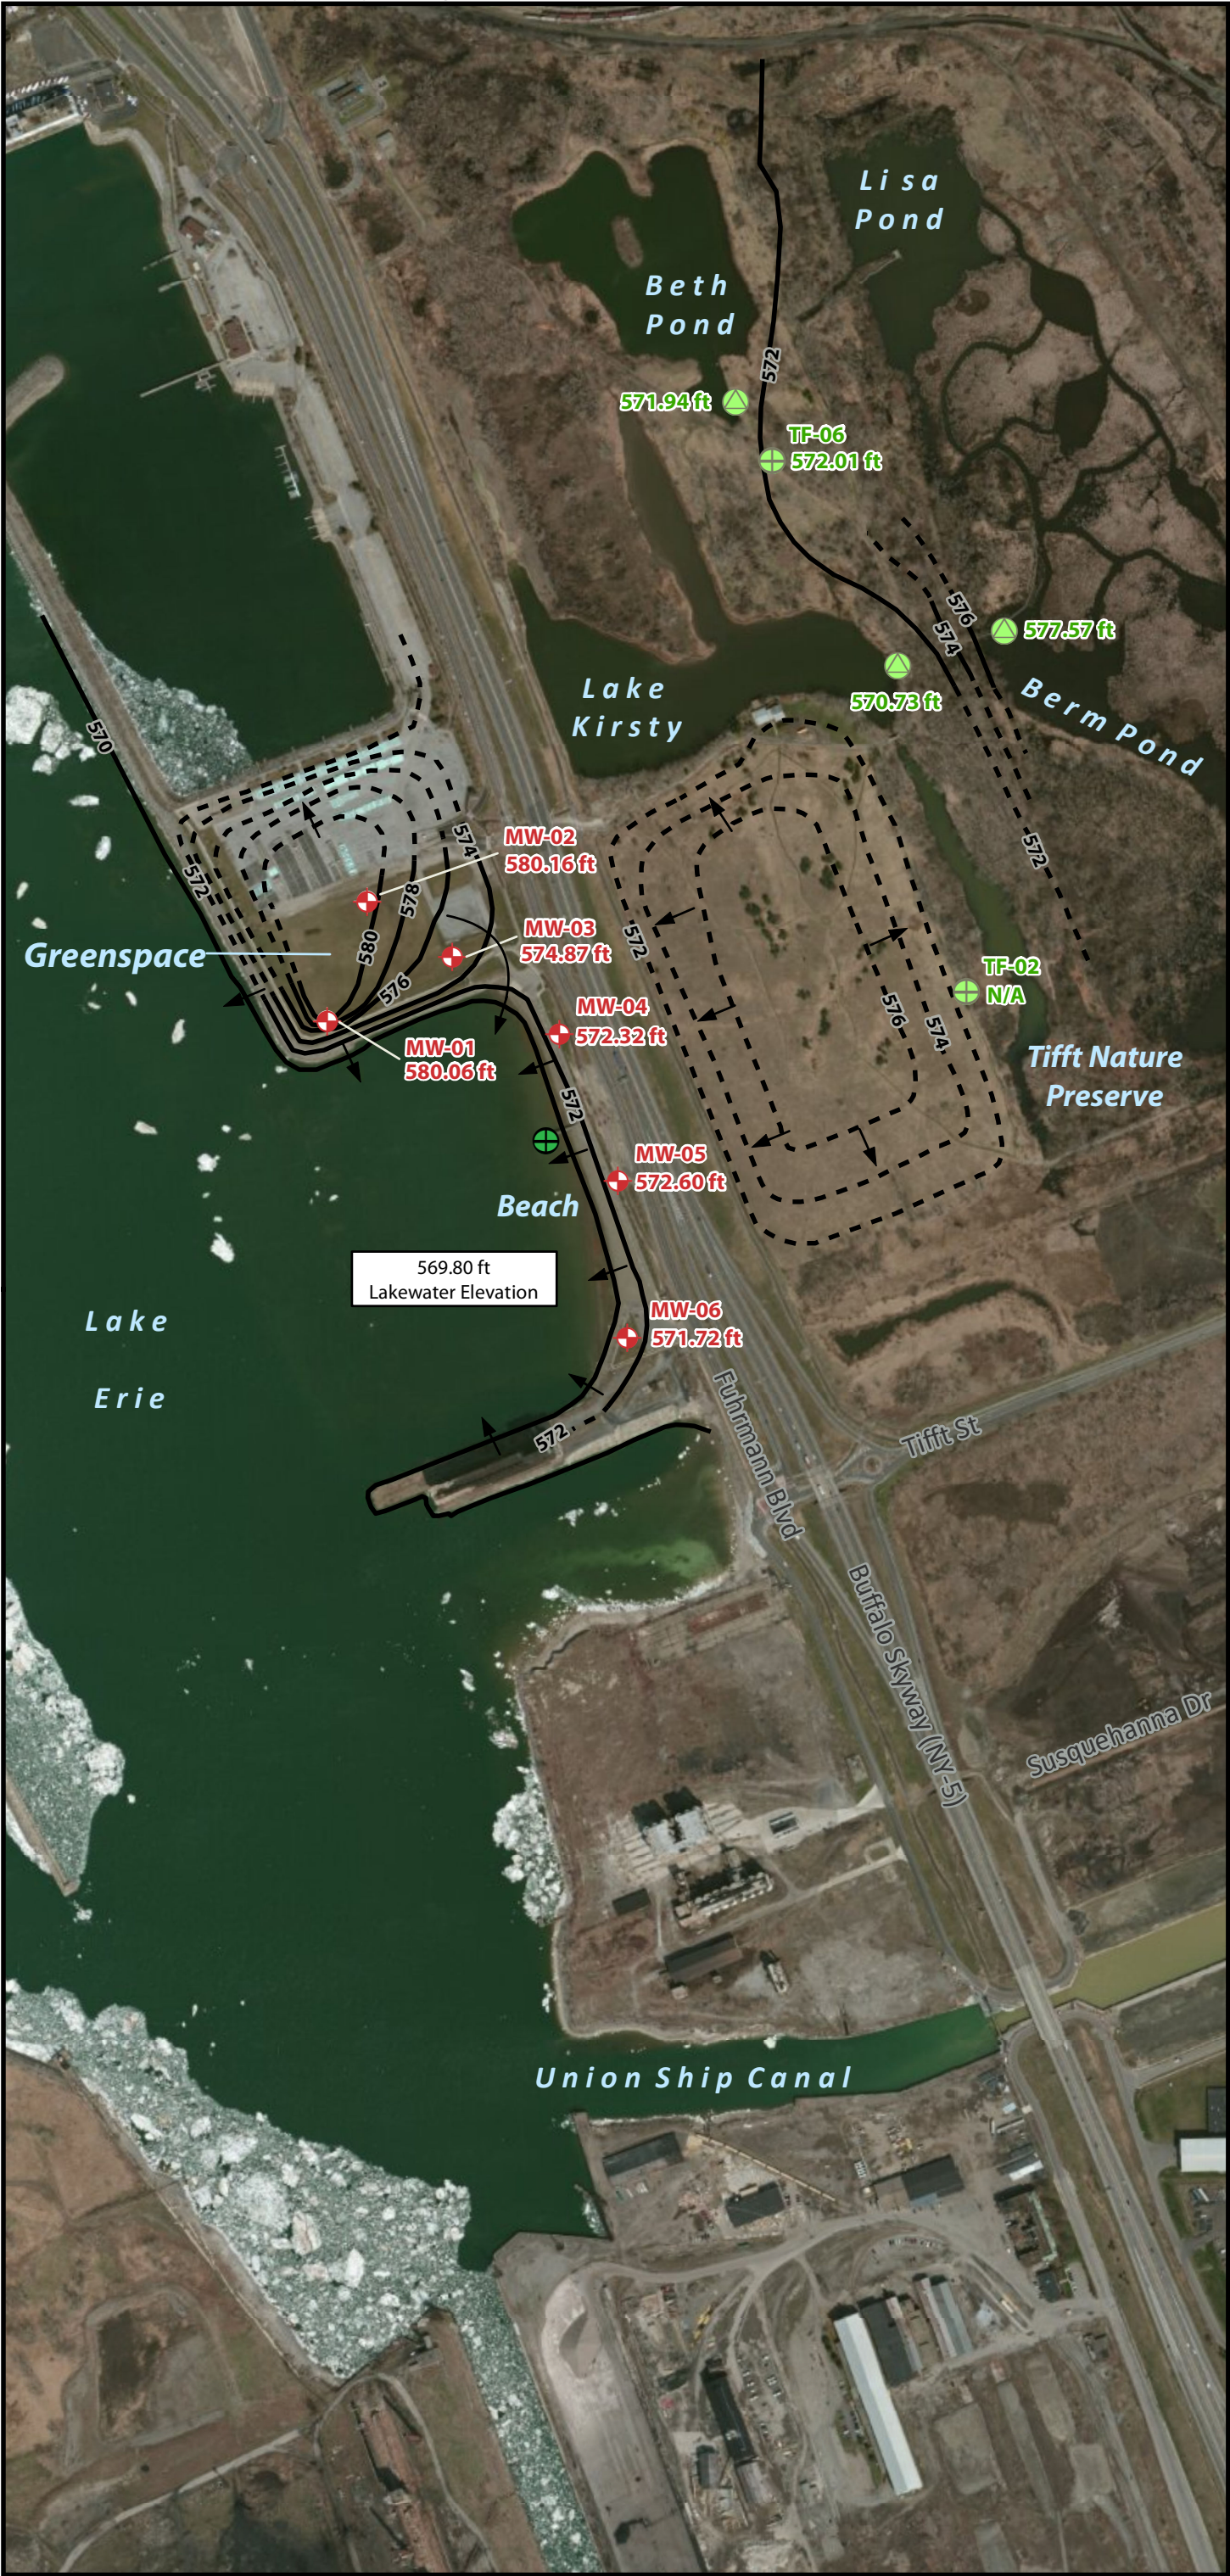
Figure 5
Groundwater Contour Map
October 29, 2013
Buffalo Harbor State Park
Buffalo, New York
