**Sanitary Survey
for the
Buffalo Harbor State Park –
Gallagher Beach
Erie County
Buffalo, New York**

Contract Number D003773

September 2015

ECOLOGY AND ENVIRONMENT ENGINEERING, P.C.
368 Pleasant View Drive
Lancaster, New York 14086

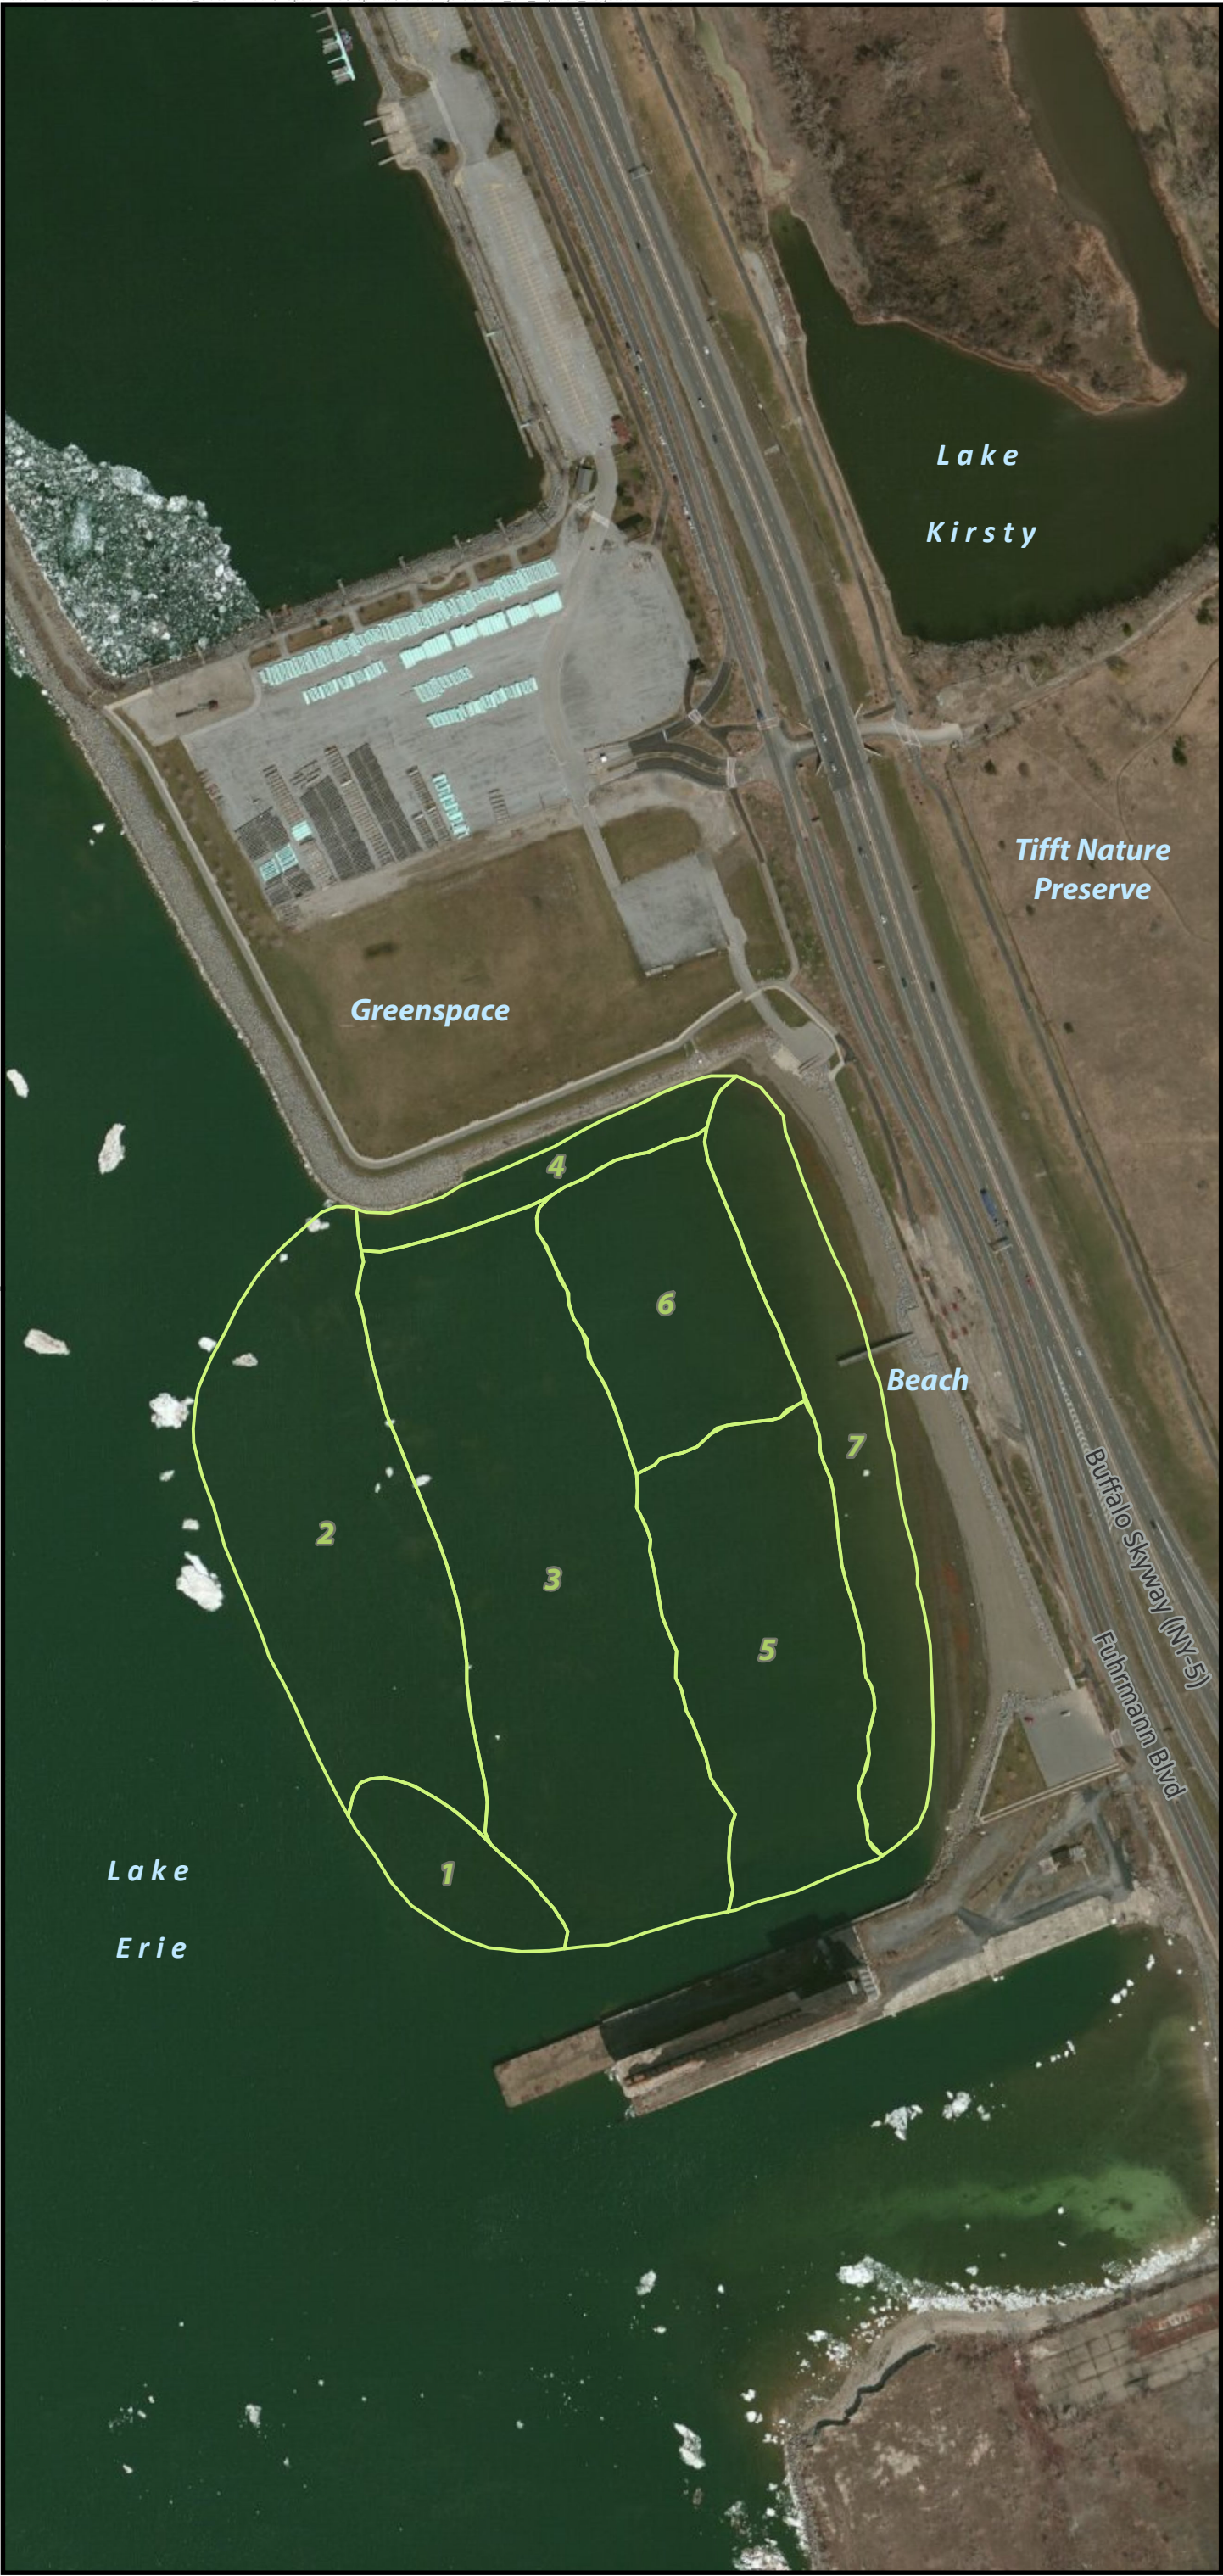
Figure 6
Approximate Locations and Densities
of the Different Submerged Aquatic
Vegetation Species Observed
at Gallagher Beach
Buffalo Harbor State Park
Buffalo, New York

Section 7: 25%-50% Wild Celery
50%-75% Bare

Overall, the dominant species found within the Gallagher Beach embayment during this survey was wild celery (*Vallisneria americana*). It was found in every area that SAV was present with the exception of a small area in the southwest portion of the embayment, which has become a dense monoculture of Eurasian watermilfoil (*Myriophyllum spicatum*). The Eurasian watermilfoil was common in the deeper portion of the embayment, as well as along the riprap on the north edge, but it was only co-dominant with other SAV species in those areas, and did not form a monoculture. The other species found to often be co-dominant with the wild celery were American waterweed (*Elodea canadensis*), grassleaf mudplantain (*Heteranthera dubia*), and Richardson's pondweed (*Potamogeton richardsonii*). Lastly, coontail (*Ceratophyllum demersum*) was also observed, but only a limited number of individuals.
