# The Local Landmarker

## Issue 17, Winter 2011

## *Using Substitute Building Materials at Historic Buildings*

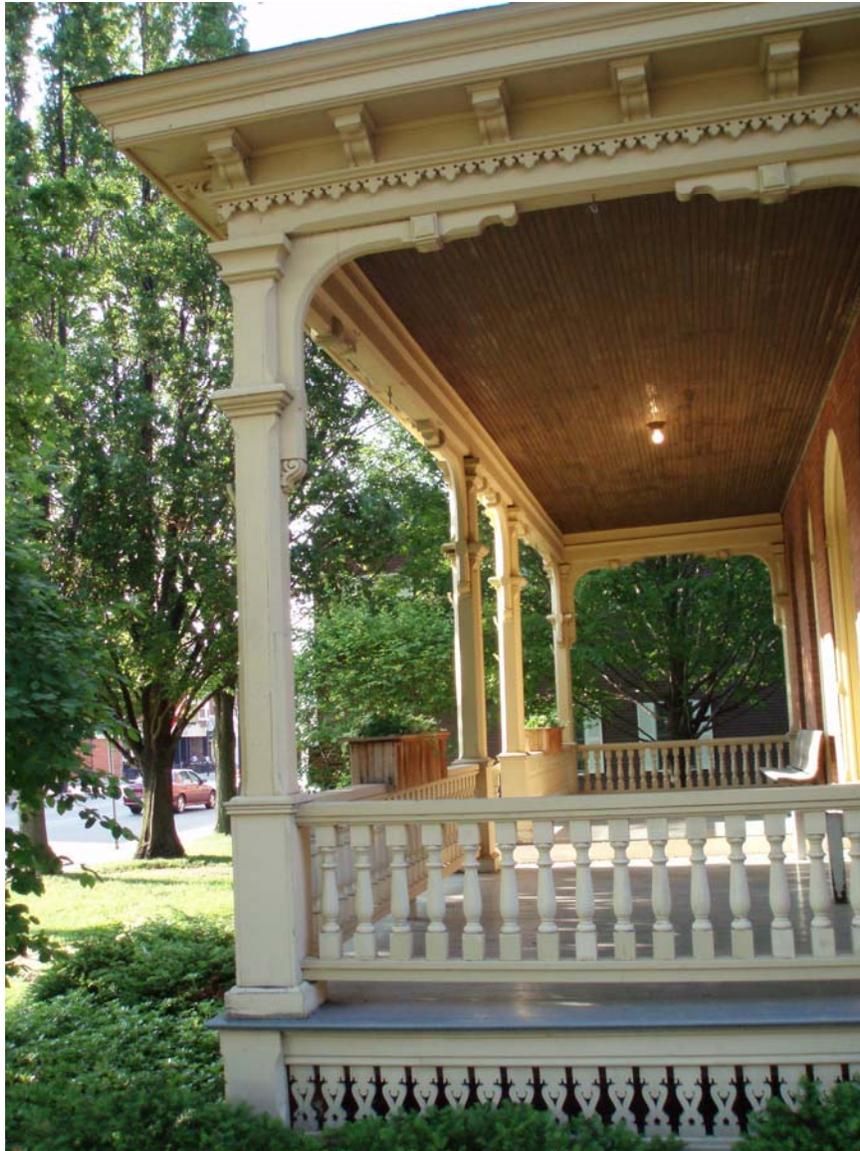
*On the Cover: A Victorian-era front porch in the Village of Orchard Park, Erie County, is an excellent example of how historic features add to the character of a building and also the streetscape. Decorative elements are everywhere on the porch, from just under the porch roof to under the porch floor. Since porches are constantly exposed to the elements, they typically need constant maintenance and repair. If any of the materials here were deteriorated and needed replacement, the question then is how and with what?*

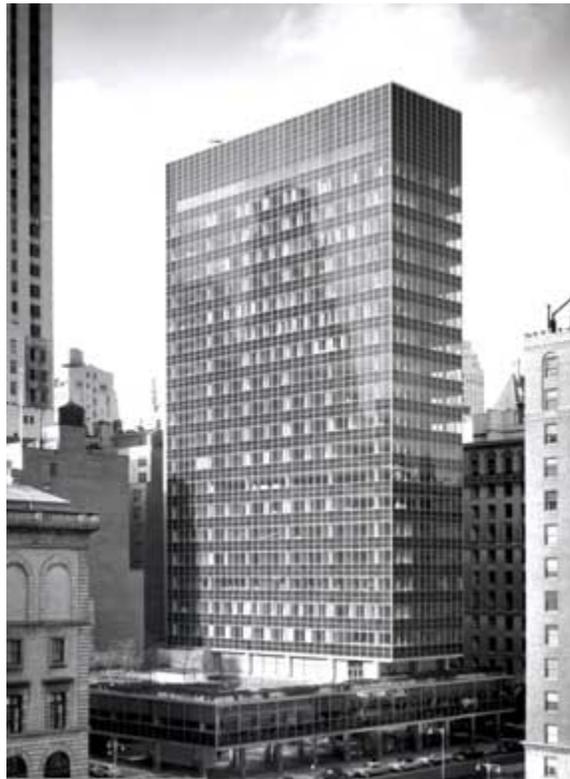
*Lever House in New York City: A landmark of a modern architecture. The failure of the original sealant materials at the glass curtain walls proved that not all modern replacement materials perform as promised, and sometime must be replaced themselves.*

Another, much more modern example of original materials being found inadequate for reuse was at Lever House, a National Register listed icon of modern design on Madison Avenue in New York City (1951-52). The building was radical for its time, one of the first glass “curtain-wall” skyscrapers in the United State. It rose along the traditionally stone and classically detailed Madison Avenue streetscape in the first years of the 1950s, making a bold statement about the future of architecture. Its sleek glass walls were sealed against the dirt of New York City, using “high-tech” sealants and gaskets designed to last indefinitely. Unfortunately, the technology required for the design was fairly new and experimental, and “indefinitely” proved to be about 45 years. By 1990, the building was leaking water to the interior and heat and air conditioning to the exterior. Water infiltration was so bad that interior steel supports were rusting away and sections of the glass skin were actually falling off. During an extensive rehabilitation, the exterior materials were removed and rebuilt using systems and materials that would perform better than the original, given what has been learned about glass curtain walls since 1952. The appearance of the new exterior is extremely close to the original, but did not replicate each detail as originally built; to do so would have been inviting a new cycle of infiltration and deterioration. The main thought in any situation like this is “don’t repeat the mistakes of the past”.

1. The appearance of the historic material must be matched; this includes material wear and color fade testing to ensure that the color and texture match today will still be a match tomorrow.
2. The physical properties of the historic material vs. the new must be accounted for to prevent actions such as galvanic corrosion (in the case of metals), or expansion and contraction (to prevent gaps or build-up of damaging internal pressures).
3. Understanding the performance expectations of any new materials, ensuring that they have been tested and have performed well over a number of years. That “miracle” material just on the market may not perform as promised over the long term. An example of this was the original gaskets at Lever House, which failed much earlier than expected.
