National Register of Historic Places Registration Form

historic name 1883 Barn

street & number 2981 Elmira Rd

city or town Newfield

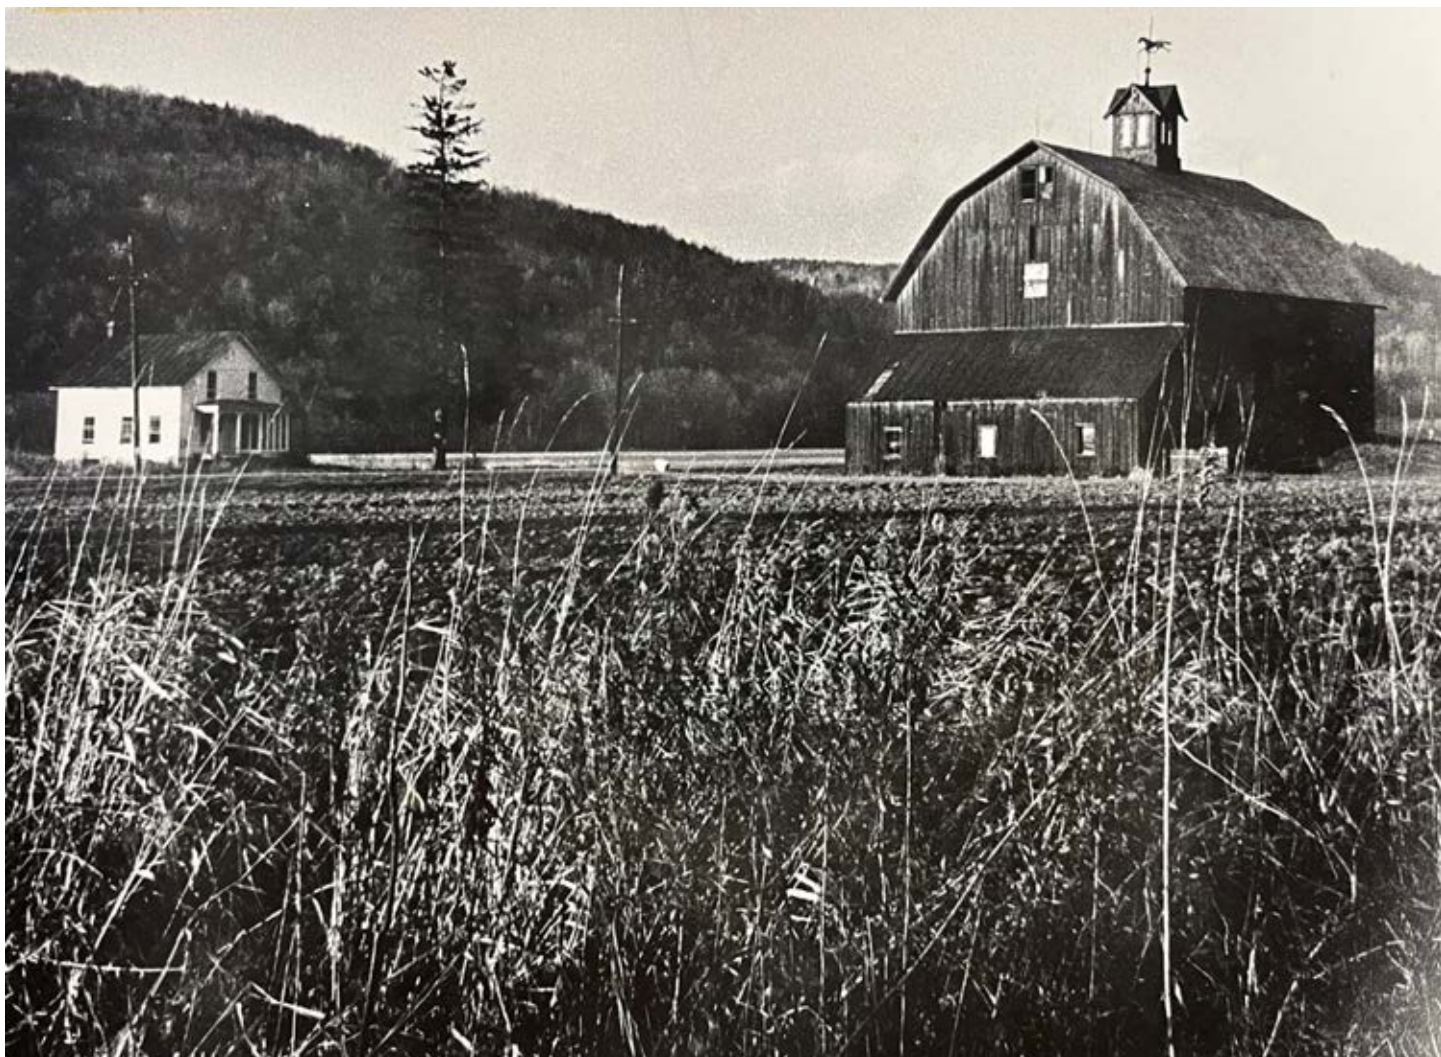
Figure 1: Barn prior to Romanoff and Saltonstall conversion project, note original farmhouse prior to demolition, and shed roof addition on barn gable end.

In 1965, Ivan and Harriet Bower sold an approximately forty-two-and-a-half-acre lot on the east side of Elmira Road (Route 13) to Saltonstall and Romanoff. This lot included the 1883 barn and a small wood-frame hen house. A year later the Bowers sold another two lots of twelve acres and seventy-three acres to Saltonstall and Romanoff. This land, on the west side of the highway, included a nineteenth-century wood-frame house associated with the farm (Figure 1).²¹ Romanoff later recalled that the house was in a deteriorated state when

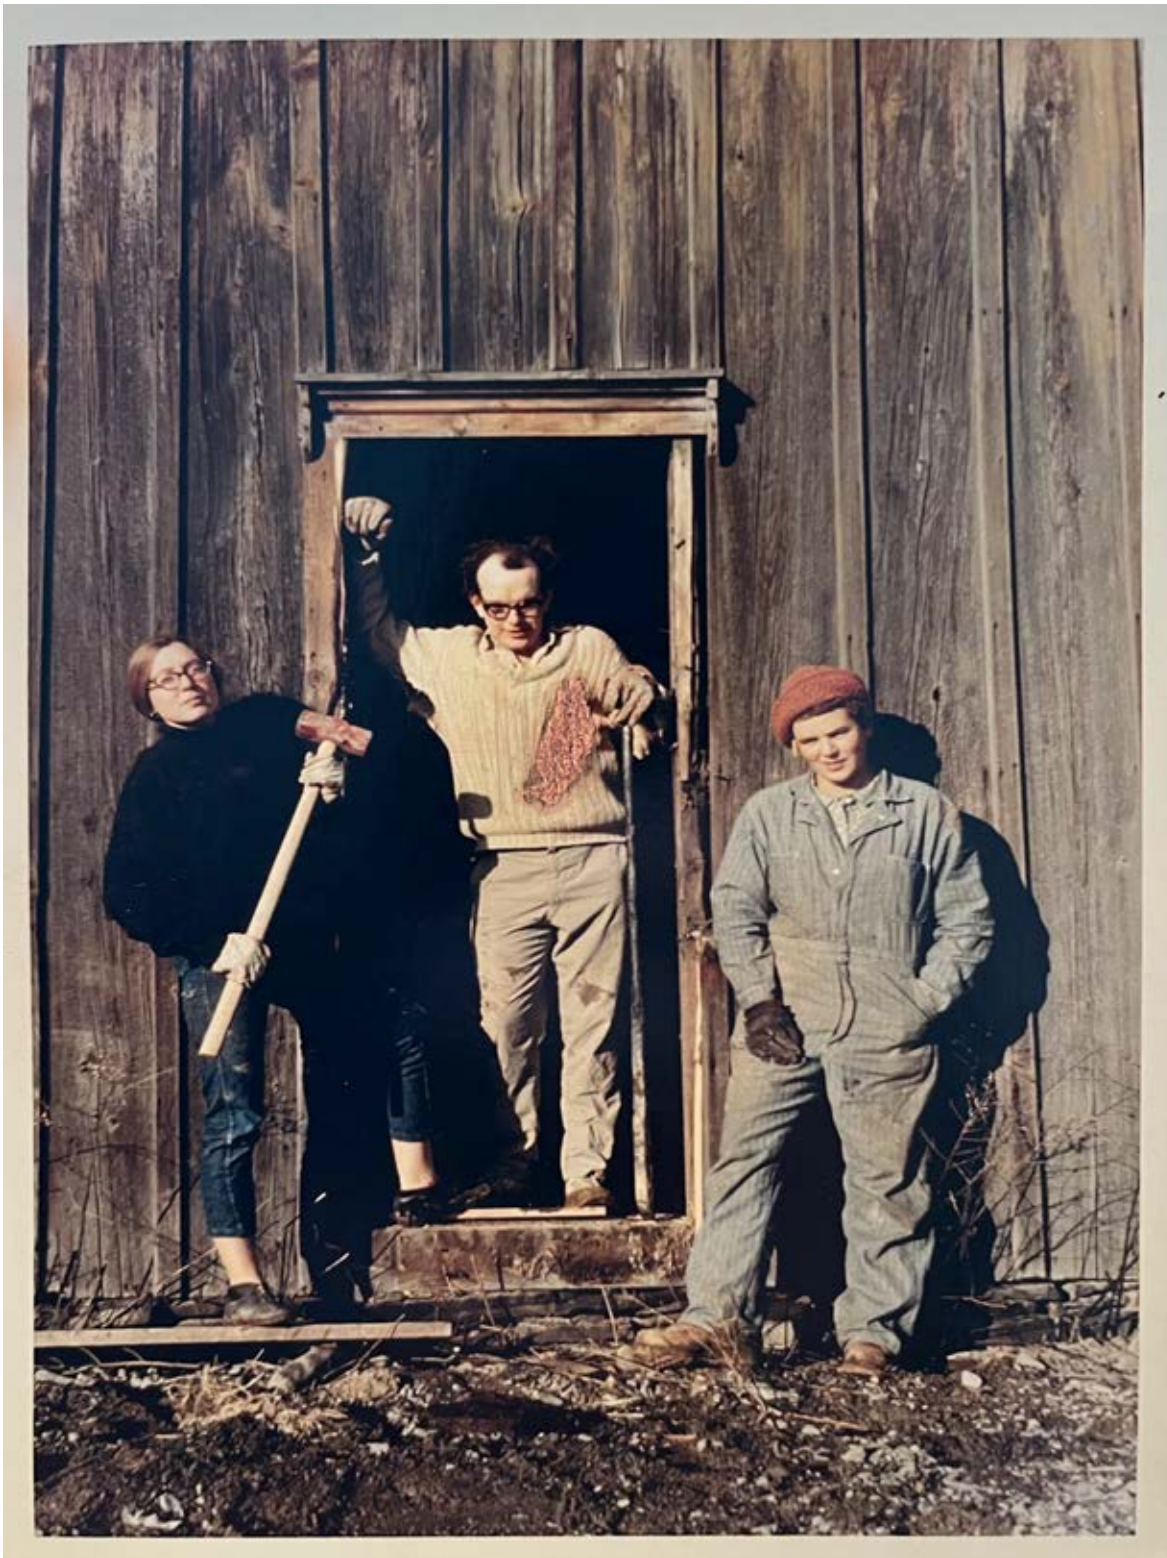
Figure 2: The 1883 Barn conversion involved many assistants and volunteers.

They began work without a clear design or plan with the aid of several friends and helpers (Figure 2). “‘We had nothing particular in mind when we started,’ Romanoff said, adding that she originally sought to ‘work with what we had and not lose the building’s openness.’”²³ Much of the first year was spent cleaning out the structure—of materials left behind by the previous owner and their livestock. Clearing tons of manure and sandblasting layers of old lime paint revealed the extent to which the foundation had deteriorated. They lifted the barn with screw jacks and inserted new concrete footers in place of rotted wood beams (Figure 3). They built new concrete masonry unit (concrete block) walls on the north, south, and west sides, and the east side walls flanking the surviving area of original masonry wall.²⁴

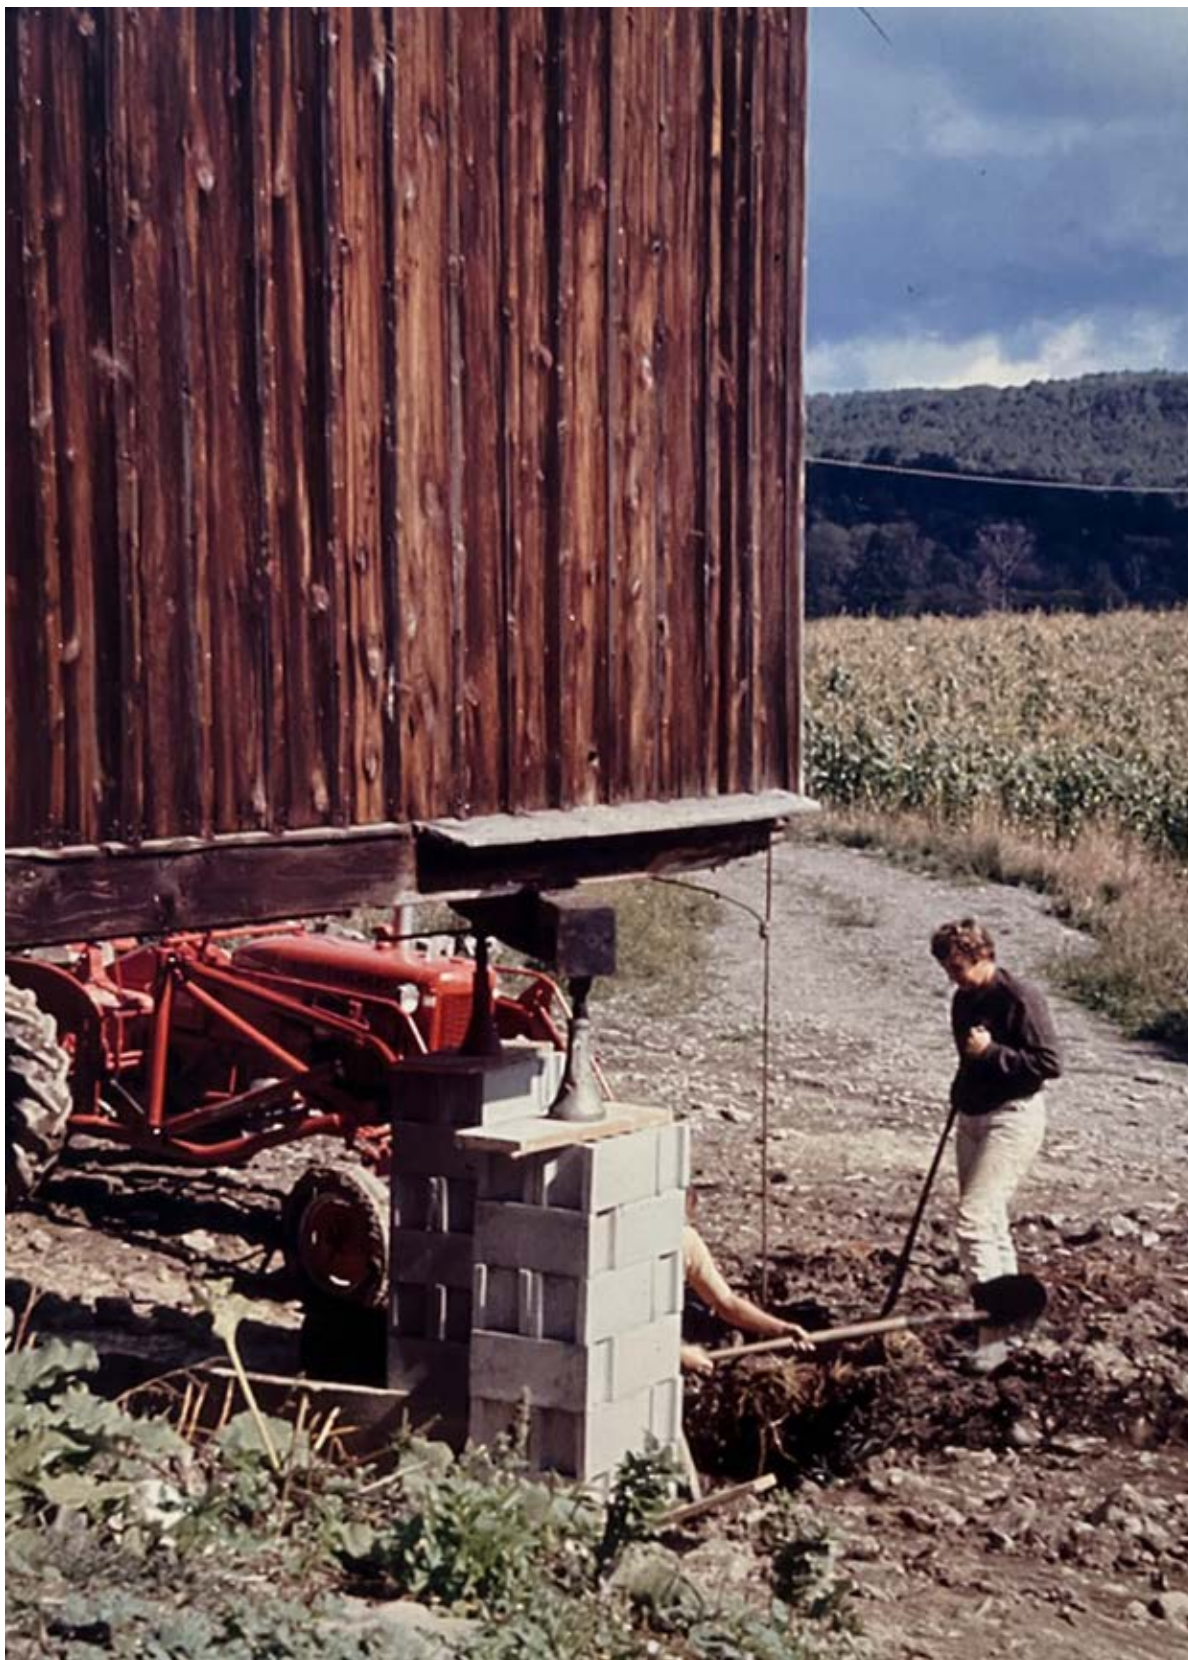
Figure 3: Vicky Romanoff and friend leveling barn and installing masonry block foundation.

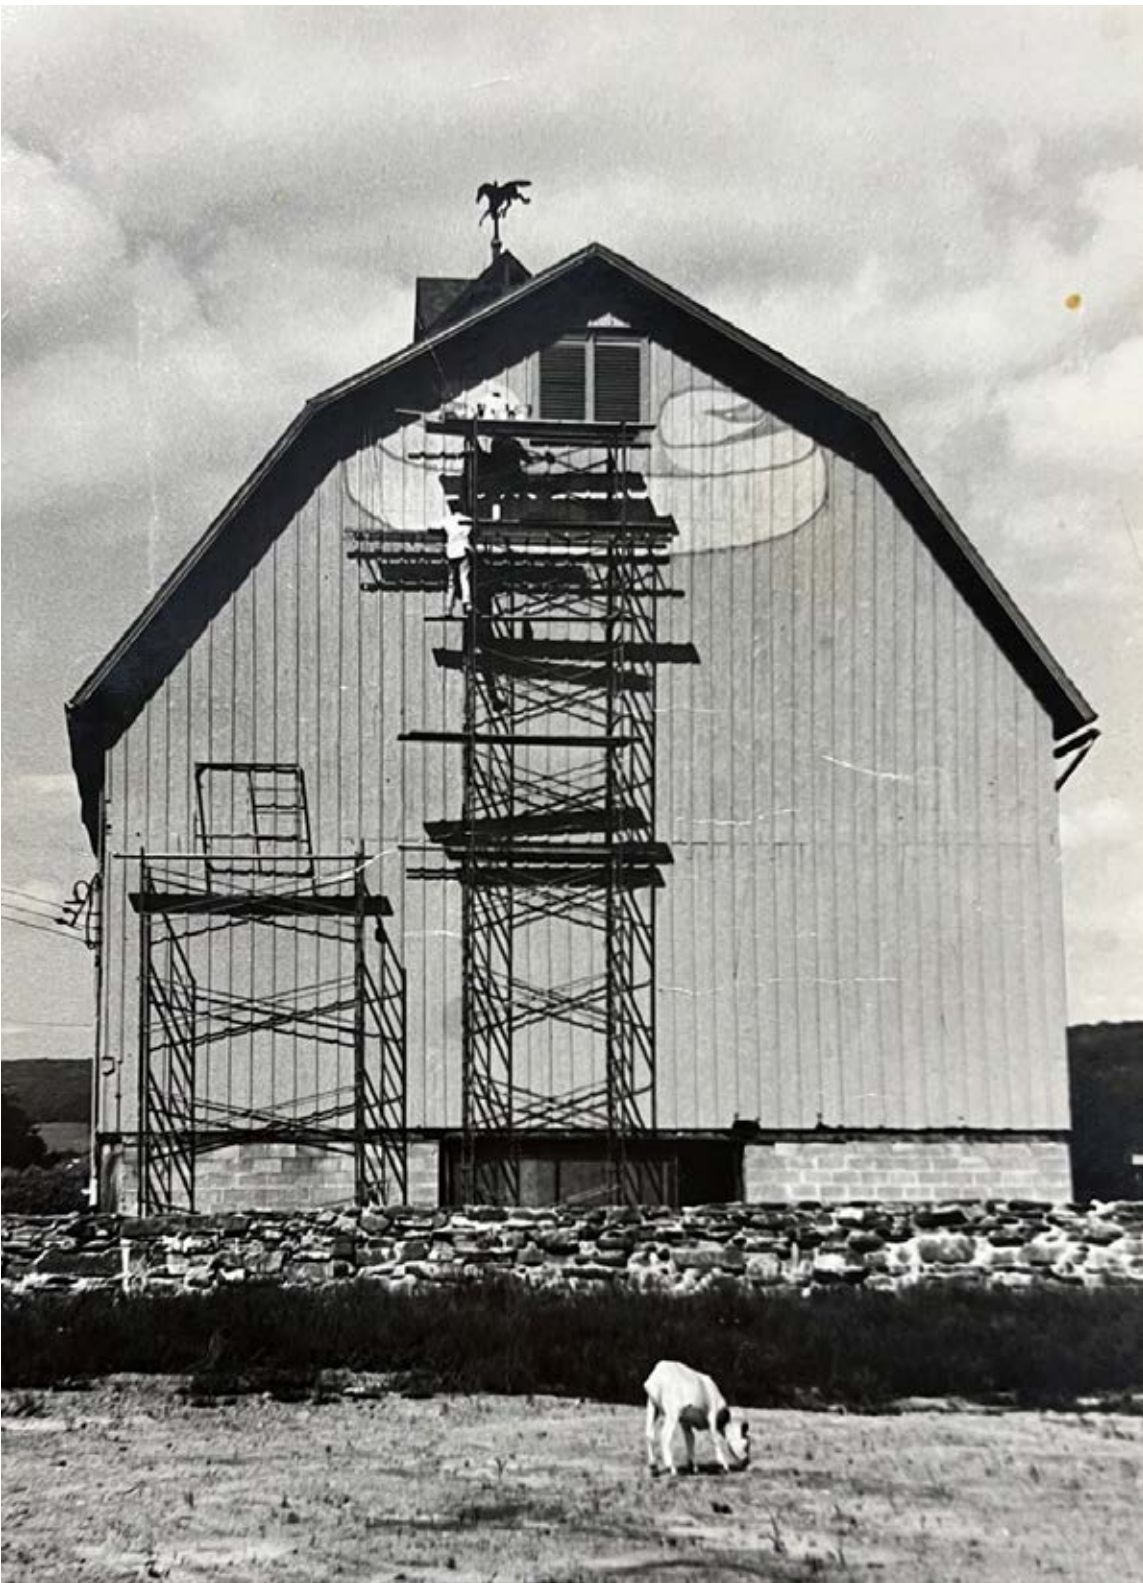
Figure 4: Romanoff repainting gable end.

On the exterior, they replaced the entire roof surface with twenty-four-inch long hand split shakes that survive on the building in 2025, reworked the cupola (replacing louvers with sash windows), and installed a hammered tin weathervane.²⁵ They covered the barn’s brown color with a new paint color and accent and repainted the faded “A.D. 1883” and swag in the gable ends (Figure 4).²⁶

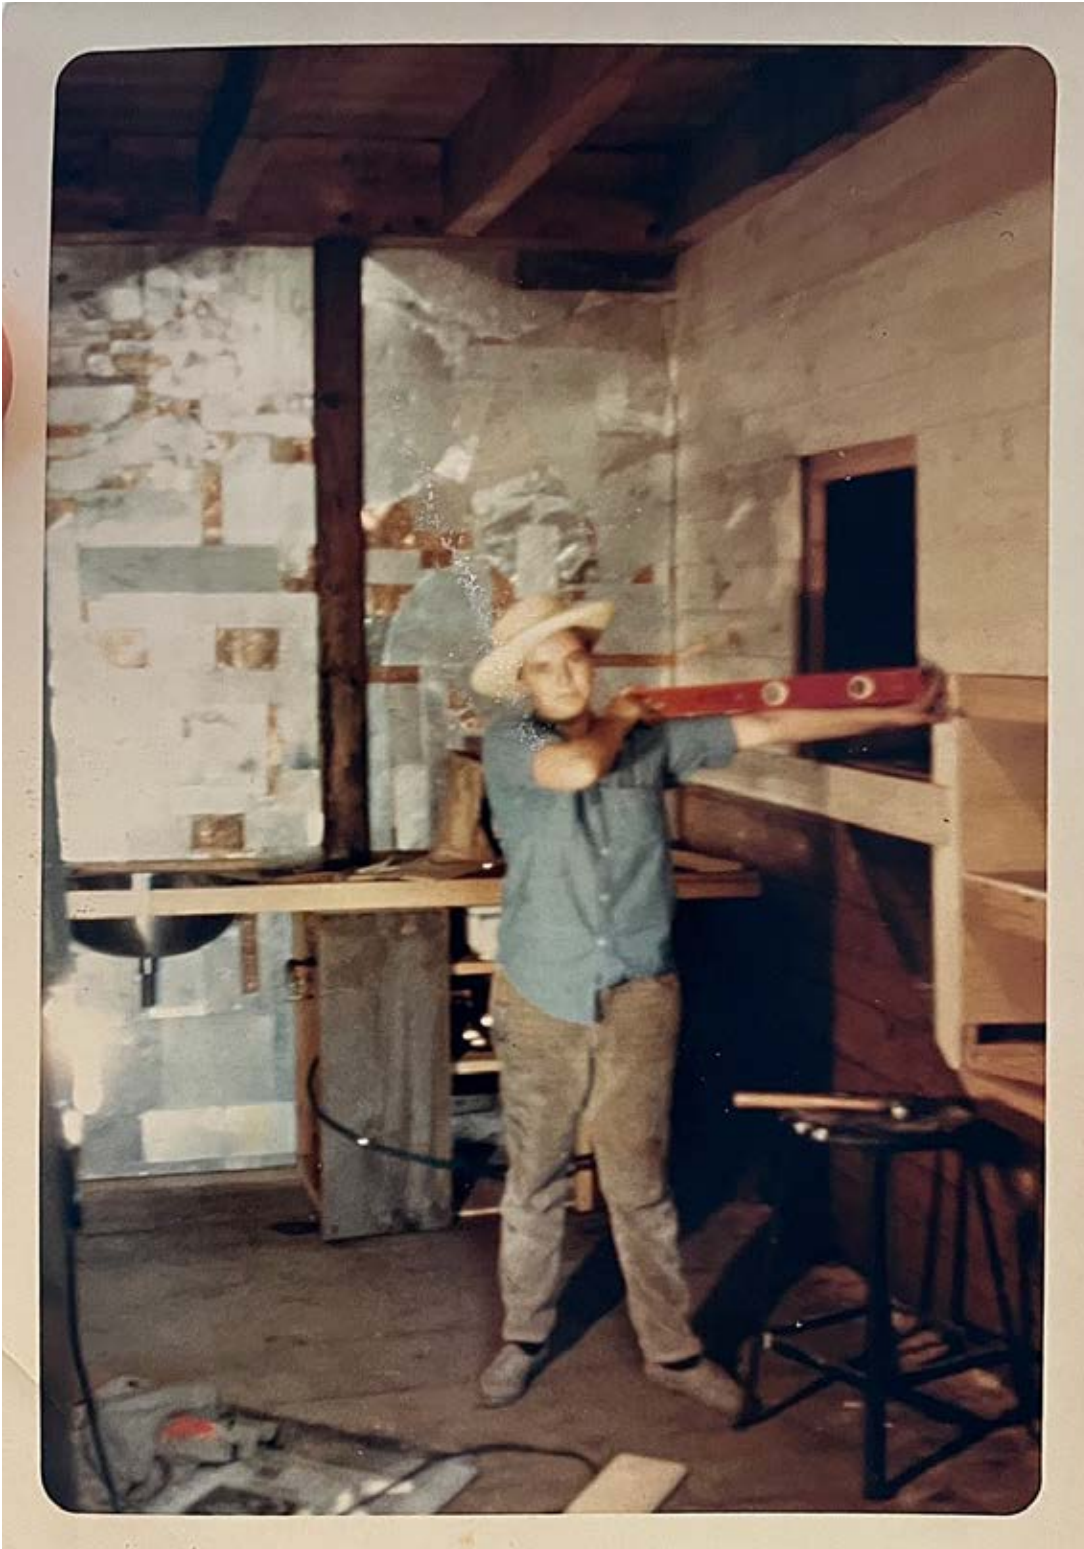
Figure 6: Romanoff working on the kitchen. Wall mosaic is to rear.

The kitchen featured exposed ceiling beams, fieldstone countertops, and a cooking area and appliances concealed within a brick-lined cooking alcove to retain the “rustic effect” of the space (Figure 6). Bricks in the alcove were salvaged from the Ithaca City Hall, demolished in 1965. Most distinct was the scrap metal collage that covered the kitchen’s entire west wall (including behind the counters and sink). Romanoff assembled the collage by nailing into geometric patterns pieces of metal she gathered from the Ithaca-based building supply company, Robinson and Carpenter. According to Romanoff, the “old-timers” there would set aside materials that were left over or would otherwise be discarded—whether it was bits of lumber, unsold windows, or metal—for Romanoff to pick through. Romanoff and Saltonstall also received assistance from Cotton-Hanlan, a lumber dealer in downtown Odessa that Romanoff recalled was very generous and supportive. When workers there got to know Romanoff and Saltonstall and learn about the barn project, the workers would set aside piles of cut boards and scrap that were not commercially valuable for her to select from and purchase at little charge.

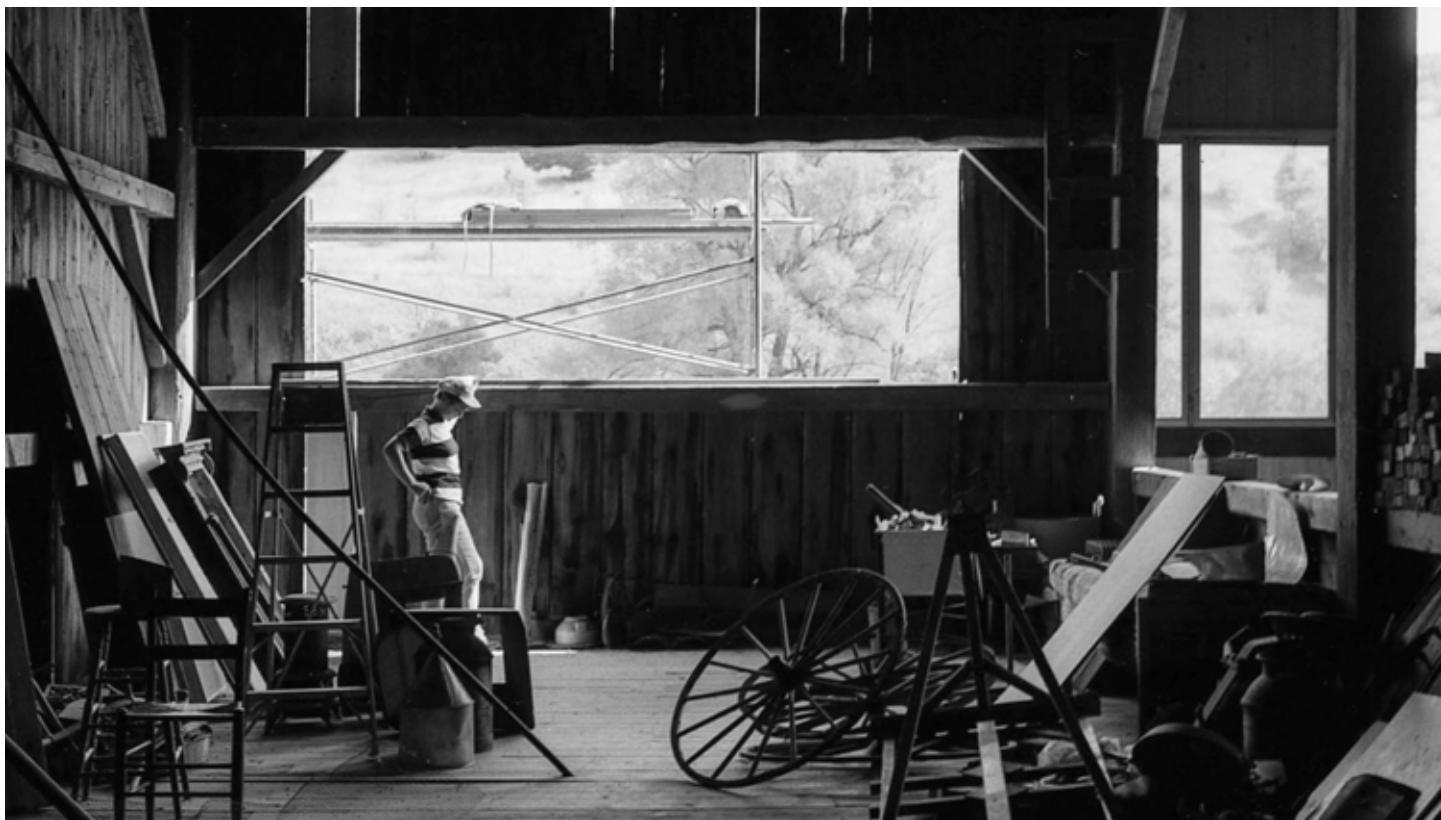
Figure 7: Romanoff working on the living room, with window opening cut but sash not yet installed.

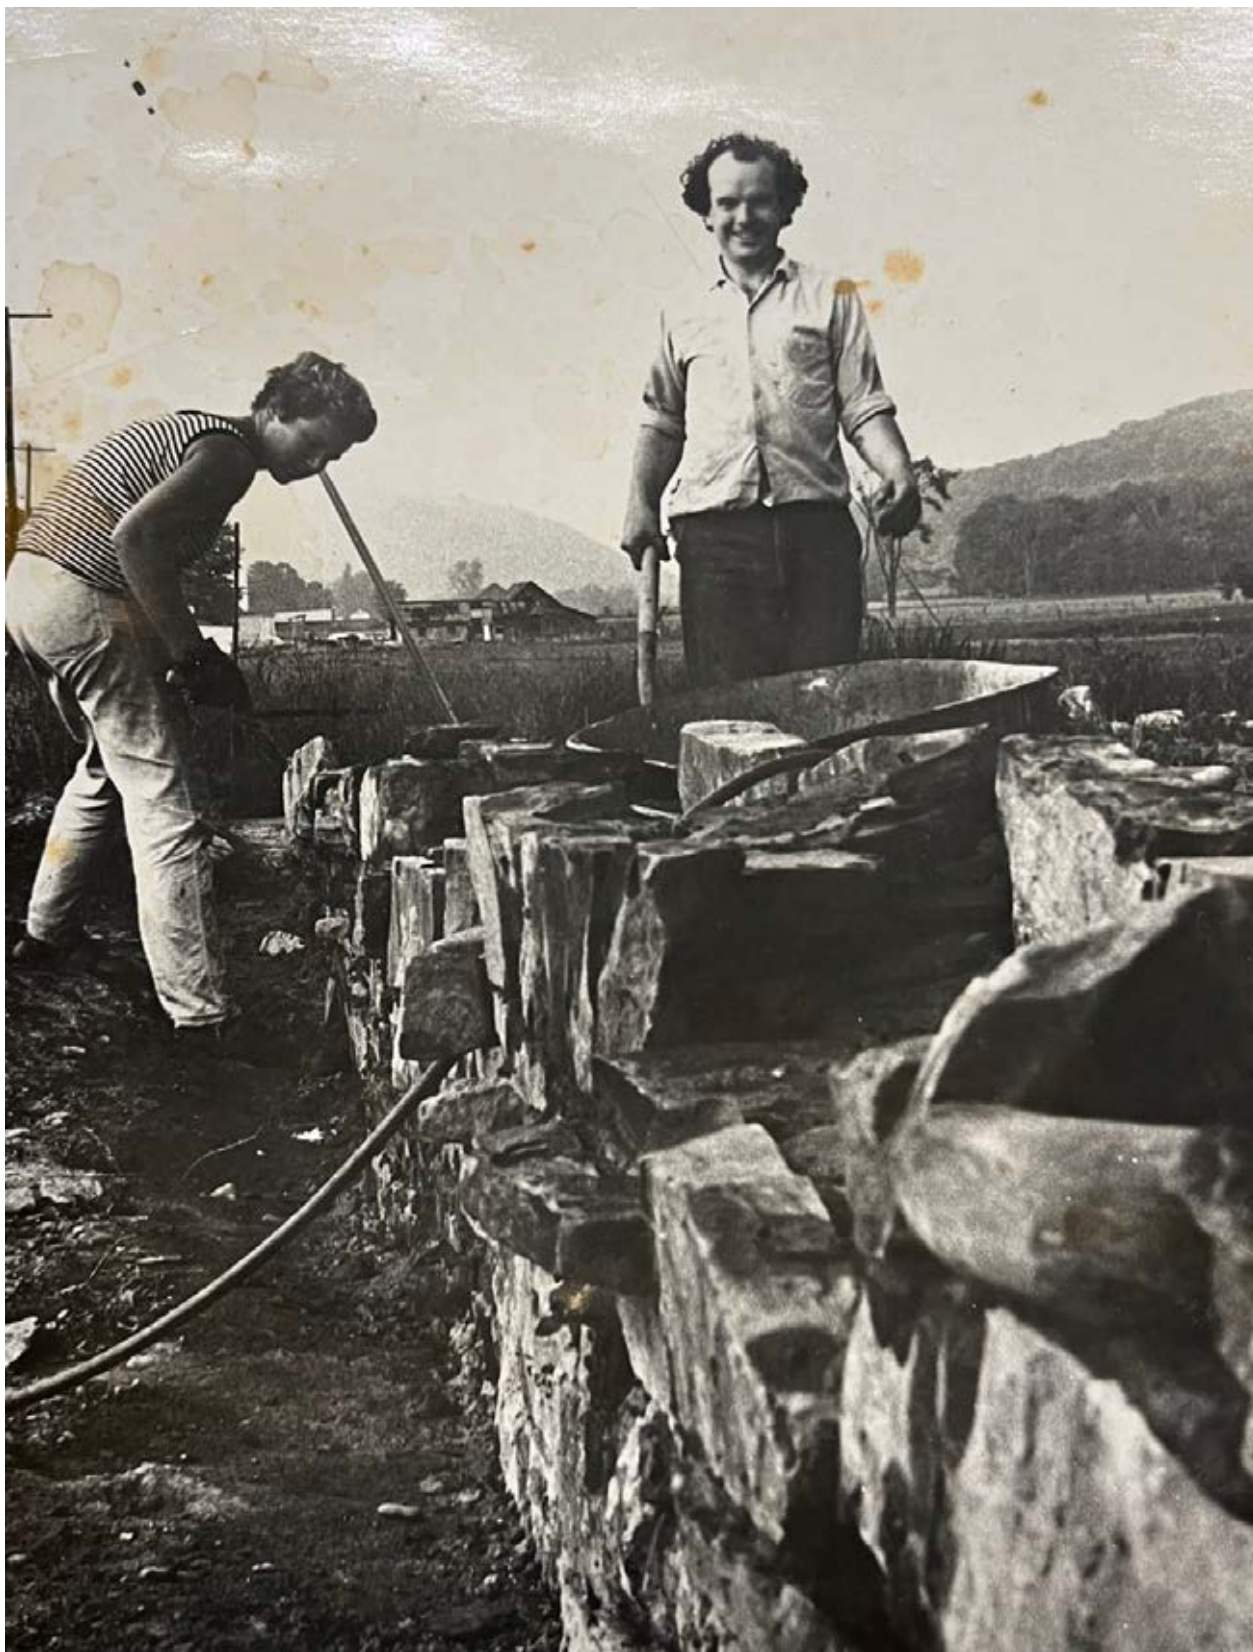
Figure 8: Romanoff and friend building the stone wall.

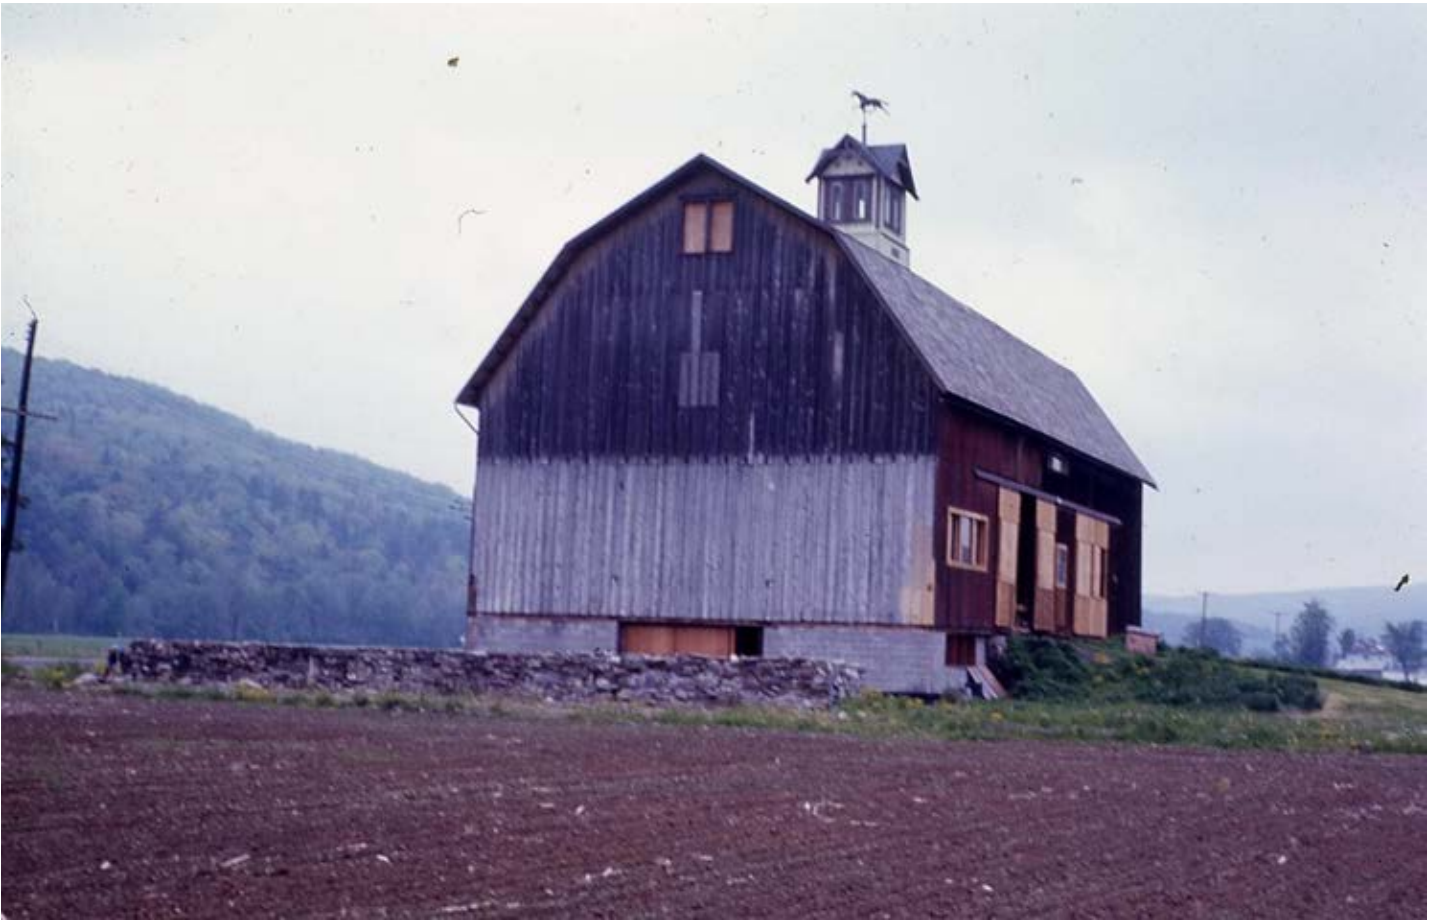
Figure 9: State of the conversion process in 1968, showing how alterations were sensitively integrated into the barns historic configuration.

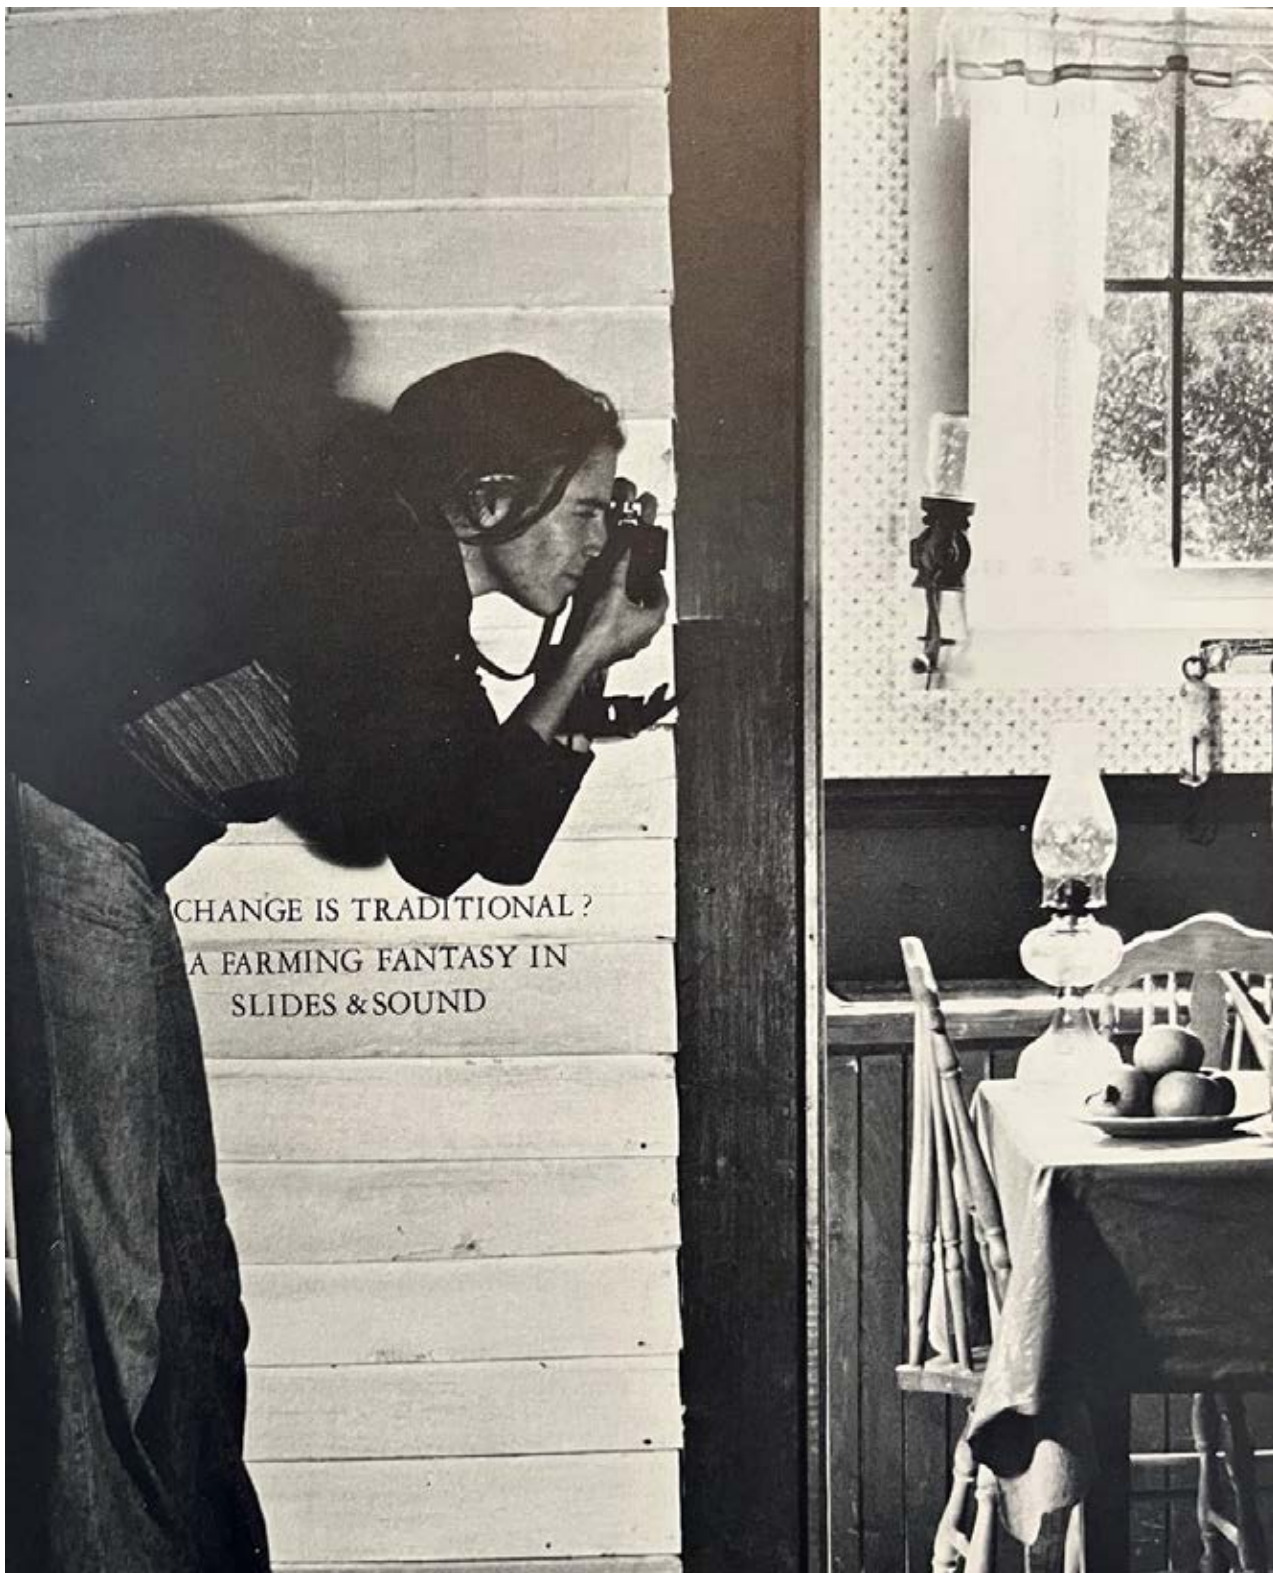
Figure 11: Connie Saltonstall photographing the *Giddy Up Napoleon* exhibition.

The most significant event organized at the barn was a two-week exhibit held daily from October 17 to 31, 1976. Titled *Giddy Up, Napoleon! It Looks Like Rain!*, after a popular nineteenth-century plowing song, the exhibition celebrated the long history of agriculture in Tompkins County (Figure 11).⁴² A collaboration between Saltonstall, Romanoff, and Sarah Adams, the event was presented to the public as an open house (or open barn) that also marked the completion of Romanoff and Saltonstall's decade long conversion project. The *Ithaca Journal* noted that "To be sure, the renovation work has been done sporadically. But it's now accomplished and the two are ready to open the barn door, so to speak, and let the crowds in."⁴³

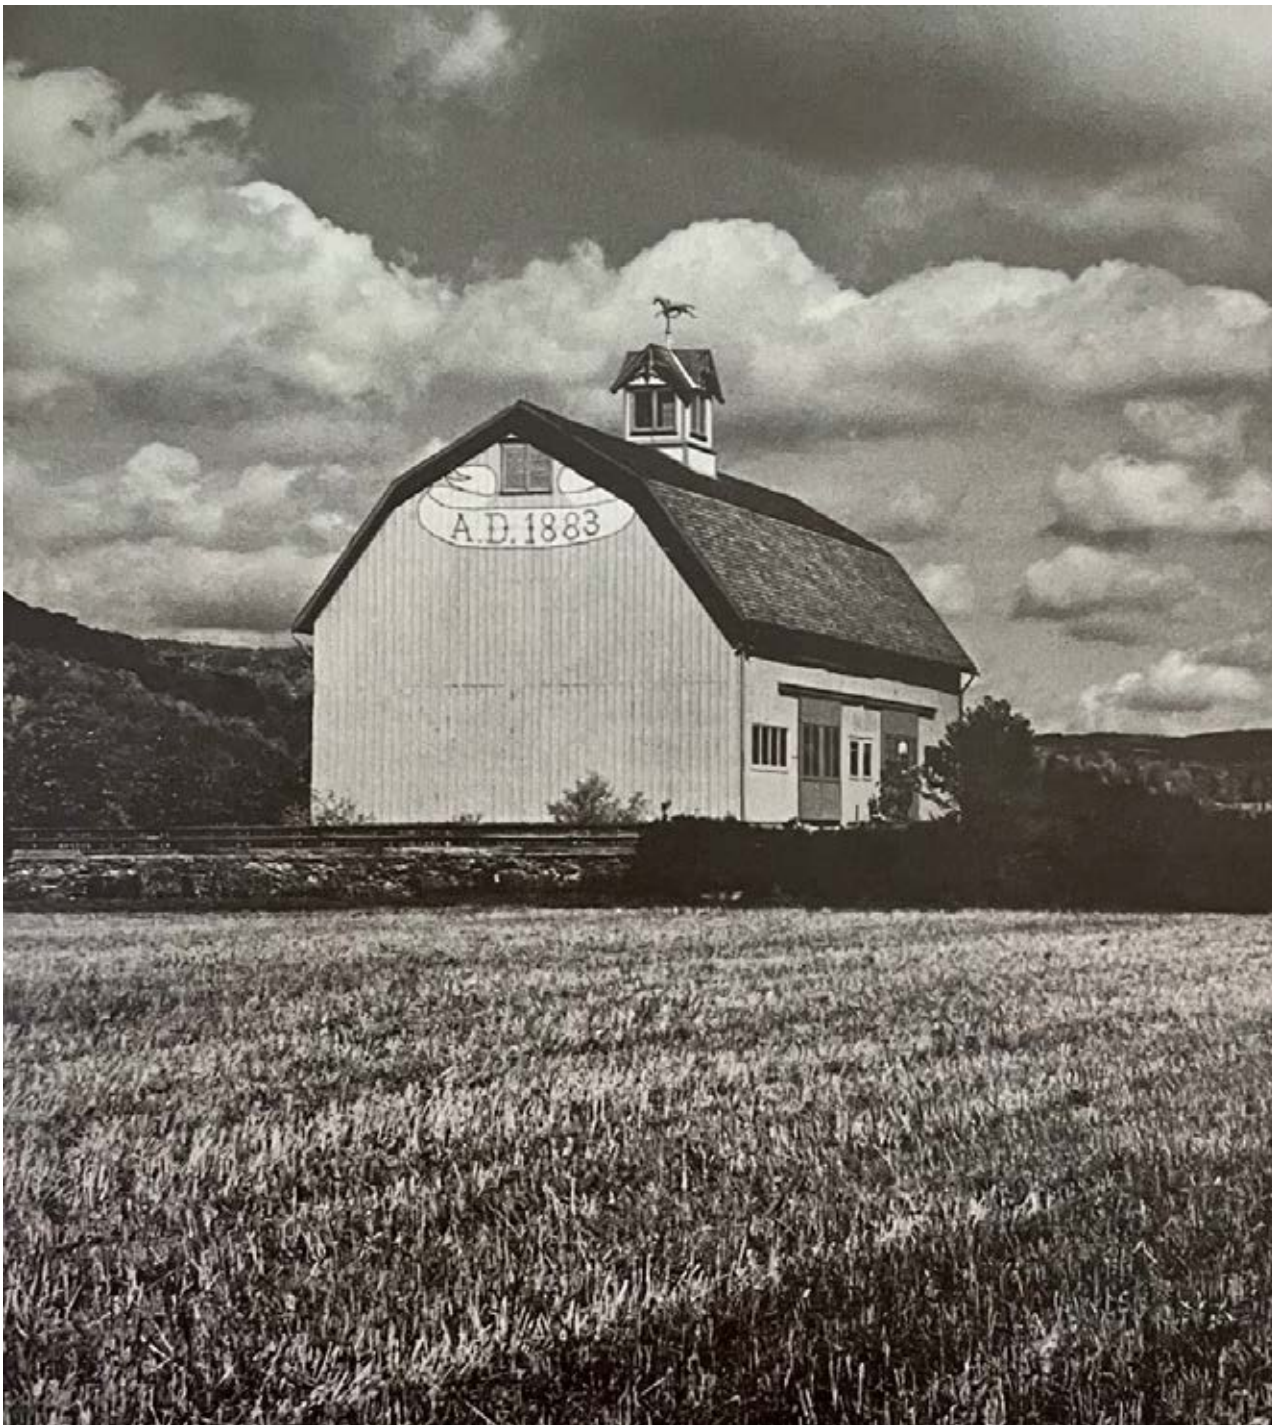
Figure 12: 1883 Barn as shown in 1988 sales prospectus.

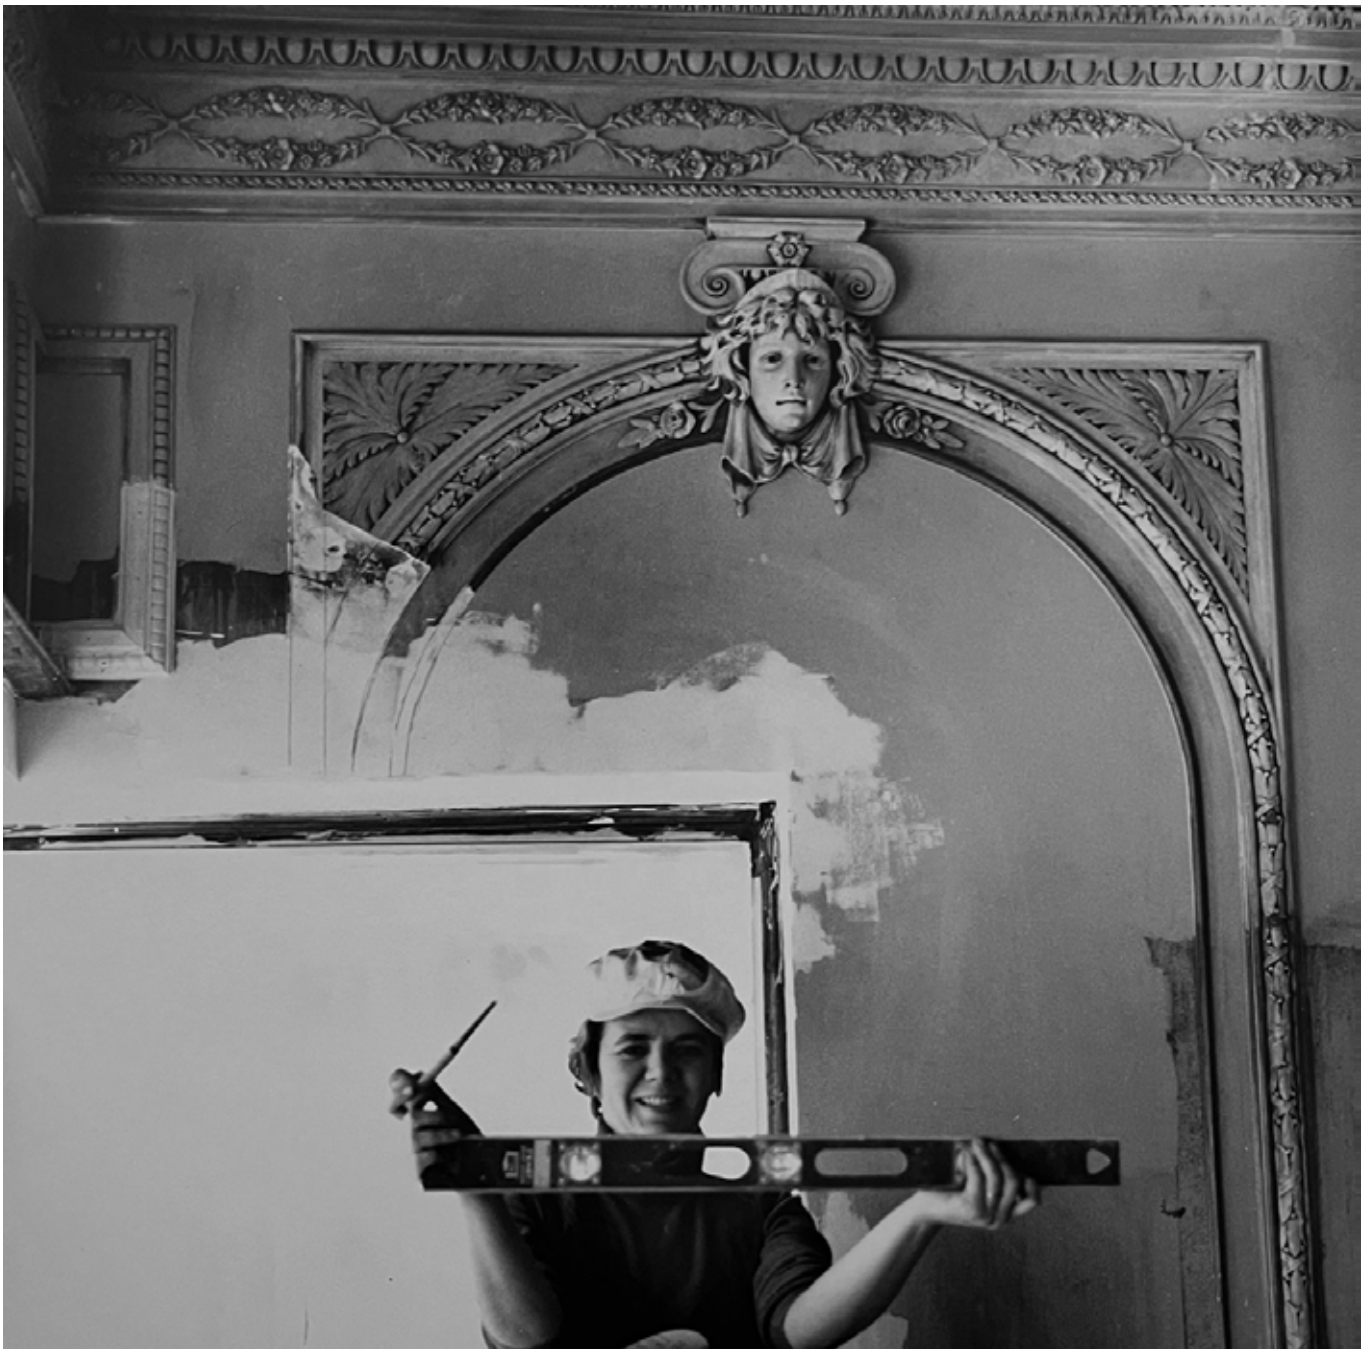
Figure 13. Romanoff working on Simeon's restaurant rehabilitation.

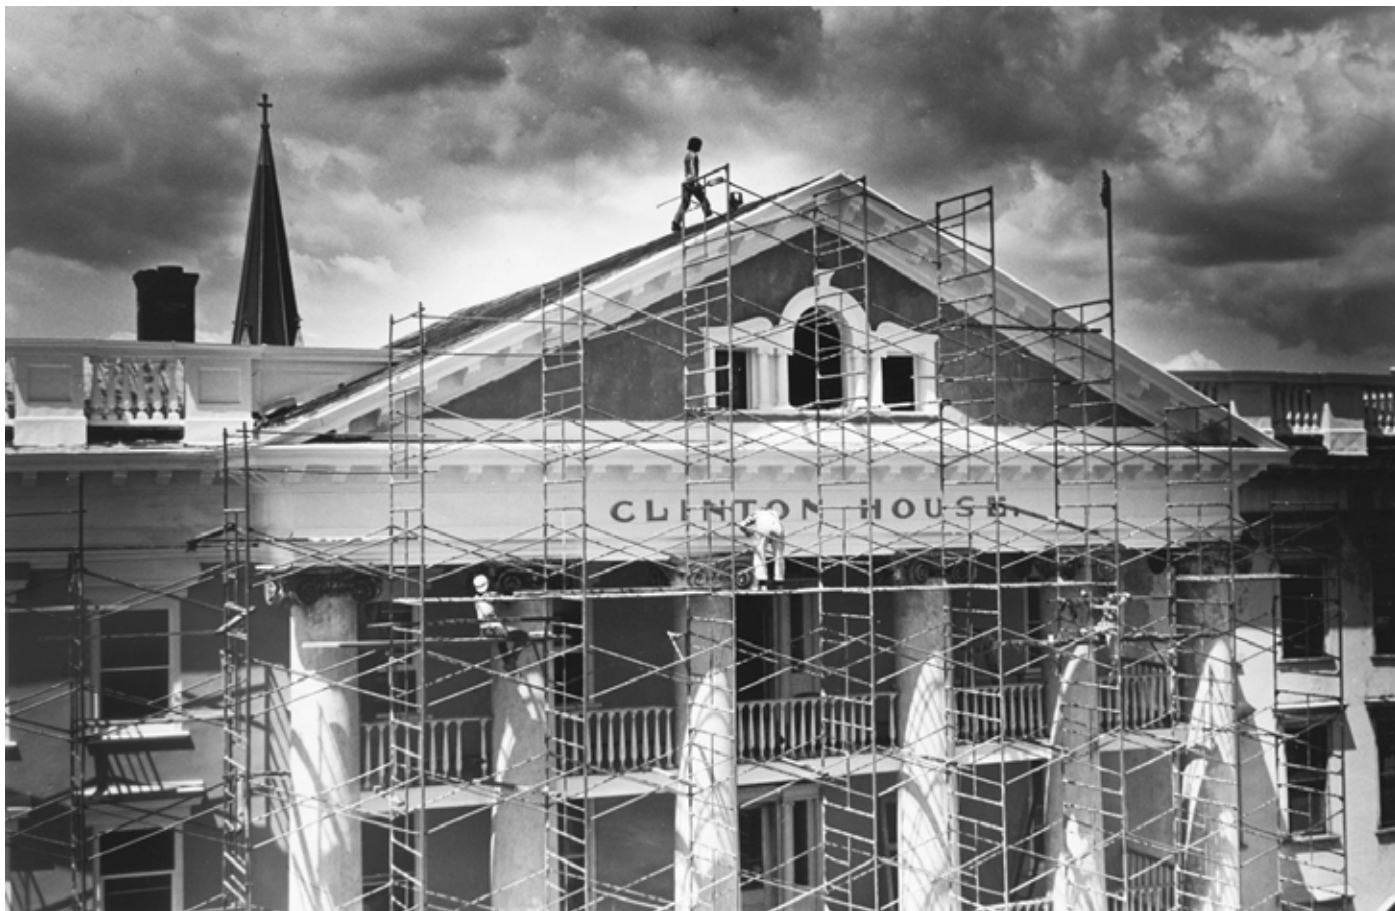
Figure 14. Restoration of the Clinton House in Ithaca.

A decade later, Romanoff and Adams were involved in the preservation of Clinton Hall, a 1837 to 1846 Greek Revival commercial building next door to Clinton House. The building was severely damaged in a 1975 fire and was threatened with demolition when Romanoff and Adams, along with Jules Burgevin, Historic Ithaca, and its then executive director, Carol U. Sisler, and other community members, helped forestall its destruction.⁵⁵ In 1985, developer Joseph Ciaschi purchased the building and hired Romanoff and Associates to lead an extensive rehabilitation campaign that included reconstructing historic cast-iron storefronts, the second-floor balcony, and the roof balustrade.⁵⁶
