United States Department of the Interior
National Park ServiceNational Register of Historic Places
Registration Form

1. Name of Propertyhistoric name Ballston Spa National Bankother names/site number N/Aname of related multiple property listing N/A**2. Location**street & number 87 Front Street

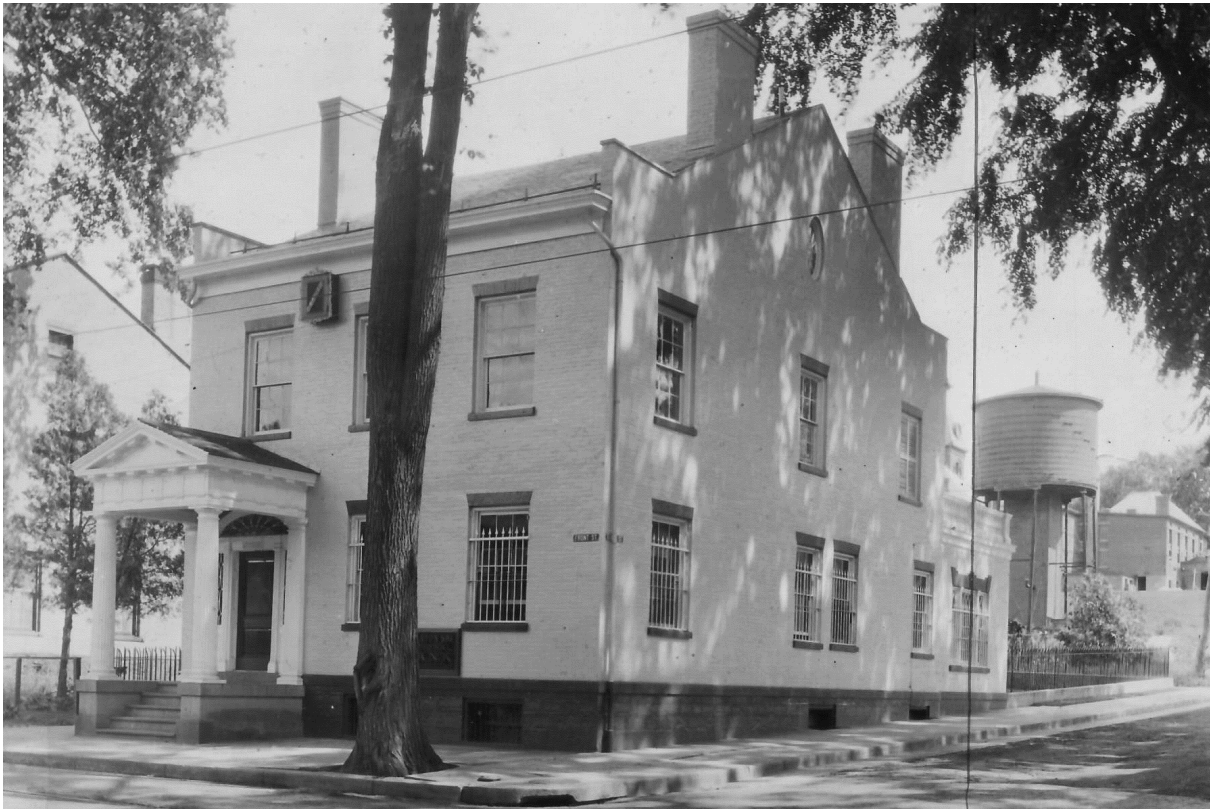
Figure 1: Historic photo from 1915 taken from northwest, showing 1911 brick addition off southwest corner.

second floor. Today, there is a joint in the brick of the west wall that corresponds with the southwest corner of the 1911 addition. In 1924, Albany architect Marcus T. Reynolds was engaged to design an addition to house a new state-of-the-art vault with a marble-clad lobby that included four private viewing booths for the safe deposit box holders. This was also clad on the exterior with brick walls and a flat roof. Historic photos show a simple cornice with a stepped profile wrapped both additions. The 1924 addition is now entirely enveloped within the later 1970 addition, although on the interior the marble clad lobby and original 1924 vault remain fully intact.

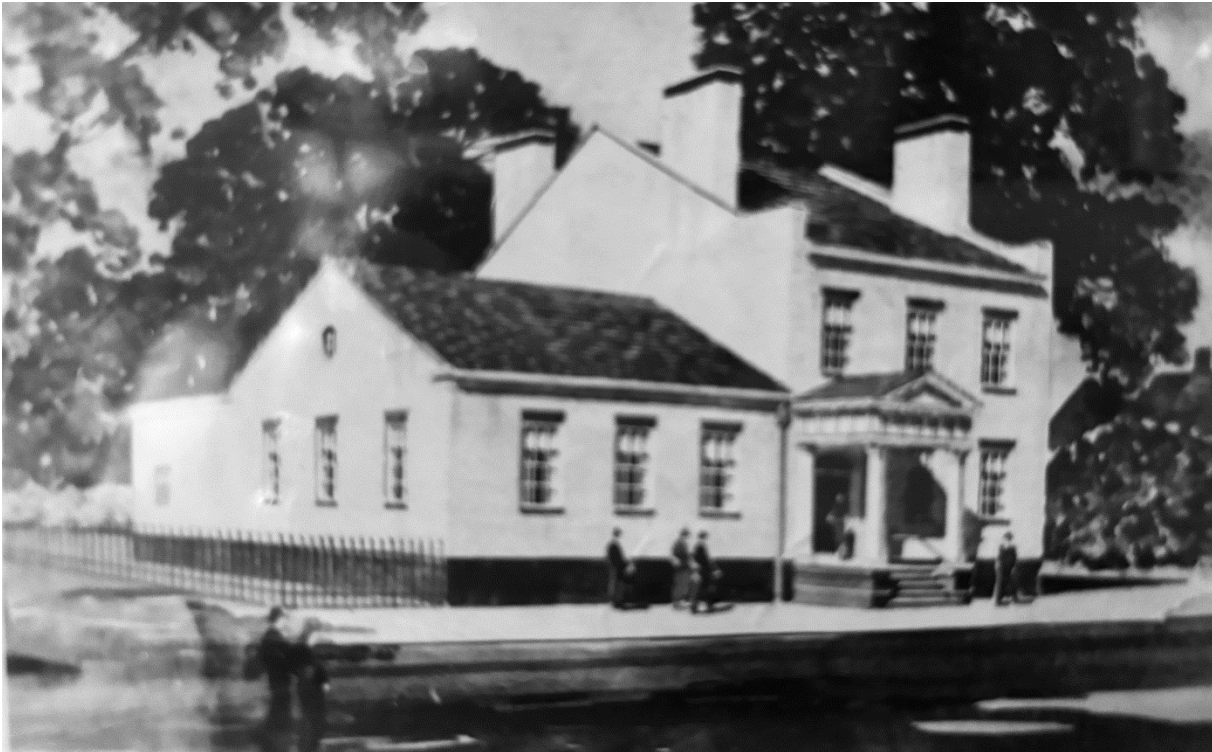
Figure 2: Hoggson Brother's rendering of 1952 expansion

while modernizing the interior. These changes are seen today in the one-story addition appended to the original east wall using matching brickwork, foundation, uniform window openings and replicating the pitch of the gabled roof. With attention given to complementing the Federal style of the original building, the east wing was made to look as if it were always part of the original construction, despite doubling the footprint of the banking room interior. This east wing included a flat roofed extension off the rear, connecting to and matching the earlier rear additions.

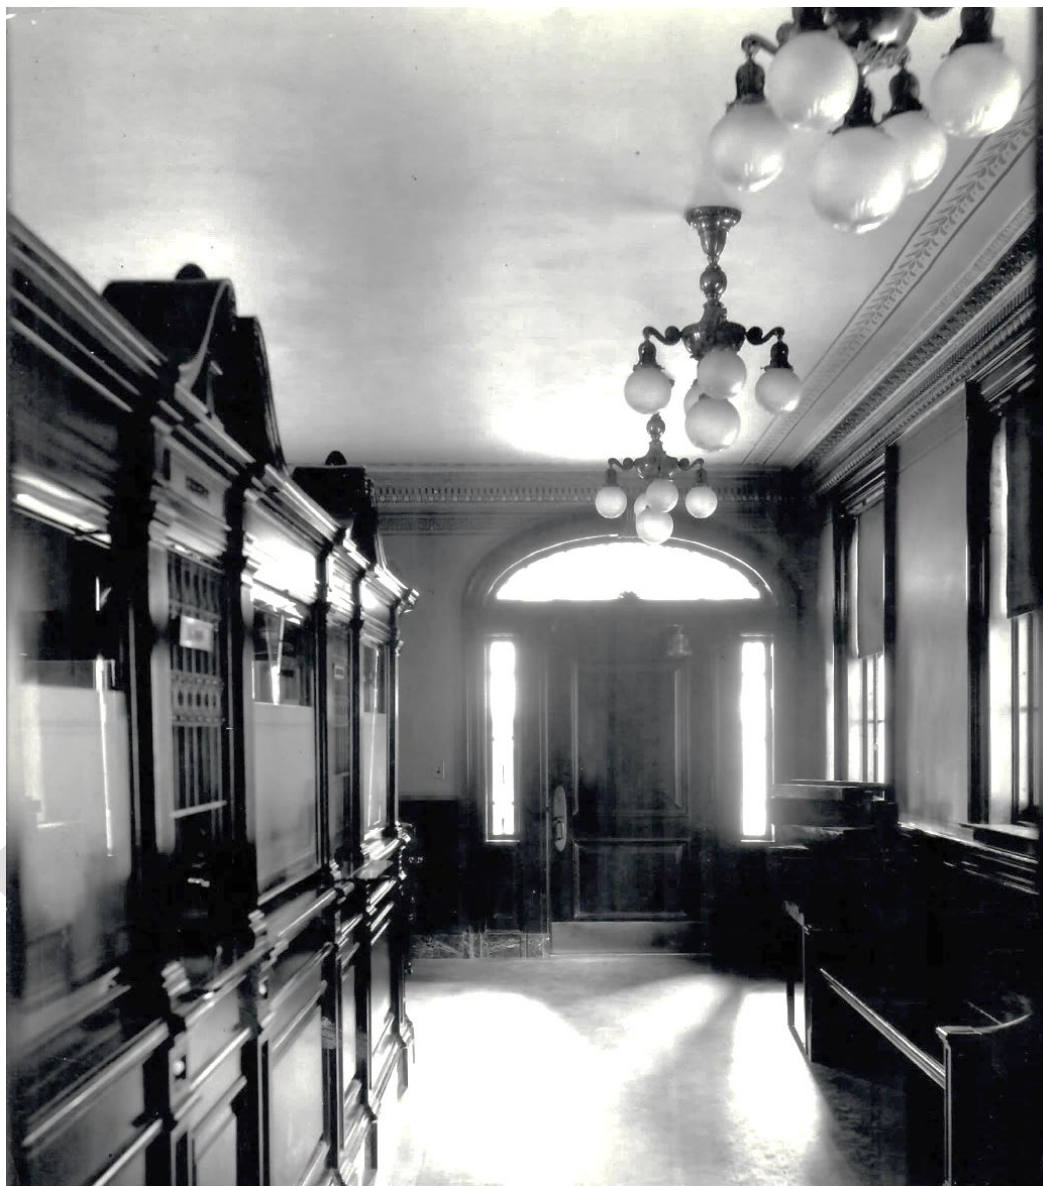
Figure 4: View of interior, front banking room with teller screen to west of entry door.

a large open space was arranged with workstations lit by two windows on the north and two on the west wall. To the east of the teller screen was a broad hallway, or lobby space, with windows on the east wall that terminated at the main staircase and doorway to the president's office in the southwest corner. The window and door trim according to historic photos was wide and deeply molded, with a dark stain or painted finish. By 1900, the bank house was heated with a hot water radiator system and was wired for telephone.

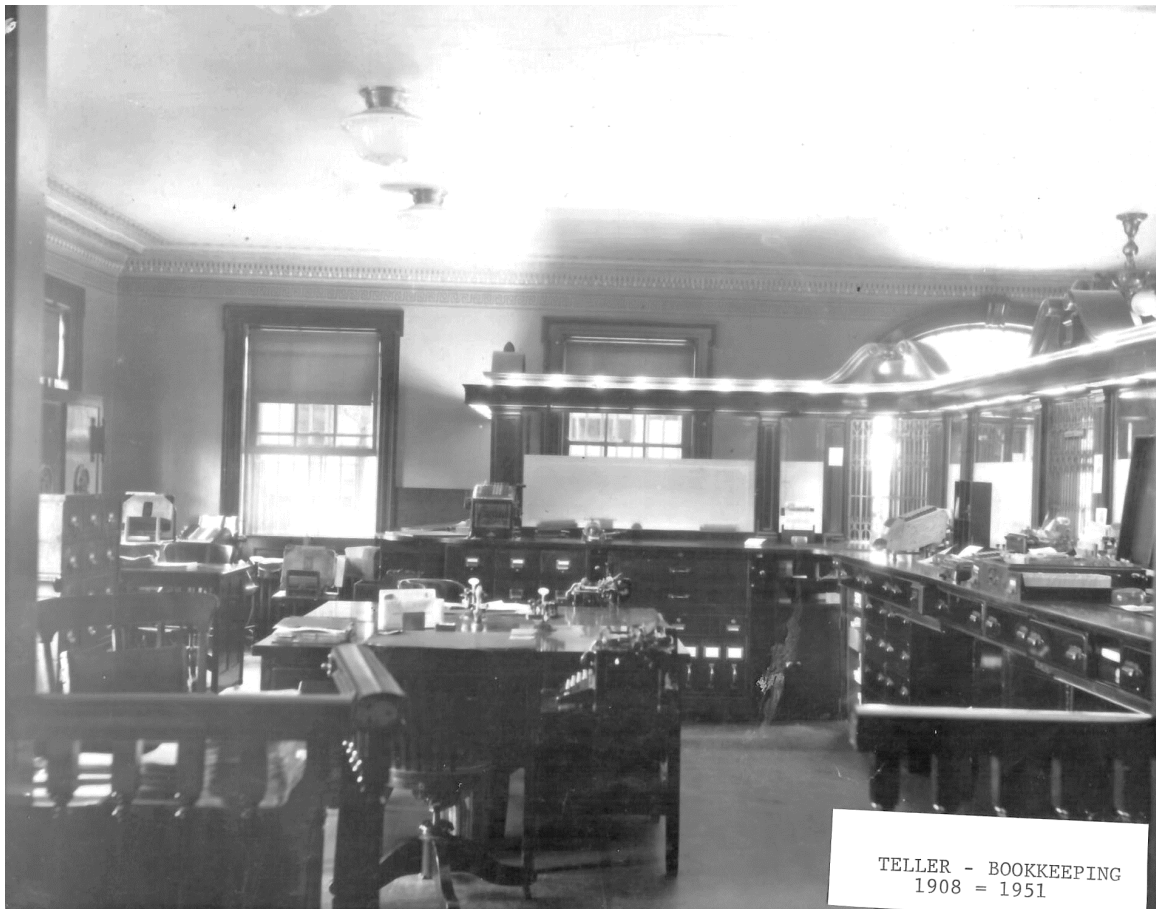
Figure 5: View of interior banking work room in front northwest portion of building.

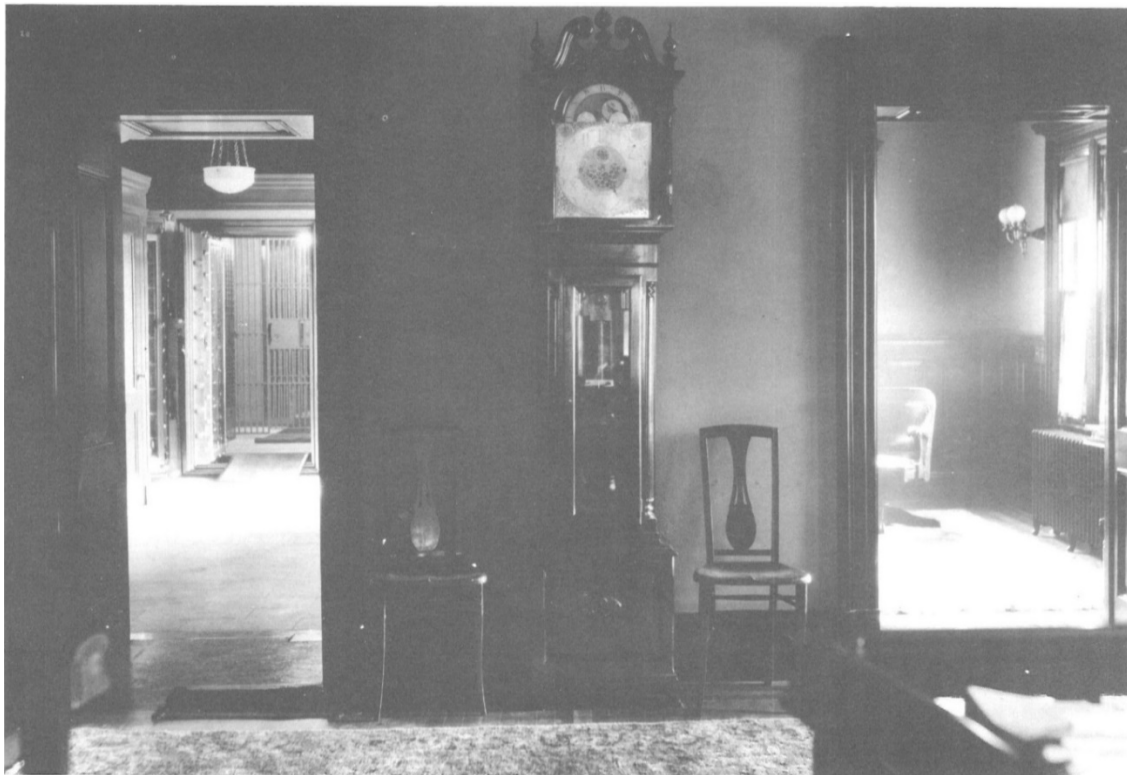
Interior of Home Office Ca 1925

Figure 6: Historic photo ca. 1925 showing new vault & vault lobby on the left.

foot-deep reinforced concrete. The walls of the vault were built of eight-inch thick steel and concrete with the steel being laid in plates to restrict drilling or burning. Two steel doors weighing seven tons and one ton, respectively, lock with combination and time locks with forty-six bolts into a ten-ton steel frame. The floors and walls of the surrounding vault room were finished with marble and featured four booths for box holders. The vault interior contained 454 safe deposit boxes of differing sizes, compared to the previous offering of sixty boxes. The entire bank building was equipped and protected using electricity at this time.¹²

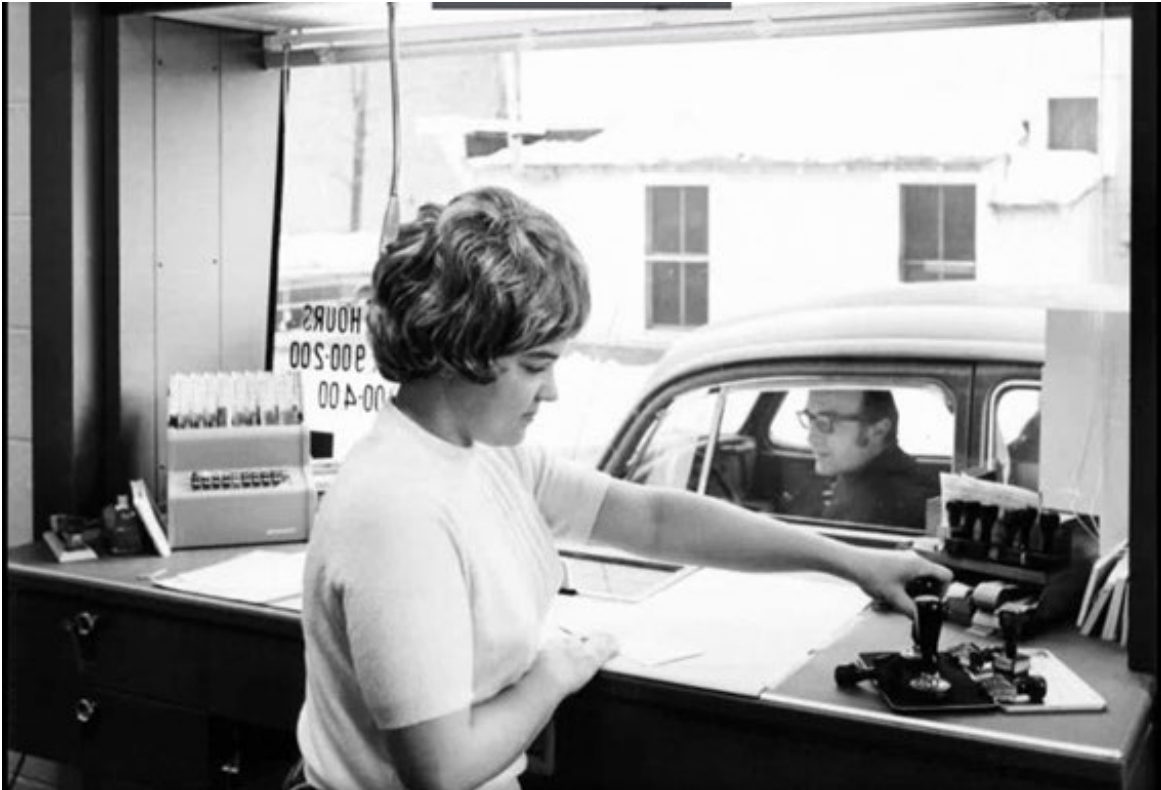
Figure 8: View from within new teller booth along east elevation showing drive-up teller window.

Within three years of completion, in the summer of 1973, the drive up window on the east side was further expanded to include brick columns supporting a roof structure and the installation of "satellite windows" that are electronically controlled with an audio panel and pneumatic carrier tubes to transport the transactions between customer and teller.¹⁶

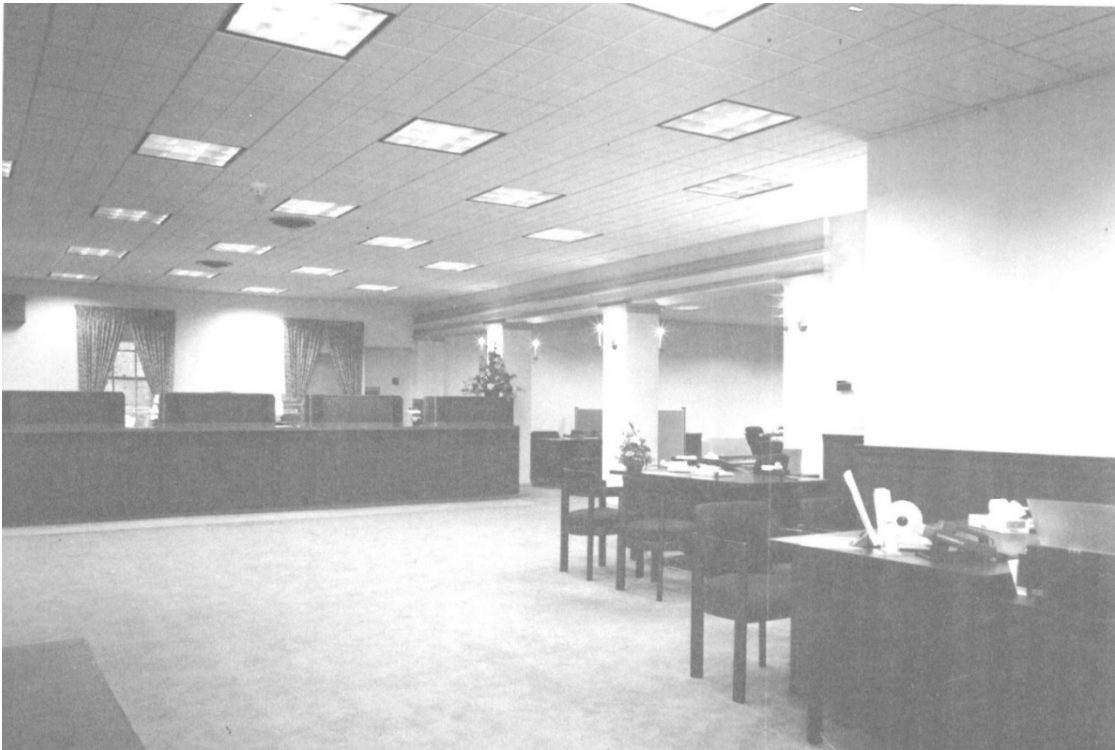
Figure 9: View of bank lobby space after 1985 expansion. Note the teller counter has been moved to along the east wall.

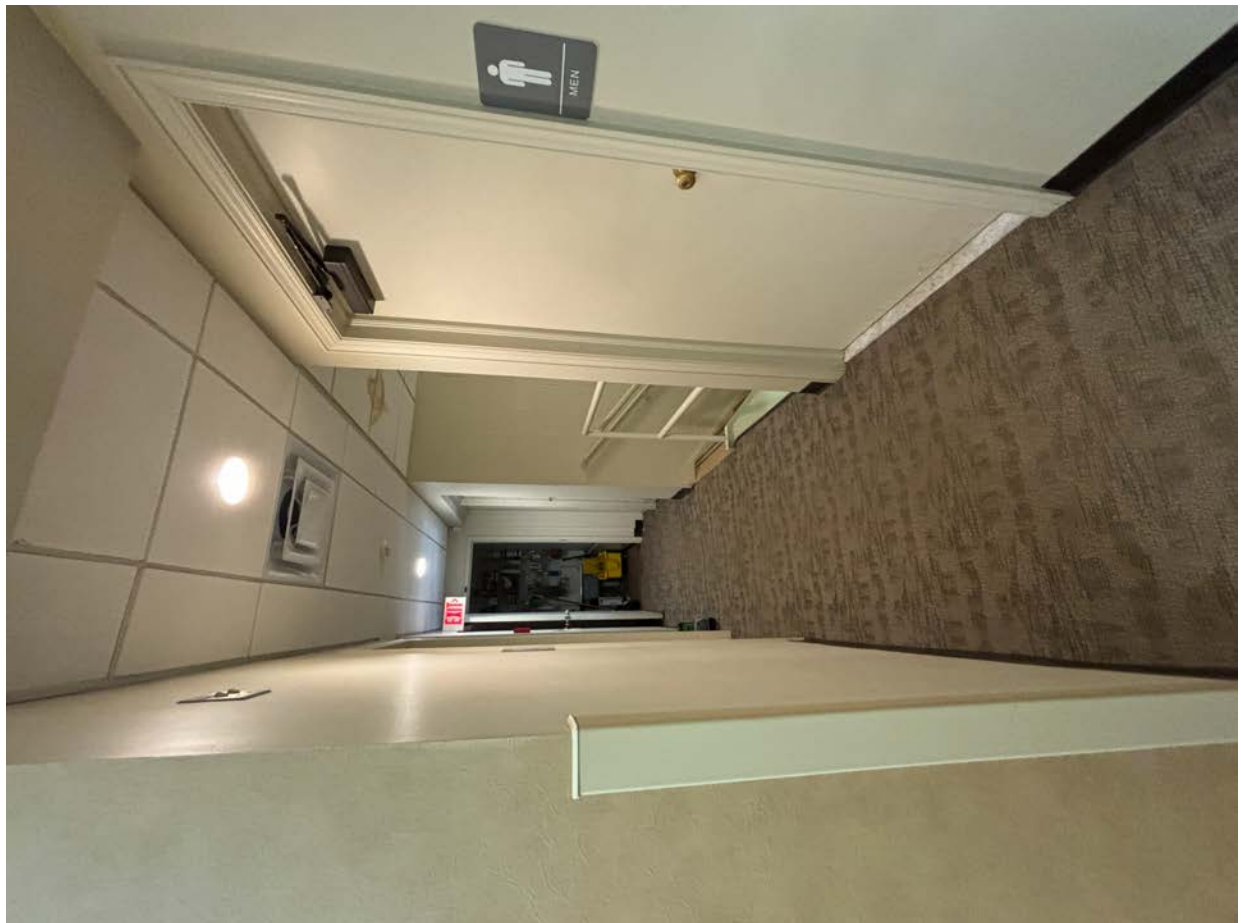
NY_Saratoga County_BallstonSpaNationalBank_0024

- 0024 Interior of 87 Front Street. First floor view looking east of hallway in rear entry area with bathrooms, CMU stairwell to basement, maintenance spaces and south staff entry.

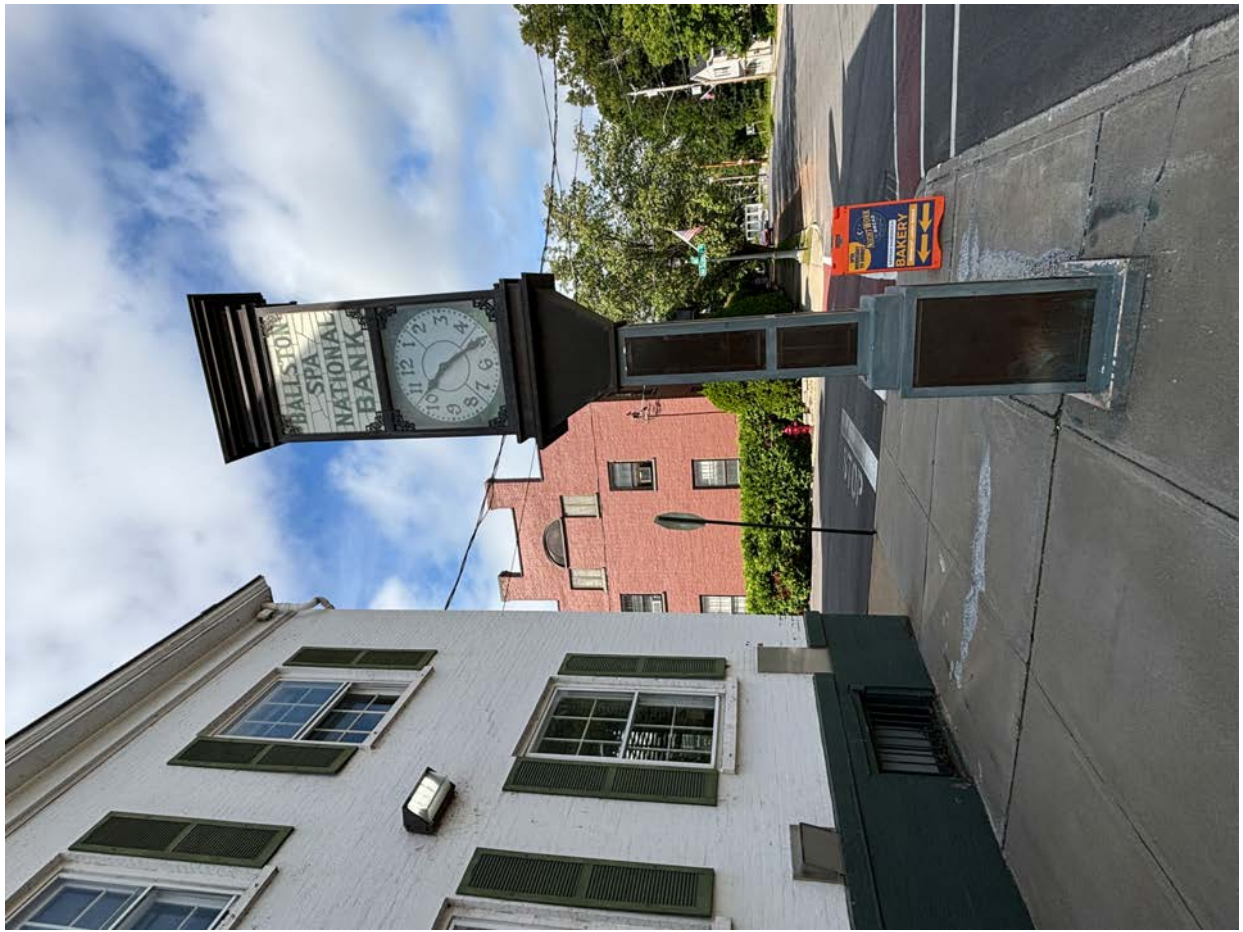
NY_Saratoga County_BallstonSpaNationalBank_0025

- 0025 Original 1926 chime clock on sidewalk in front of 87 Front Street. View looking west at the intersection of Front & Science Streets.

The Art Nouveau street clock with opalescent leaded art glass faces and electric chimes was installed on the sidewalk in front of the building in May 1926. It remains in its original position on the sidewalk before the front façade of the original ca. 1824 building.
