# National Register of Historic Places Registration Form

Historic name: Chenango Canal Prism, Towpath and Lock 106

Other names/site number: Walker's Lock

The Historic and Engineering Resources of the Chenango Canal

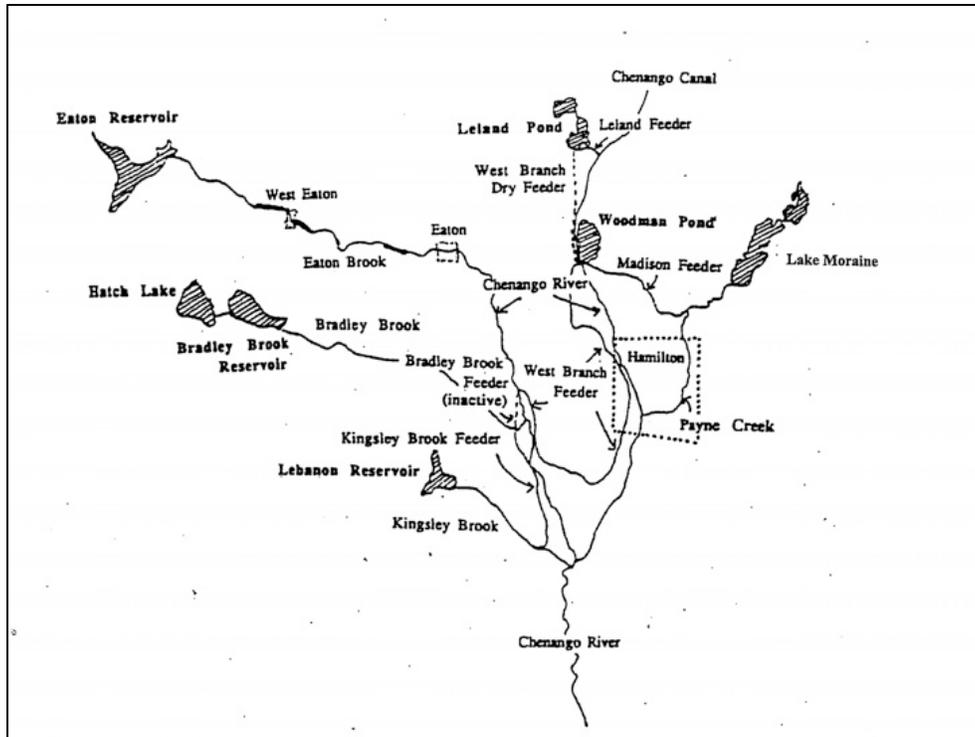
Figure 1. Chenango Canal Summit Level Feeder and Reservoir System, from Michele McFee's *Limestone Locks and Overgrowth*.

The Chenango Canal's water supply was facilitated by an intricate system that required the use of natural resources in the surrounding area to fill the canal. Chief engineer John Jervis decided upon the use of reservoir springs, a technique widely used in Europe but one not commonly employed in the United States, to fill the canal as it progressed uphill towards Bouckville.<sup>13</sup> The canal's water supply came from the Chenango River and six reservoirs: Madison's Brook at New Berlin; Woodman's Pond at Hamilton; Leland's Pond at Bouckville; and Bradley's Brook, Hatch's Lake and Eaton Brook Reservoir in Eaton (Figure 1).<sup>14</sup> The choice of employing reservoirs to feed the canal, instead of using creeks, was beneficial for industries along the route. Had the canal been fed by local waterways beyond the river, there was potential for the canal to drain the creeks during dry seasons, and by doing so eliminating the power source for many water-powered mills located on the creeks. Such a system could also jeopardize livestock and crops on surrounding farms.

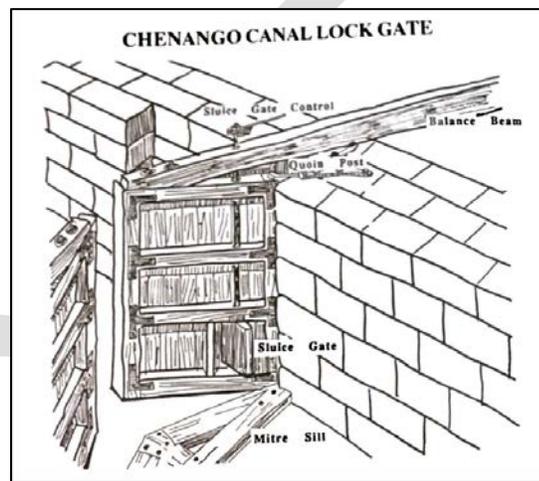
Figure 2. Chenango Canal Lock Gate Sketch, from Michele McFee's *Limestone Locks and Overgrowth*.

approximately 13 feet, and the walls rise eight feet above the current water level at their highest point. Approximately 40 feet from the southwestern end of the lock are recesses in the stonework that indicate the position of the former lock gates. While the southwestern recess has deteriorated, the result of hillside erosion, the recess on the northeastern side of the lock remains largely intact. The recess on the northeastern side is 12-feet wide and one and one-half feet in depth.

On the western corner of this recess there remains a protruding feature constructed of stone with a metal rod. This feature originally held a quoin post to which the lock doors, or gates, were attached, thereby allowing the lock to function. In those areas of the lock the stonework was fitted noticeably tighter, presumably having been cut to form during construction.<sup>3</sup>

Lock 106, the centerpiece of this nomination, exemplifies the early nineteenth century engineering prowess required to control water levels in order to ensure transportation over terrain of fluctuating elevation. The stonework, composed of dressed blocks of limestone, was particularly tightly fitted at the location of the lock gates, a necessity to ensure proper operation of the opening and closing mechanisms. Although the wooden members have long since deteriorated, the stonework and other remaining lock features attest to period building techniques and allow for the interpretation of this pivotal canal feature (Figure 2).

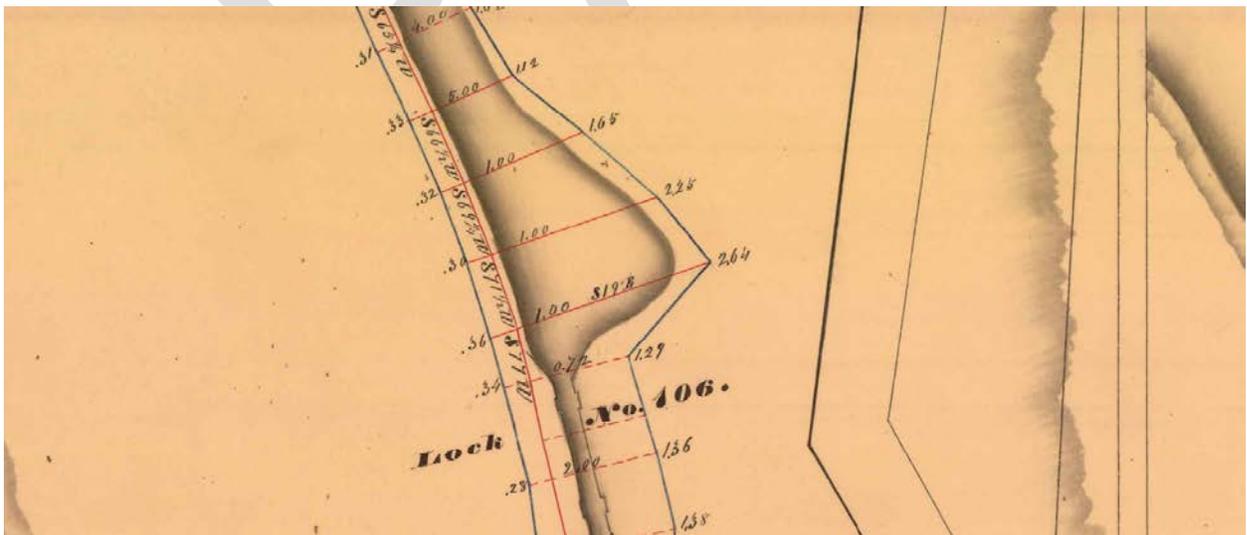
Above, state engineering map depicting Lock 106 and adjacent basin

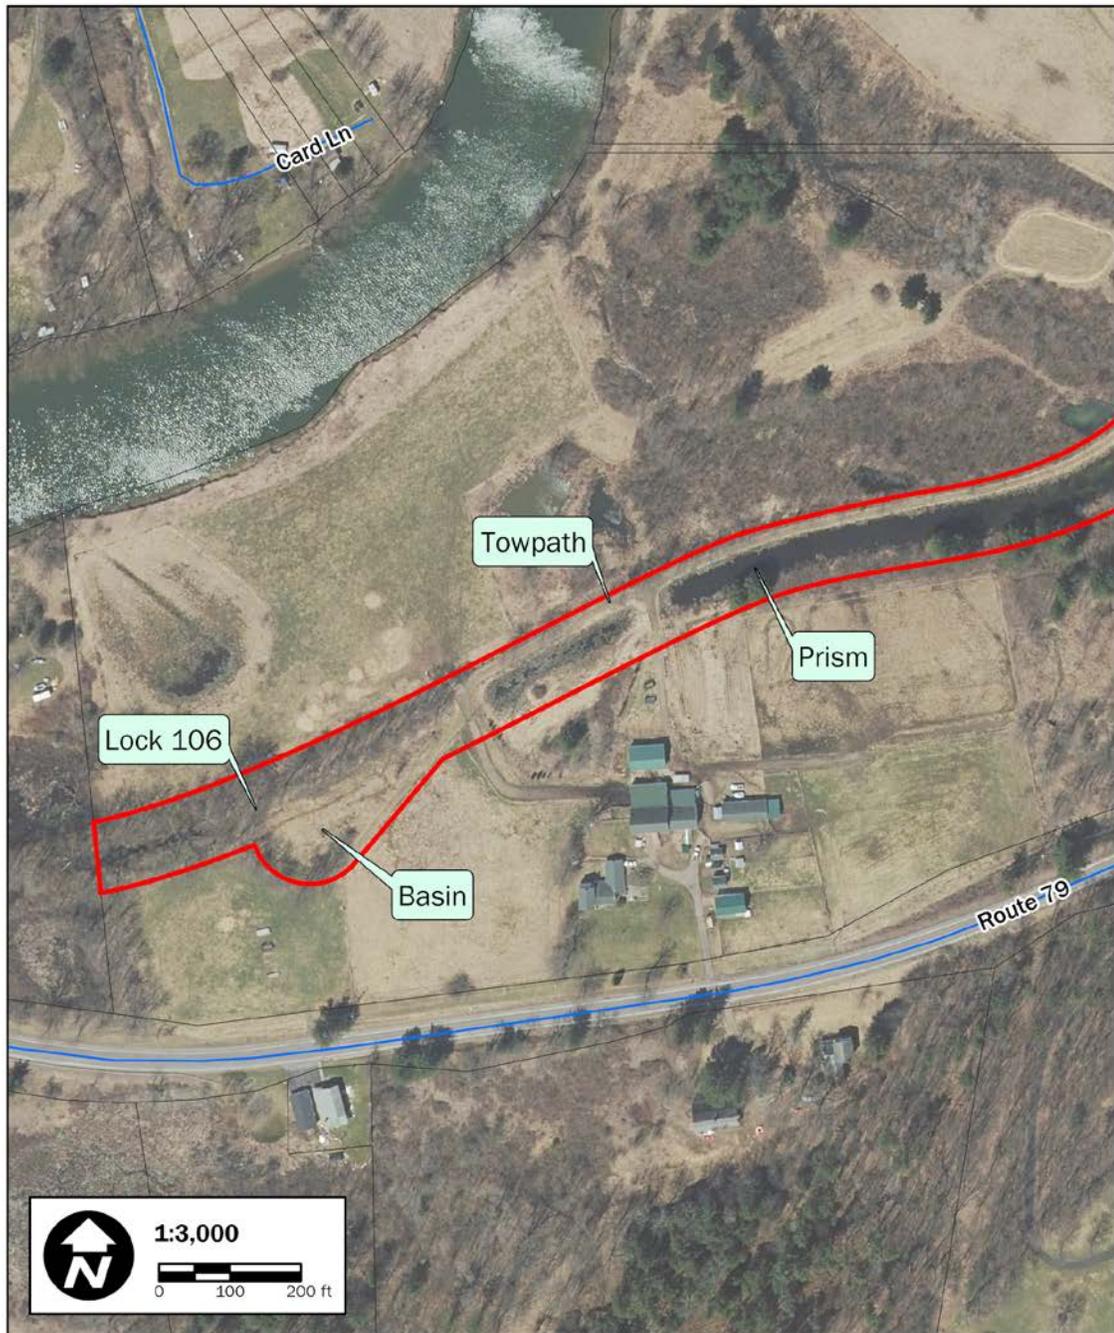
Canal Features  
Detail Map 1 of 4

Chenango Canal Lock 106, Prism and Towpath  
Town of Fenton, Broome County,  
and Town of Greene, Chenango County, New York

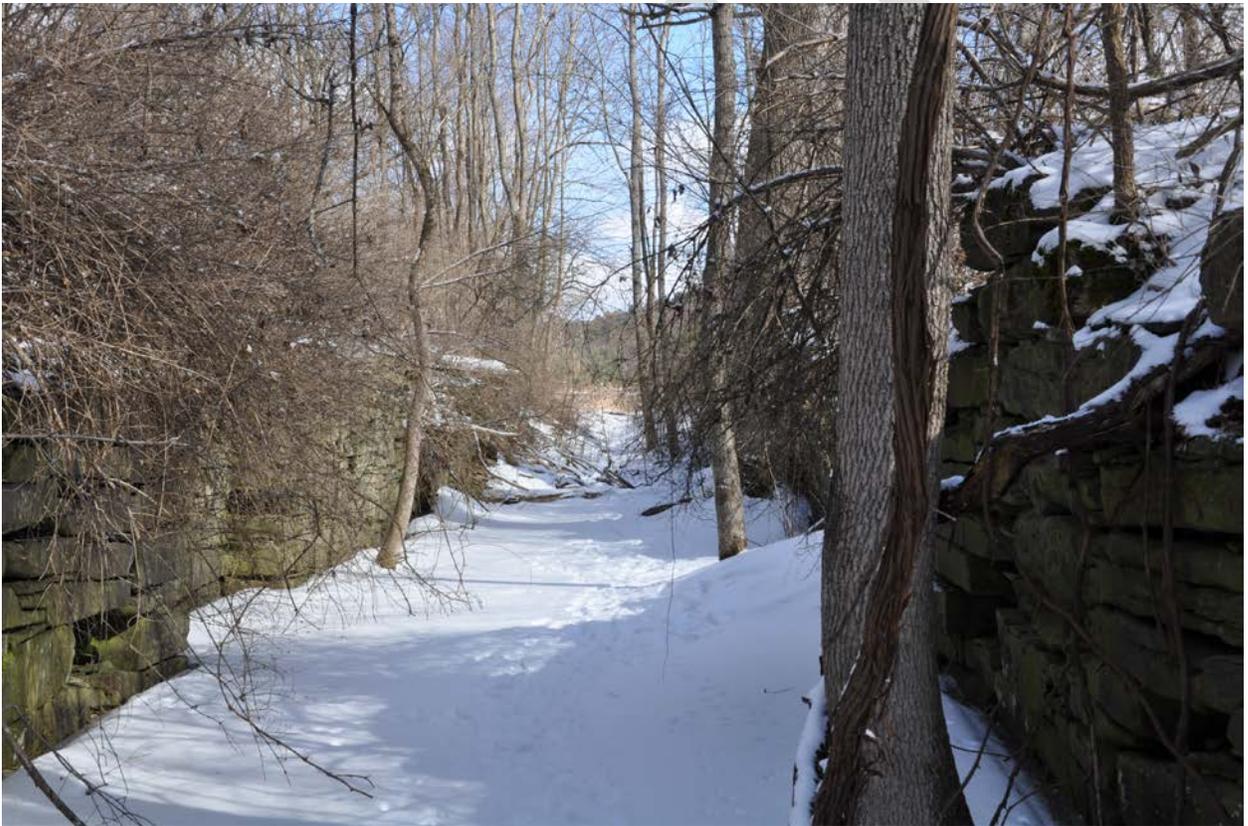
View of Lock 106 from canal. View SW. Photo 1 of \_6\_.

From the property line, the canal prism and towpath extend northeast to Lock 106; it is situated approximately 100 feet from the property line. The remnants of the canal lock consist of two dry-laid limestone walls that have been built into the sides of the prism. Engineer Holmes Hutchinson, who designed the locks on the Chenango Canal, described them as follows: "15 feet wide and over 90 feet long with a lift varying from five feet at Lock Number One in Utica to 13 feet at Lock Number 114 in Binghamton. Each lock had dry [laid] walls of hand cut stone, fitted together without mortar or cement."<sup>1</sup> The following measures were implemented to prevent erosion and absorption from the soil: "The walls and floors of each lock were covered with 2 ½" thick planks placed over 8" square pine timbers in order to retain the water. The gates, too, were made of wood with huge timbers placed on top."<sup>2</sup> While the planks and gates are no longer present, much of the lock's original stonework remains extant.

From the point at which the stone walls begin, at the northeastern end of the lock, to that where they open up to a lower elevation, at the southwestern end, the lock measures approximately 124 feet in length. The width between the two lock walls in this section is

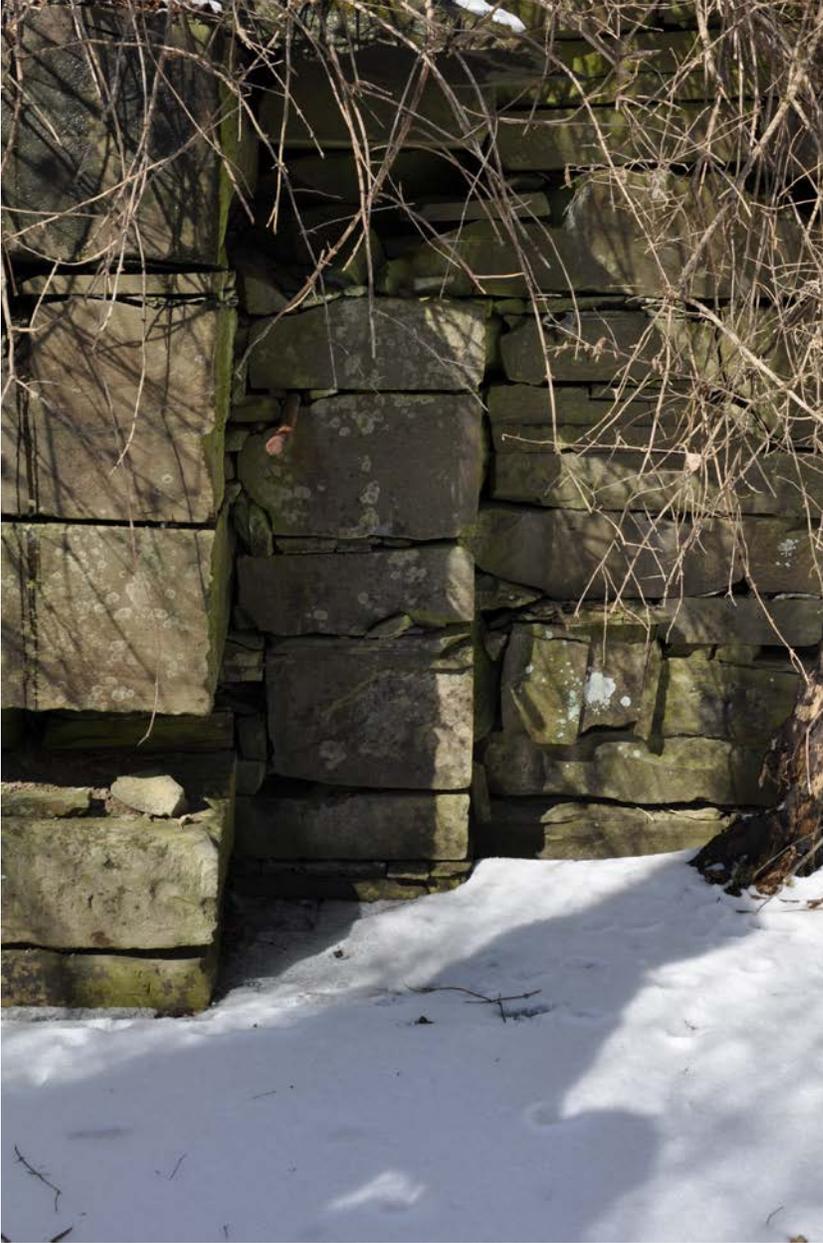
Photographer: Cynthia Falk  
Date Photographed: 2/18/2020  
Lock 106, gate location. View NE. Photo 2 of \_6\_.

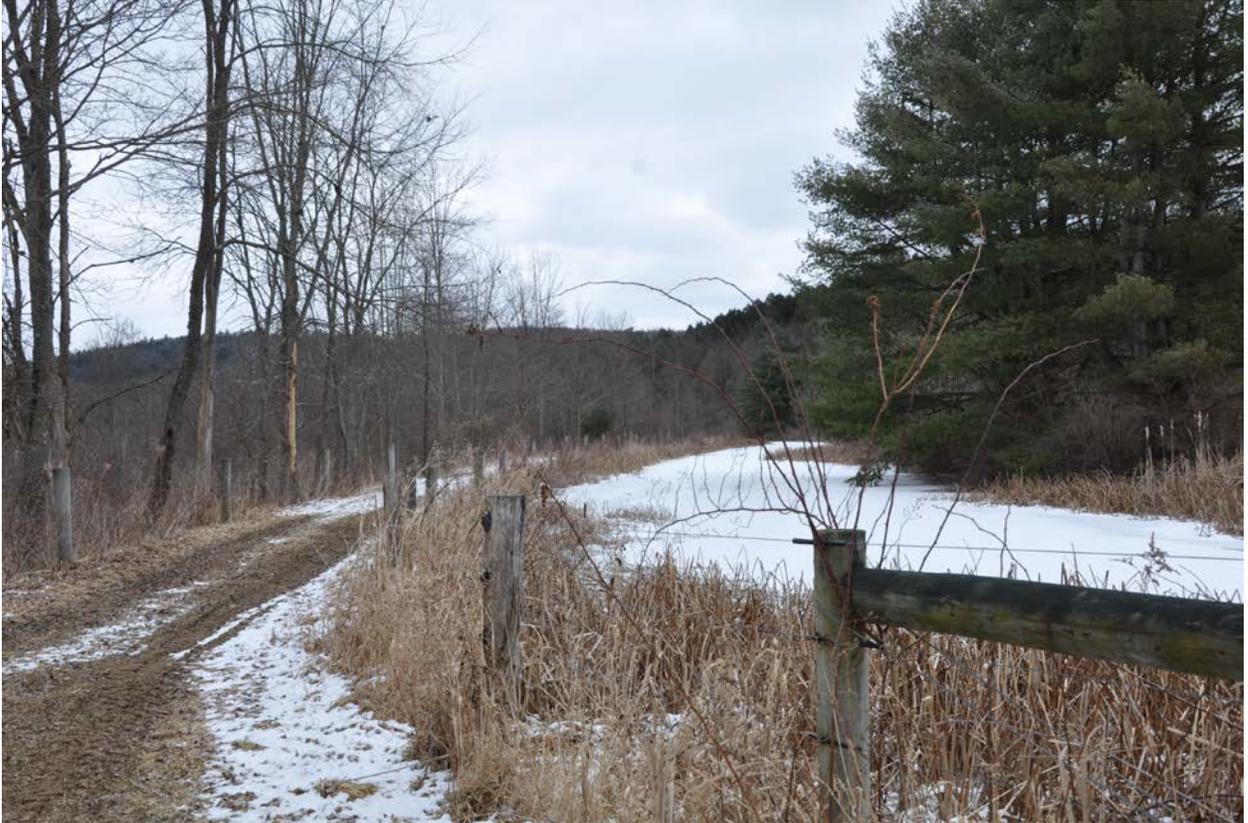
Canal prism from towpath, northeast of lock. View NE. Photo 3 of \_6\_.

Northeast of the land bridge the canal prism remains watered, and it continues on a northeasterly alignment for approximately 600 feet before bending to the north, parallel to the river. At its most intact points on this northeastern section on the farm property, the canal

prism's width is approximately 40 feet. This section of the prism maintains the distinctive characteristics of nineteenth-century canal architecture, the canal being buttressed on the eastern side by its earthen berm. Originally created during the canal's construction, the berm prevents the canal from being infiltrated by water from adjoining wetlands created by hillside runoff. Because of the berm's presence, water to the east of the canal is trapped and forms a small pond. The berm is approximately 15-feet wide and runs adjacent to the canal for approximately 500 feet.

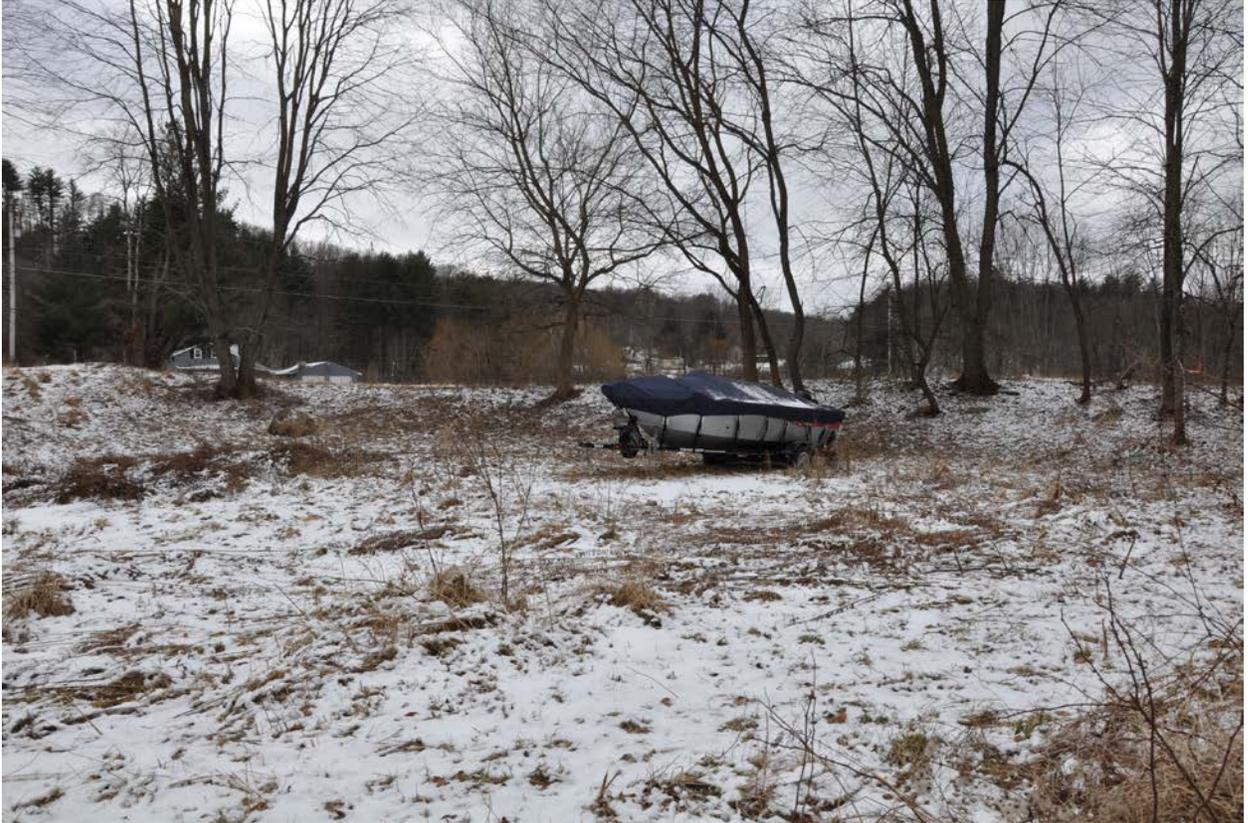
Basin depression in the ground (no longer filled with water). View NW. Photo 4 of \_6\_.

Northeast of the lock, which is about 300 feet northwest of the property's farmhouse, is a sunken field encompassing an area of approximately 1,500 square feet. This field extends from the canal lock approximately 250 feet east to a land bridge. During the canal's operation, this area—known as a canal mooring or basin—was the site of a widened docking area for boats waiting to enter the lock. Due to drainage issues, a continual issue for the Chenango Canal, this waiting area for canal vessels remains as only a shallow depression and is now used for cultivating hay. Compared to the other more conspicuous physical features of the lock and canal prism, the basin is not readily recognizable to the casual observer. Northeast of the former basin area, the prism has been bifurcated by a land bridge constructed to allow for moving livestock.

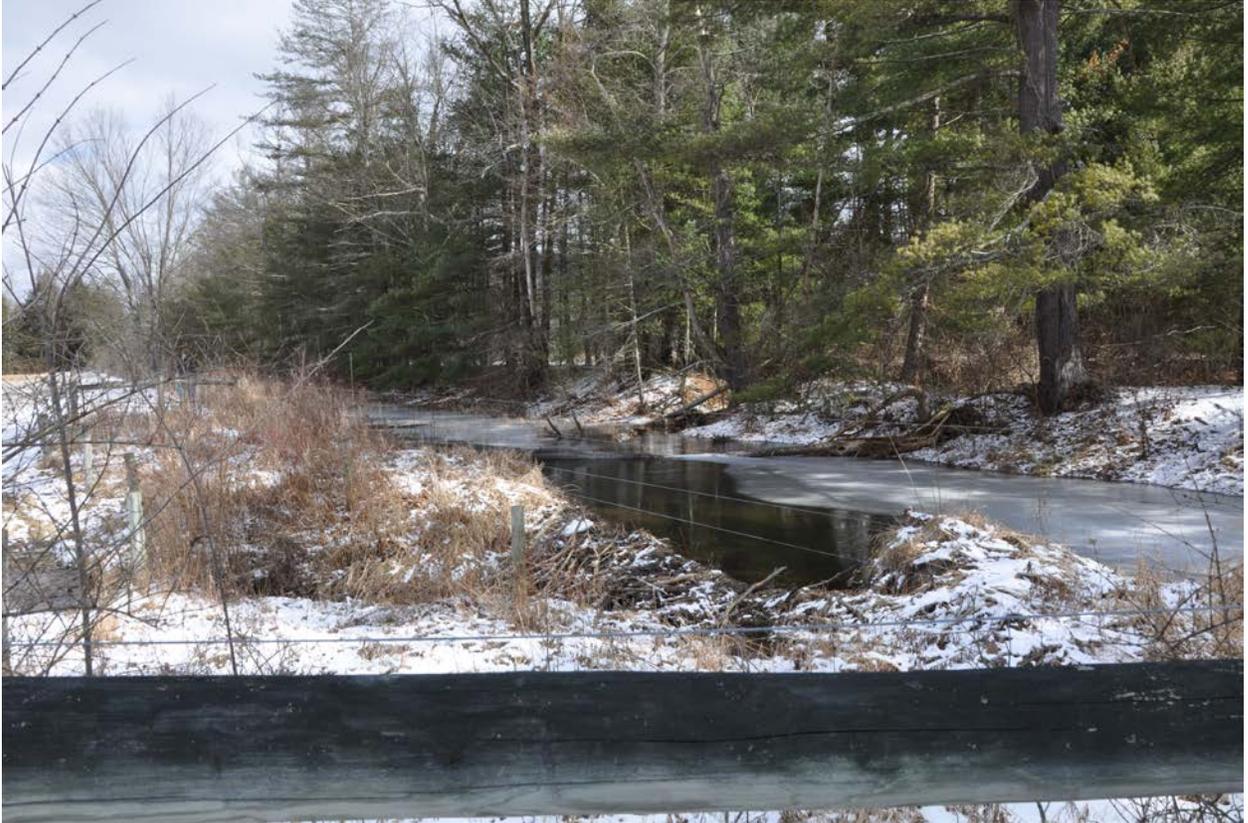
Photo 5 of \_6\_.

No longer intact, the location of the culvert discernible northeast of Lock 106. View NE.

A small tributary of the Chenango River, sometimes referred to as Tuttle Creek— named for the property's early nineteenth-century landowners, Benjamin and Rosina Tuttle—intersects with the canal about 1,400 feet from the land bridge. A culvert was constructed in this area to allow the water to flow under the canal without affecting water levels within the prism. While the location of the culvert is not visible, evidence of it nevertheless remains. There is a breach in the berm at the location of the culvert, due to the collapse of the infrastructure below. As a result, water from Tuttle Creek now empties into the canal prism before exiting further south. A concrete cattle bridge made by former landowners crosses over the resulting stream to the south. The bridge, installed after the canal's period of construction and operation, is noted as a non-contributing resource. Although the culvert no longer functions as designed, it is presumed that its associated stonework remains *in situ*.
