National Register of Historic Places Registration Form

historic name IROQUOIS DOOR COMPANY BUILDING

name of related multiple property listing Historic Resources of the Hydraulics/Larkin Neighborhood, Buffalo, Erie Co., NY

street & number 619-659 Exchange Street

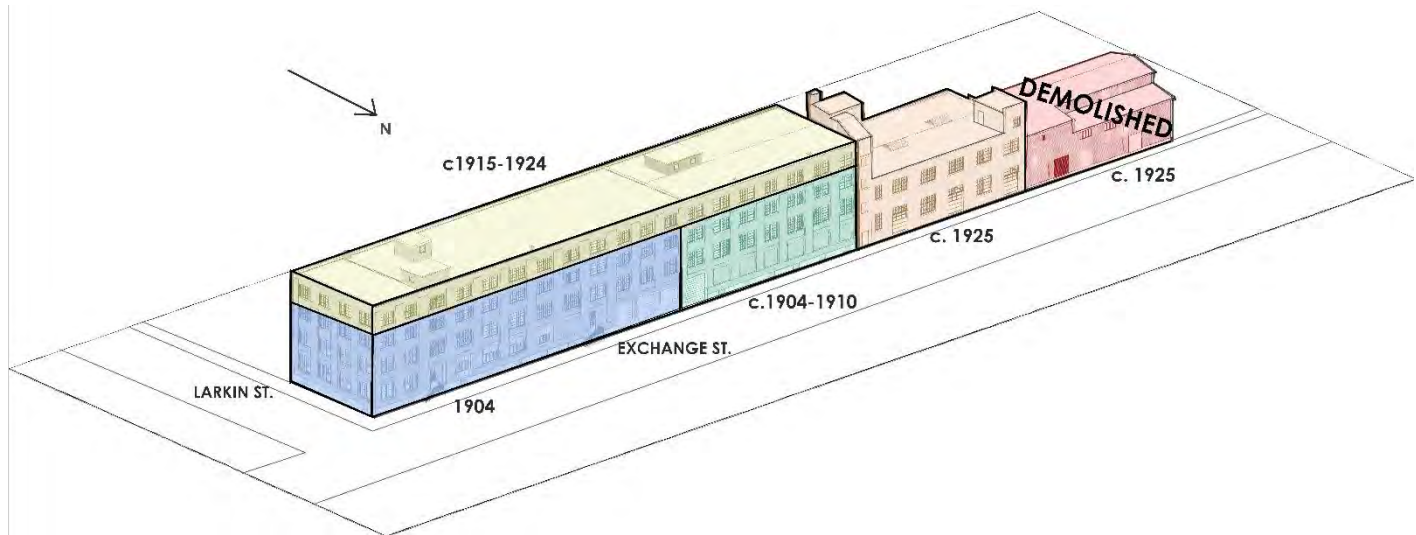
Building Phases – 3D Map of the Iroquois Door Factory at 619 Exchange Street, Buffalo prepared by Passero Associates.

In 1904 the Iroquois Door Company erected the first mill construction portion of the building on the eastern end of the property facing north onto Exchange Street. It is a rectangular, three-story, load-bearing common bond masonry building on a stacked stone foundation stretching twelve bays along Exchange Street and four bays along Larkin Street.² Between 1904 and 1910, seven additional bays in the same design were added to the west of the building along Exchange Street. Between 1910 and 1924 a fourth floor in the same design was added above the original 1904 building and the 1904-1910 addition.³ Between 1924 and 1925 a two-story, utilitarian, rectangular clay tile addition as well a two-story wood and metal sided storehouse with central monitor were added one after the other on the western end. The latter two-story wood and metal section has recently been demolished. The existing building is roughly 99,600 sq ft.⁴ The principal north and south elevations illustrate the chronology of building expansion from east to west and consist of three visually distinct sections.

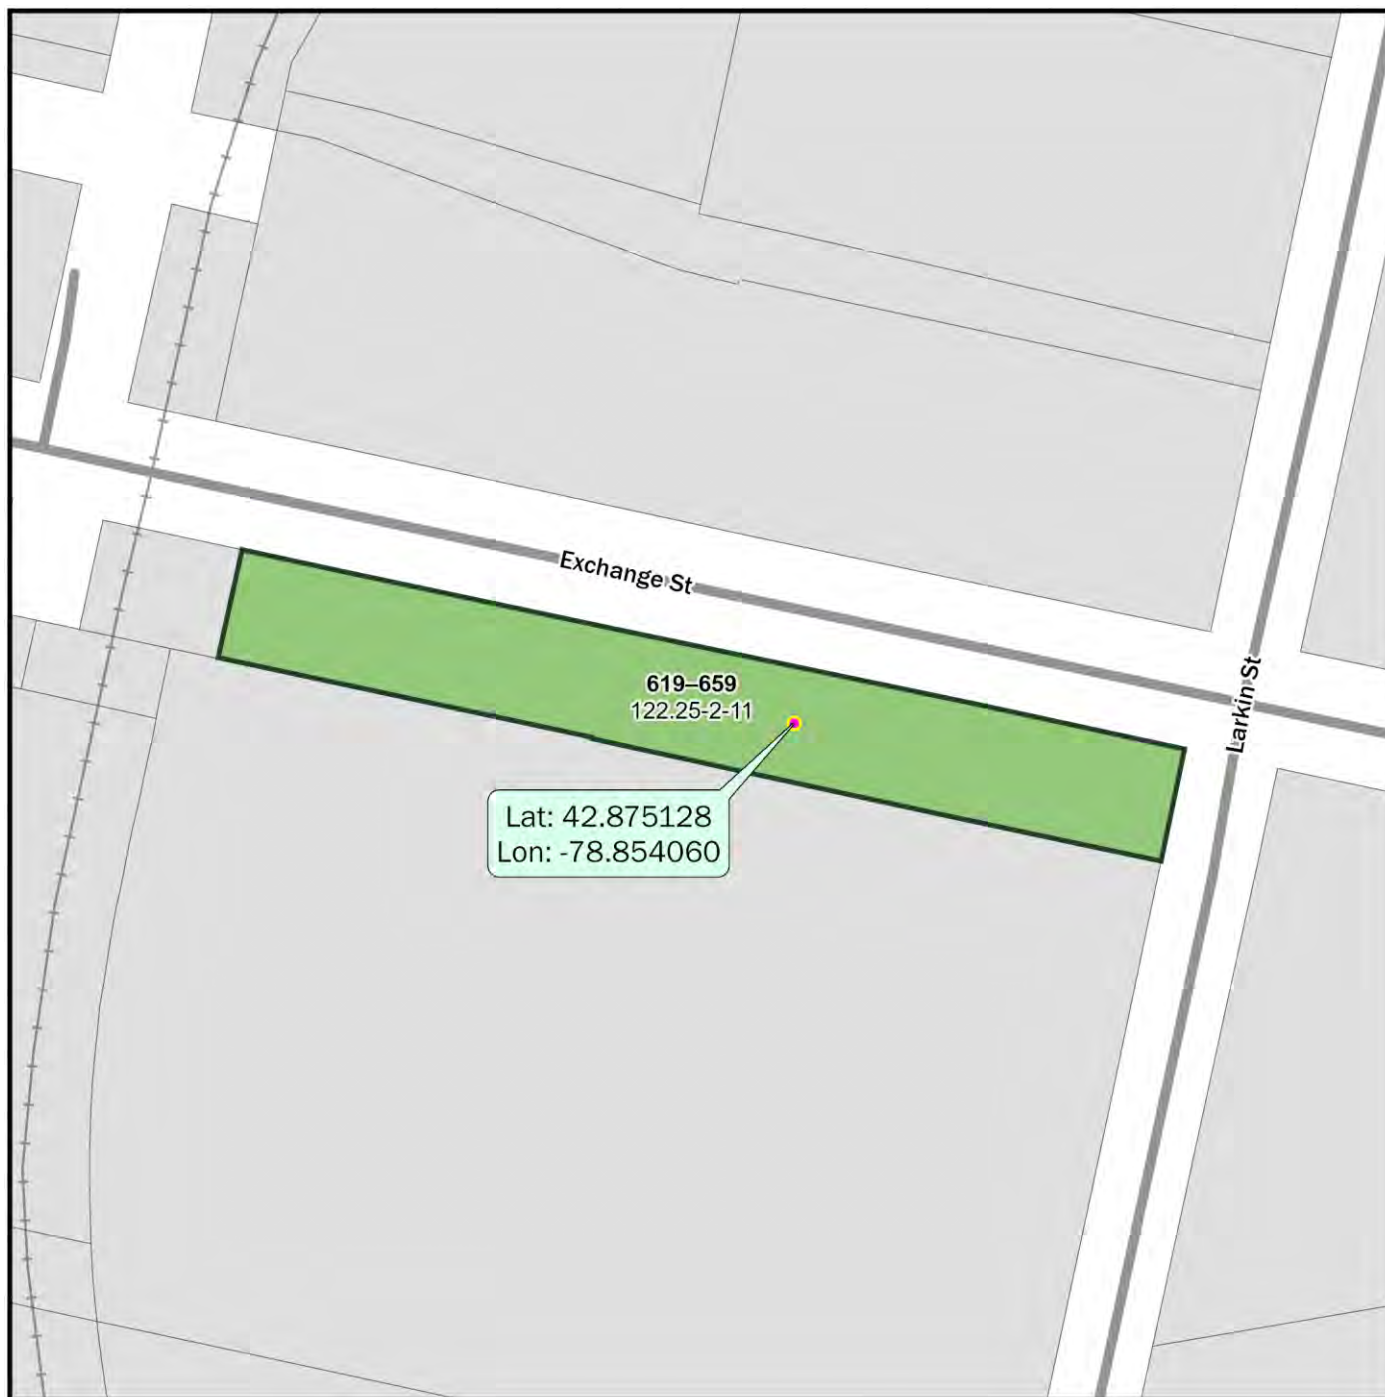
Nomination Boundary (0.72 ac)

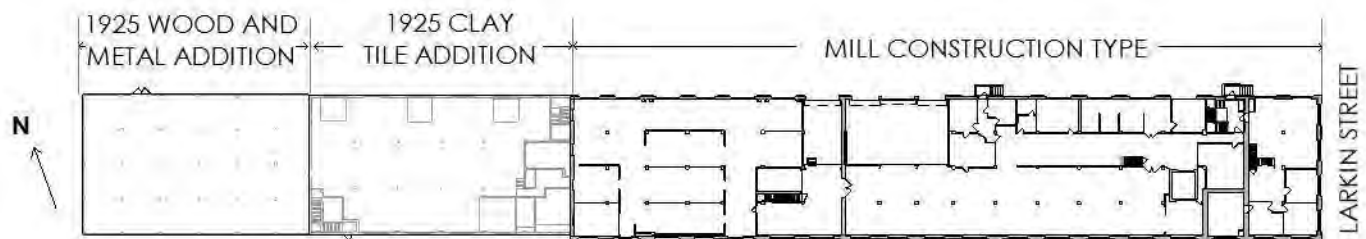
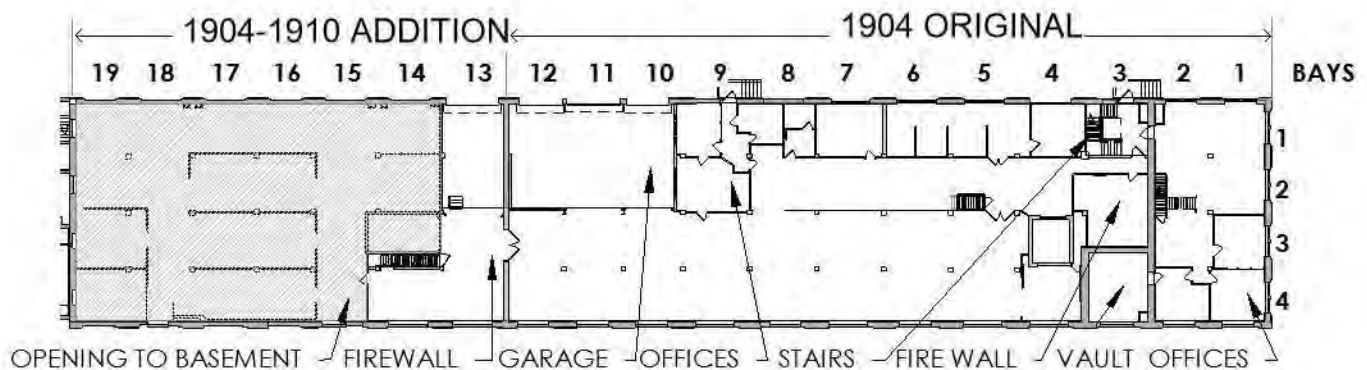
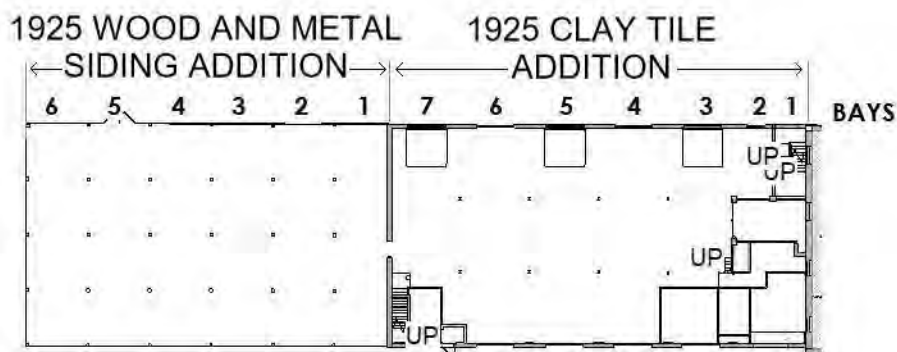
KEY PLAN IROQUOIS DOOR COMPANY BUILDING FIRST FLOOR

MILL CONSTRUCTION TYPE

1925 CLAY TILE & WOOD AND METAL SIDING ADDITION

There are two entrances to the building on the first story (Floor Plan 1). The original historic entrance is on the north elevation of the first story located at the ninth bay counting from the corner of Exchange Street and Larkin Street along Exchange Street.⁵ An exterior metal railing and brick staircase consisting of five steps with cast in place concrete treads and landing leads to the first-floor entrance. The entrance is a wood, one-panel, half-glass door with six lights and a square transom. The door is painted green with vertical metal bars covering the light and panel. Near the top of the door light in neat black lettering is the word “Iroquois” in capital letters. Below that are the words “wholesale to dealers only hours 8:00-12:00 12:30-4:30” in capital letters. The transom is frosted glass, which is cracked. Green metal vertical bars cover the transom on the exterior side. The second

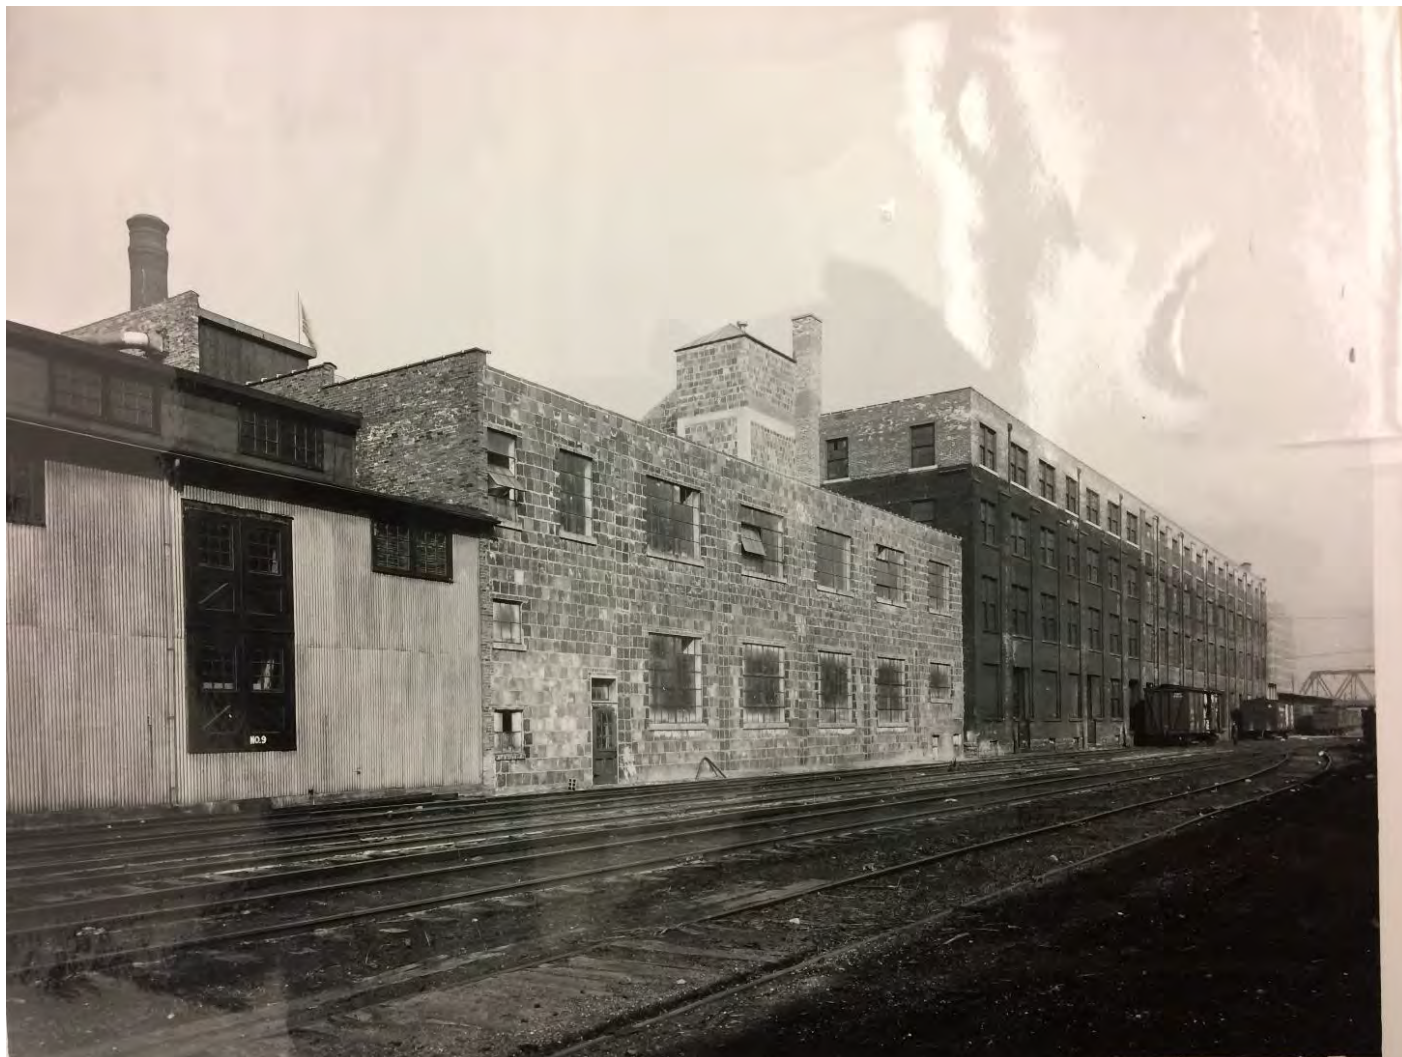
Historic Photo 1: South Elevation of Iroquois Door Company Building

Taken in 1956, the photograph shows the 1925 wood and iron clad addition to the left [no longer extant], the 1925 clay tile addition in the middle, and the original 1904, 1904-1910, and 1914-1924 portions to the right. Note the operable industrial sash windows in the 1925 clay tile addition as well as the three distinct brick color differences that mark out the original building, the 1904-1910 addition, and the 4th floor 1914-1924 addition. The railroad tracks as well as what appears to be a bridge to the right in the distance have both been removed.

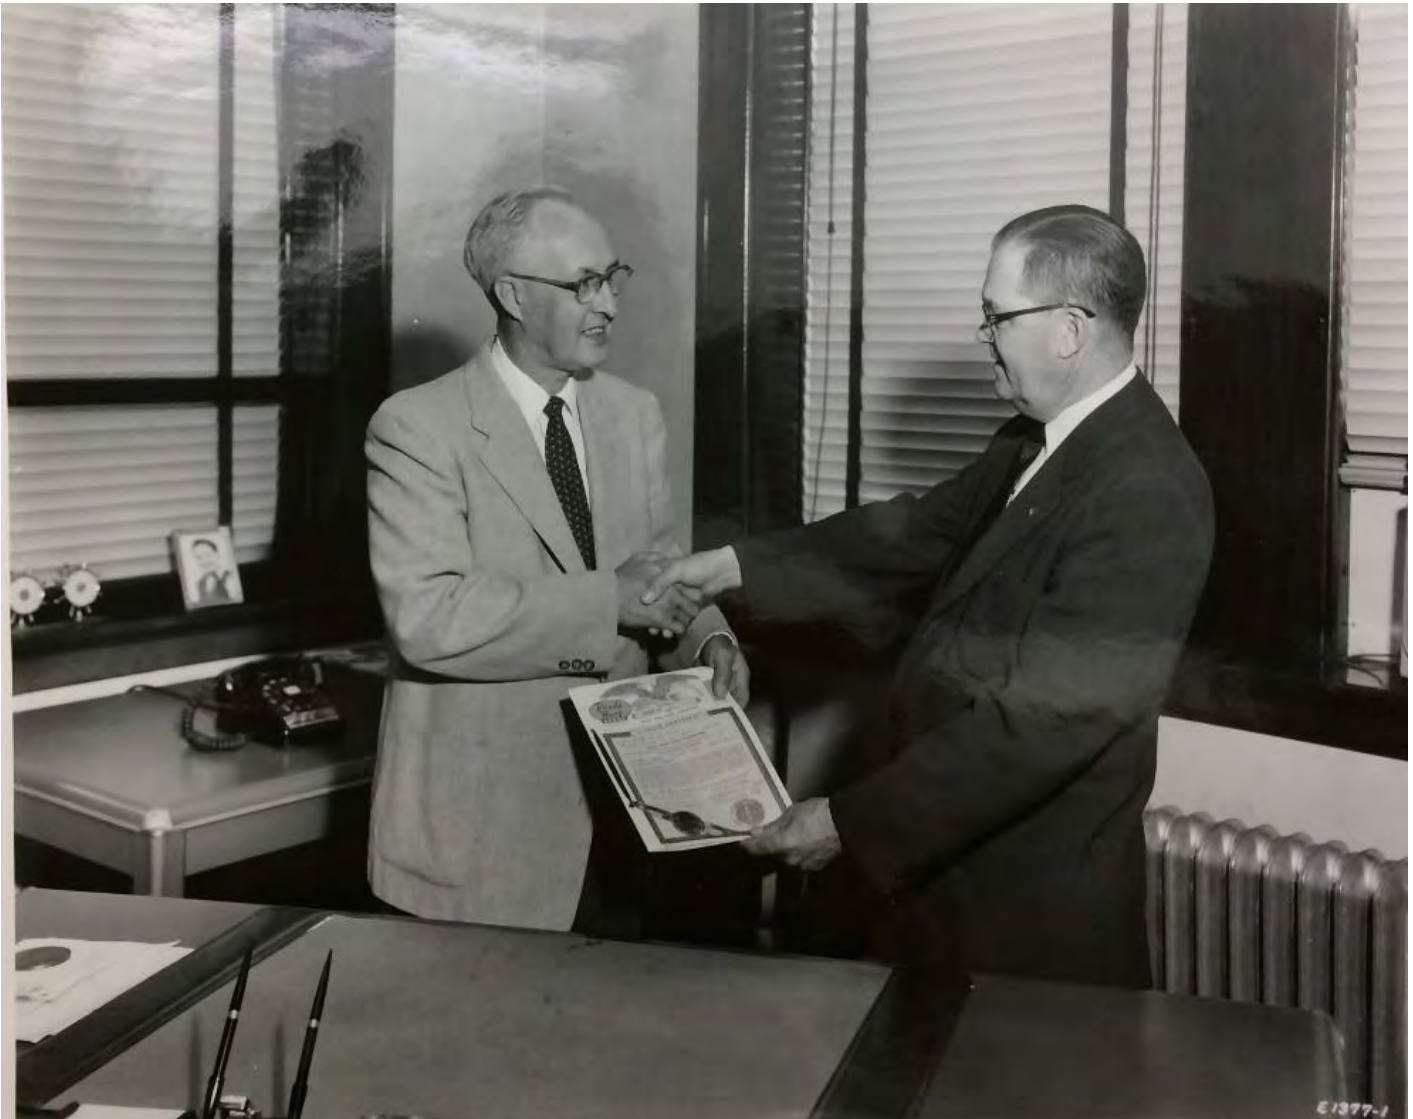
Historic Photo 2: Office in the Iroquois Door Company Building

Taken in 1956, the photograph shows two individuals in the second floor office in the northeast corner of the building. Though the paint has changed from a dark color to white, it appears that the same window details shown in the picture exist today.

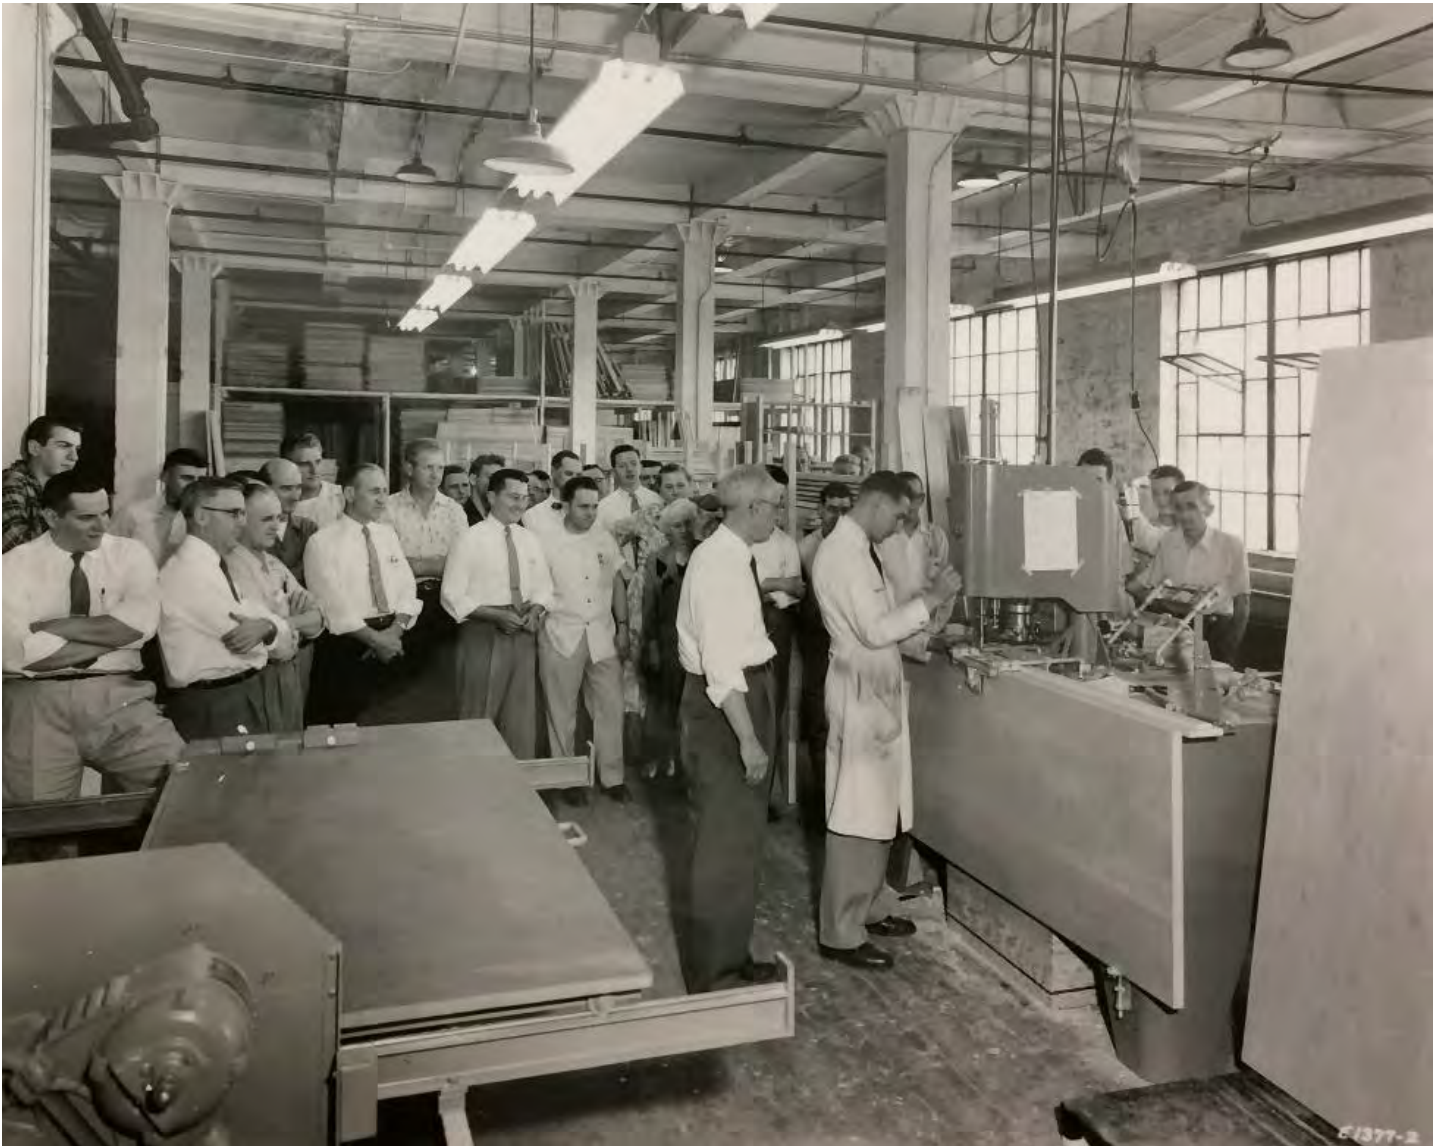
Historic Photo 3: Manufacturing Space in the Iroquois Door Company Building

Taken in 1956, the photograph shows a technician working on a new piece of milling equipment. The pattern of lights in the industrial windows in the background shows that this is the second floor. Orientation of photo and a comparison of historical to present day features suggests the photo was taken in bay 3 along Exchange Street facing west towards bays 4-12 in the original building.

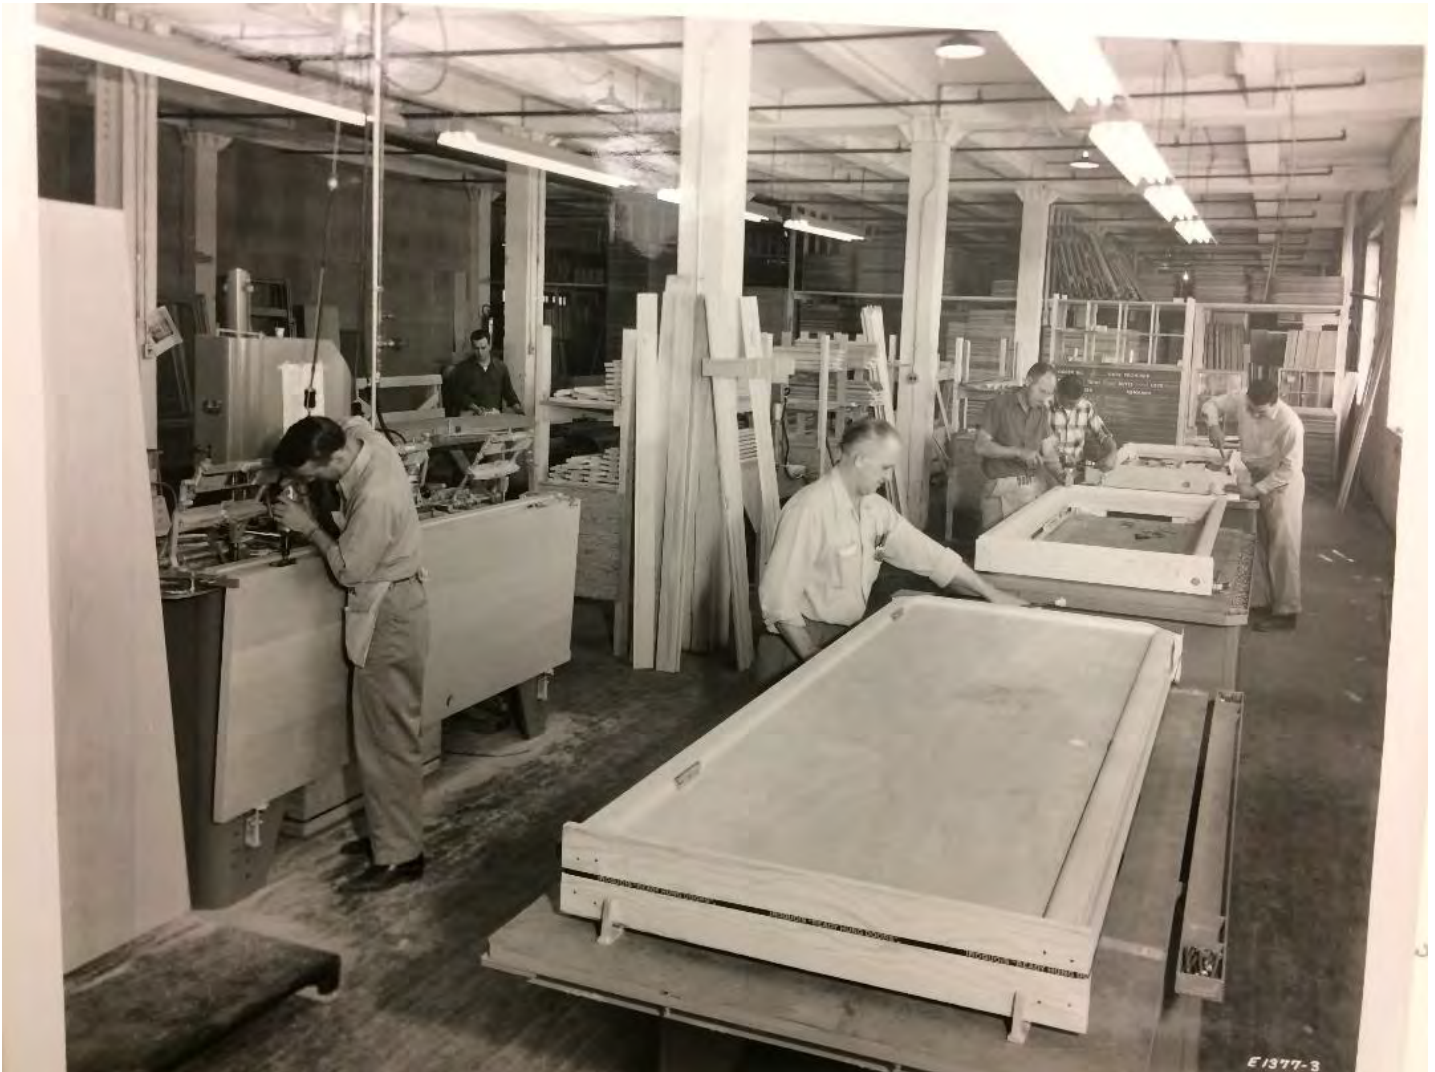
Historic Photo 4: Manufacturing Space Iroquois Door Company

Taken in 1956 a couple of feet further north and facing in the same direction as Photo 3, the photograph shows manufacturing workers constructing door frames and using equipment.

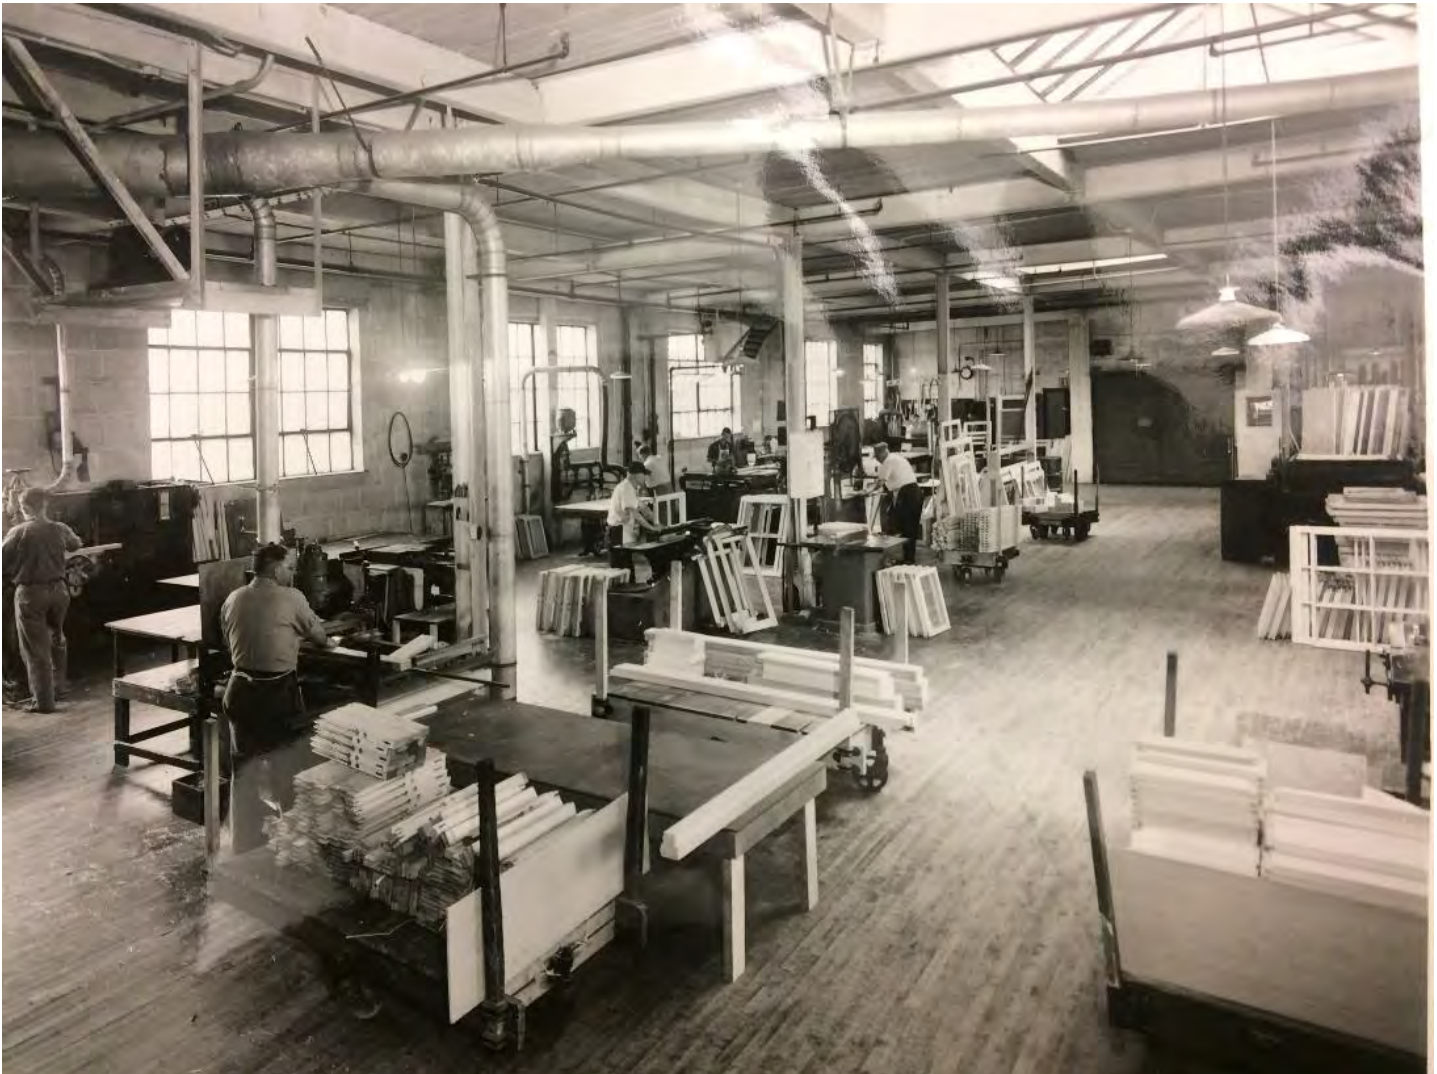
Historic Photo 5: Manufacturing Space Iroquois Door Company

Taken in 1956, the photo shows the second floor of the clay tile building facing west. The photo suggests the area was used for glazing. Note the operable steel sash windows along the south side of the building to the left, as well as the open skylights above.

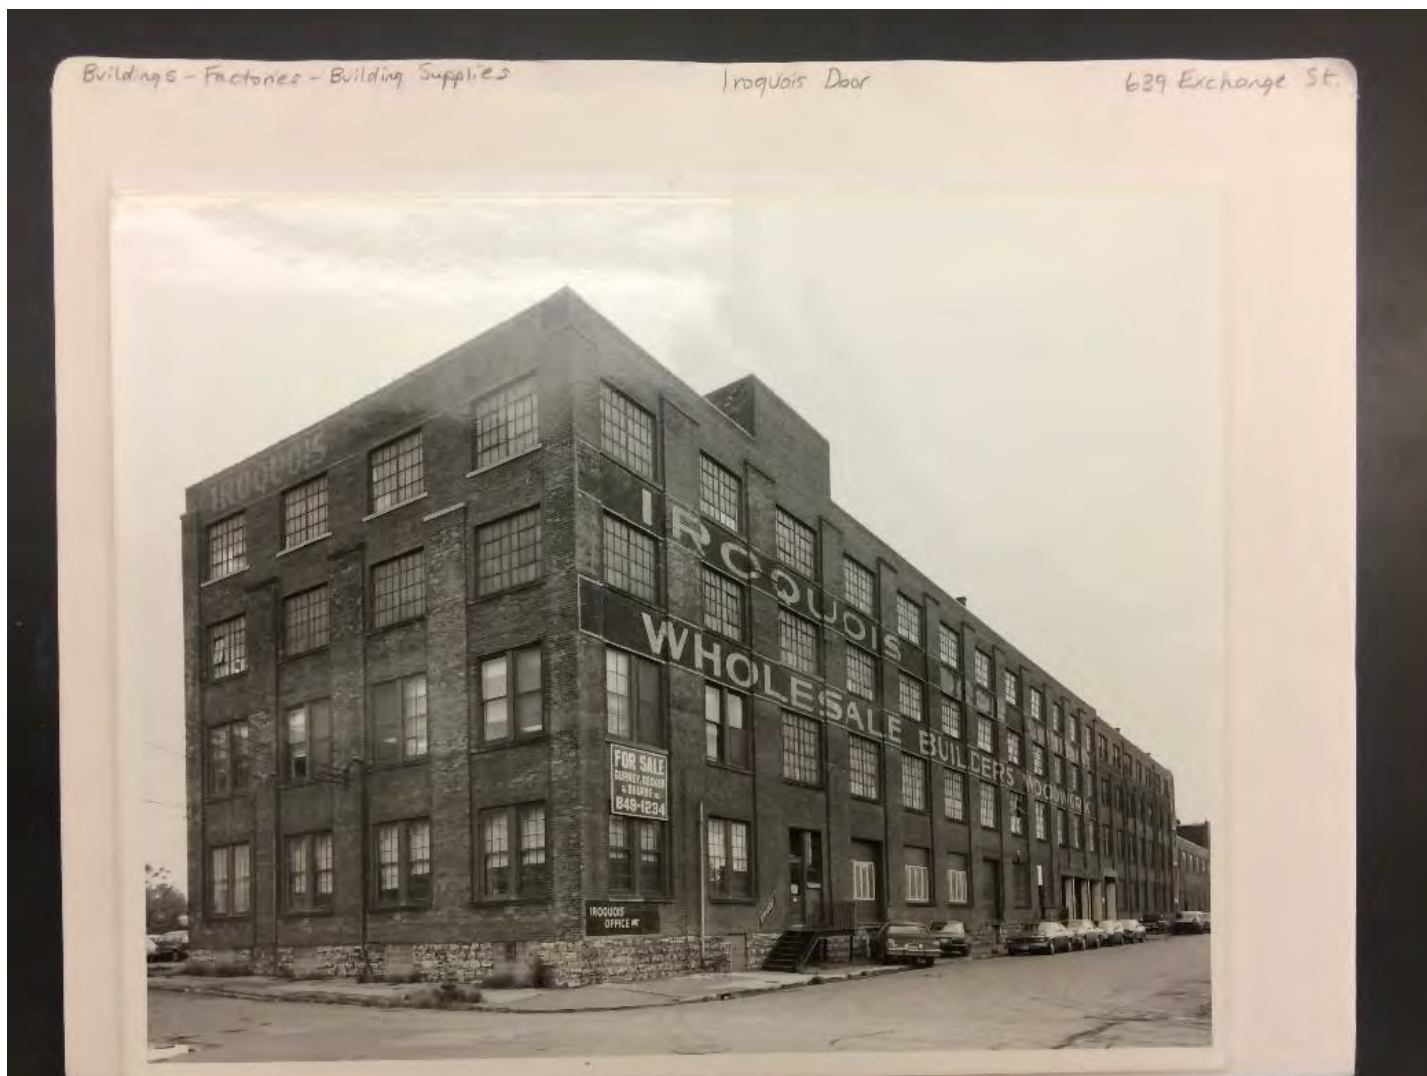
Historic Photo 6: Exterior Iroquois Door Company Building

Taken in 1987, the photo shows the Iroquois Door Factory building from the corner of Larkin and Exchange Streets. Note the cars on the leftmost side of the picture suggesting that the railroad tracks seen in Photo 1 had already been removed. The industrial sash steel windows on the 2-4th floors. The stairs leading up to the bay 3 entrance along Exchange Street is metal. The faint "Iroquois" text that can be seen above the 4th floor along Exchange Street and matching earlier historic illustrations. The photo shows the third section of the building, later demolished, at the far end.

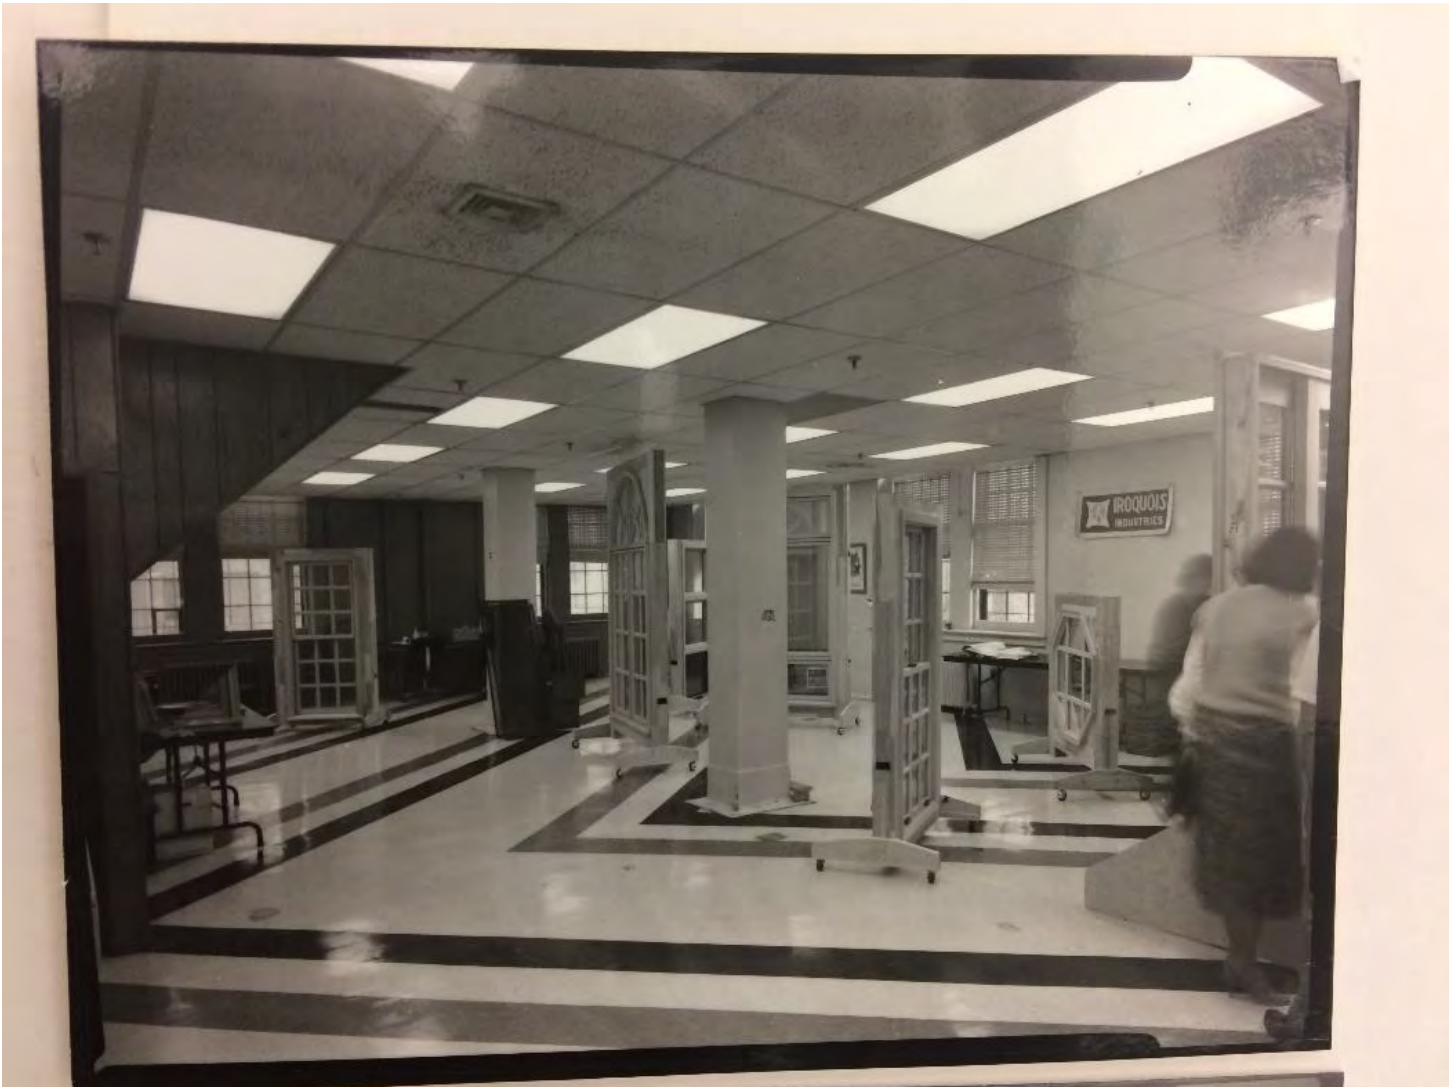
Historic Photo 7: Interior Iroquois Door Company Building Showroom

Taken in 1987, the photo shows the showroom of the Iroquois Door Factory building. The photo is taken in the southwest corner facing north east towards bay 1 and 2 as measured along Exchange Street. Window molding can be seen in the background matching the 1956 photo and what is currently there.

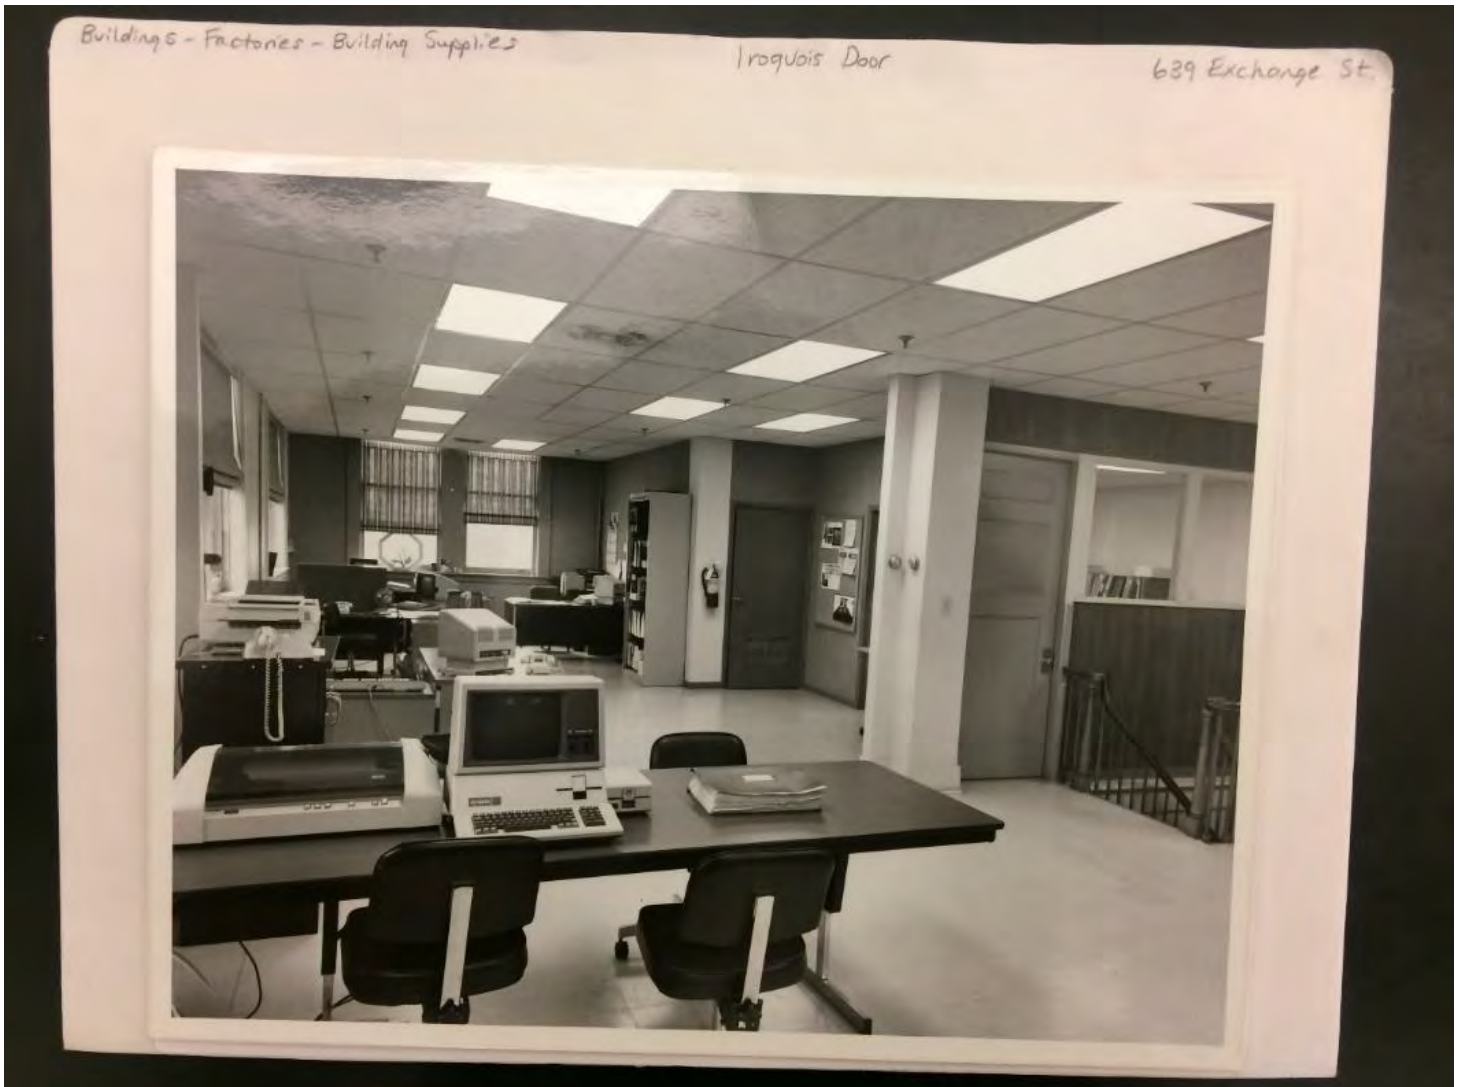
Historic Photo 8: Interior Iroquois Door Company Building Offices

Taken in 1987, the photo shows the second floor offices in bays 1 and 2 along Exchange Street immediately above the showroom. The photographer is in the northeast corner of the building facing south.

After the fire, repair work and new additions shifted some of the operations in the Iroquois Door Company building. On the first and second floors additional offices were added in the full width of bays 1 and 2 along Exchange Street, making it the center of human capital for the Iroquois Door Company. No mention is made to the dipping and glazing operations that were previously housed in these bays. The fourth floor was used for storage. The 1925 clay tile addition provided three additional overhead door openings to Exchange Street, allowing for additional loading and offloading space. The second floor as well as some of the first floor was used for planning and woodworking. The small 1925 wood and metal clad addition became the new space for lumber storage. Whereas the 1925 additions provided much needed ancillary support, the four-story original mill construction type building remained the center of operations and activity.

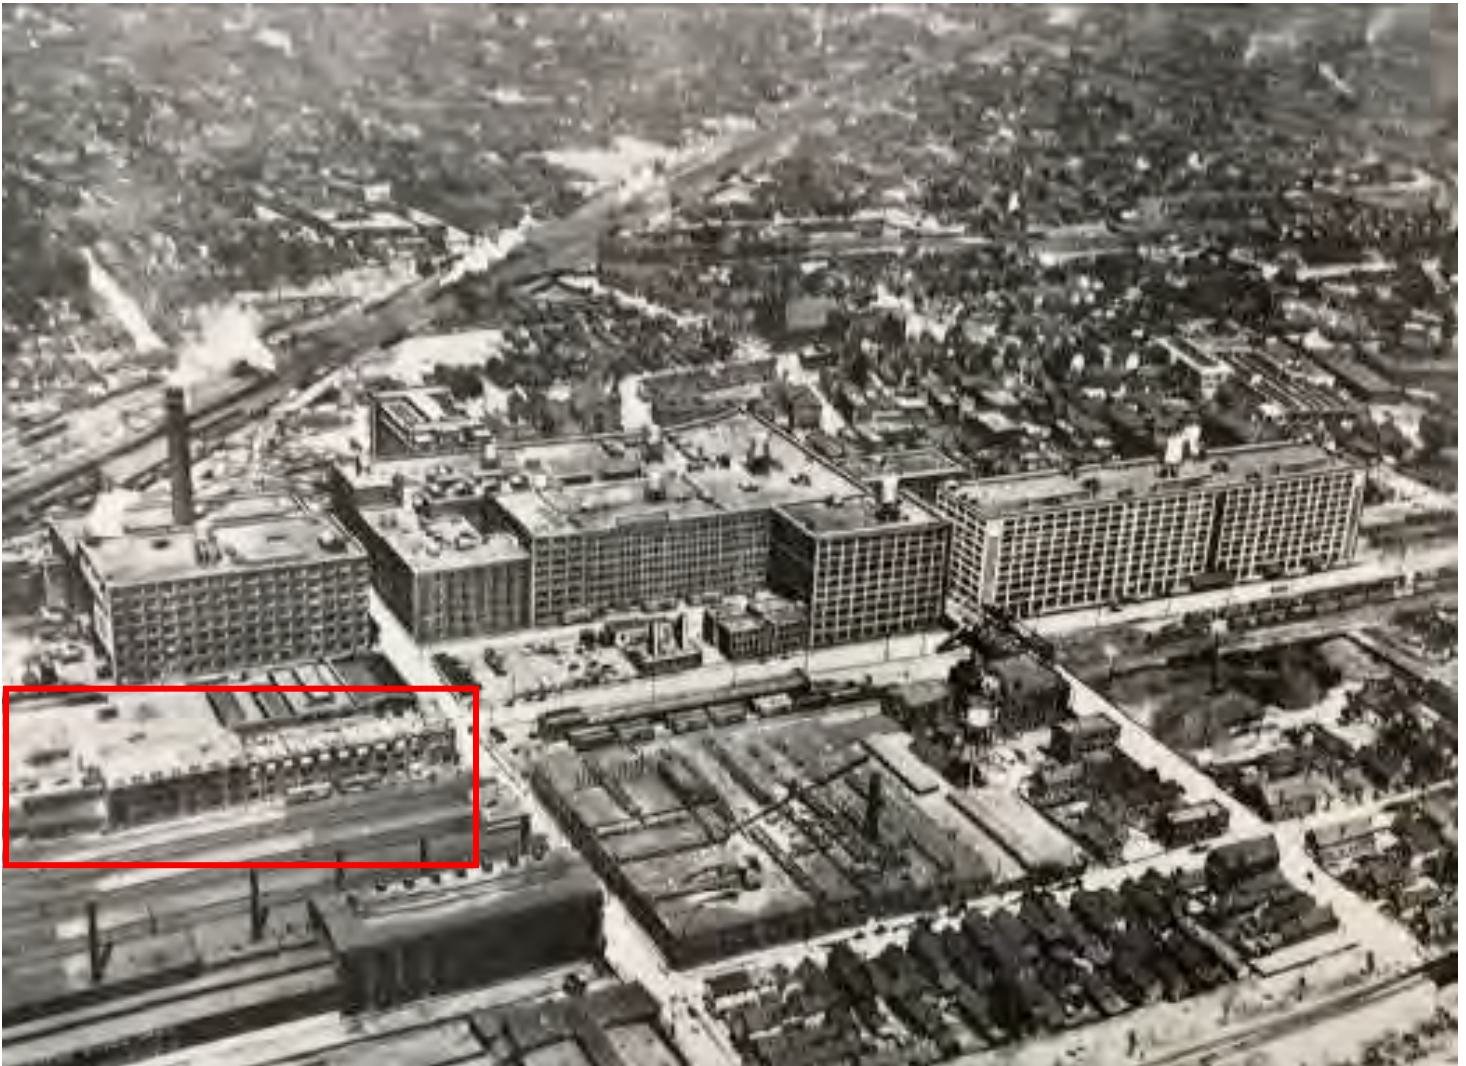
Historic Photo 9: 1924 Aerial Image of Larkin District

Taken in 1924, the aerial photo of the Larkin District shows the Iroquois Door Company building in the lower left side. Based on historical sources, the photo was taken some time after the 1924 Iroquois Door Company fire and before repair work began.

Though outlooks were good, a single event would herald a change in the company's fortune. The 1924 fire consumed the third and fourth floors of the Iroquois Door Company building.⁴⁵ The entire fourth floor of the building was destroyed and a large part of the original 1904 third floor was also gutted.⁴⁶ The Iroquois Door Company started repairs to the original building as well as expanding the workable area of the factory through two additions. Begun in 1924, a new two-story clay tile addition finished construction and began operational use for planing and wood working in 1925. It incorporated state of the art fireproof elevator equipment as well as fireproof stairs.⁴⁷ A second two-story wood and metal clad lumber storage building adjoining the 1925 clay tile building on the west side was also completed in 1925. The 1925 wood and metal clad building increased the storage capacity 40 percent and was the only building at the time that did not include a sprinkler system.⁴⁸ The utilitarian 1925 clay tile addition along with the 1925 wood and metal sided addition were not designed by Bethune. Both additions differ dramatically from the regular mill construction type. The 1925 clay tile addition obscures the first two floors of the western exterior façade of the Regular Mill Construction type building.

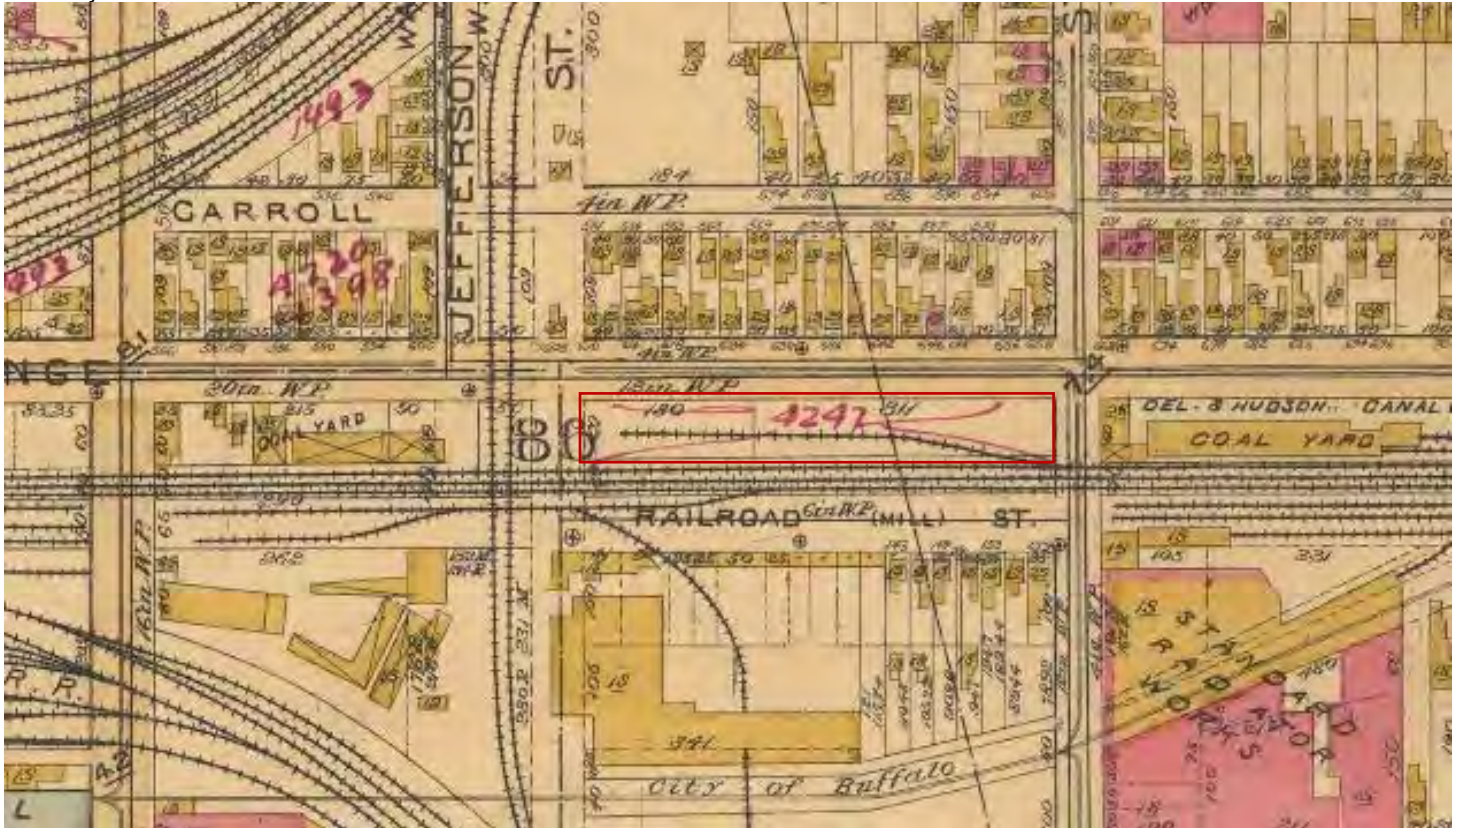
1894 City Atlas

As of 1894 there is no documented building on the plot that would eventually become the Iroquois Door Company.

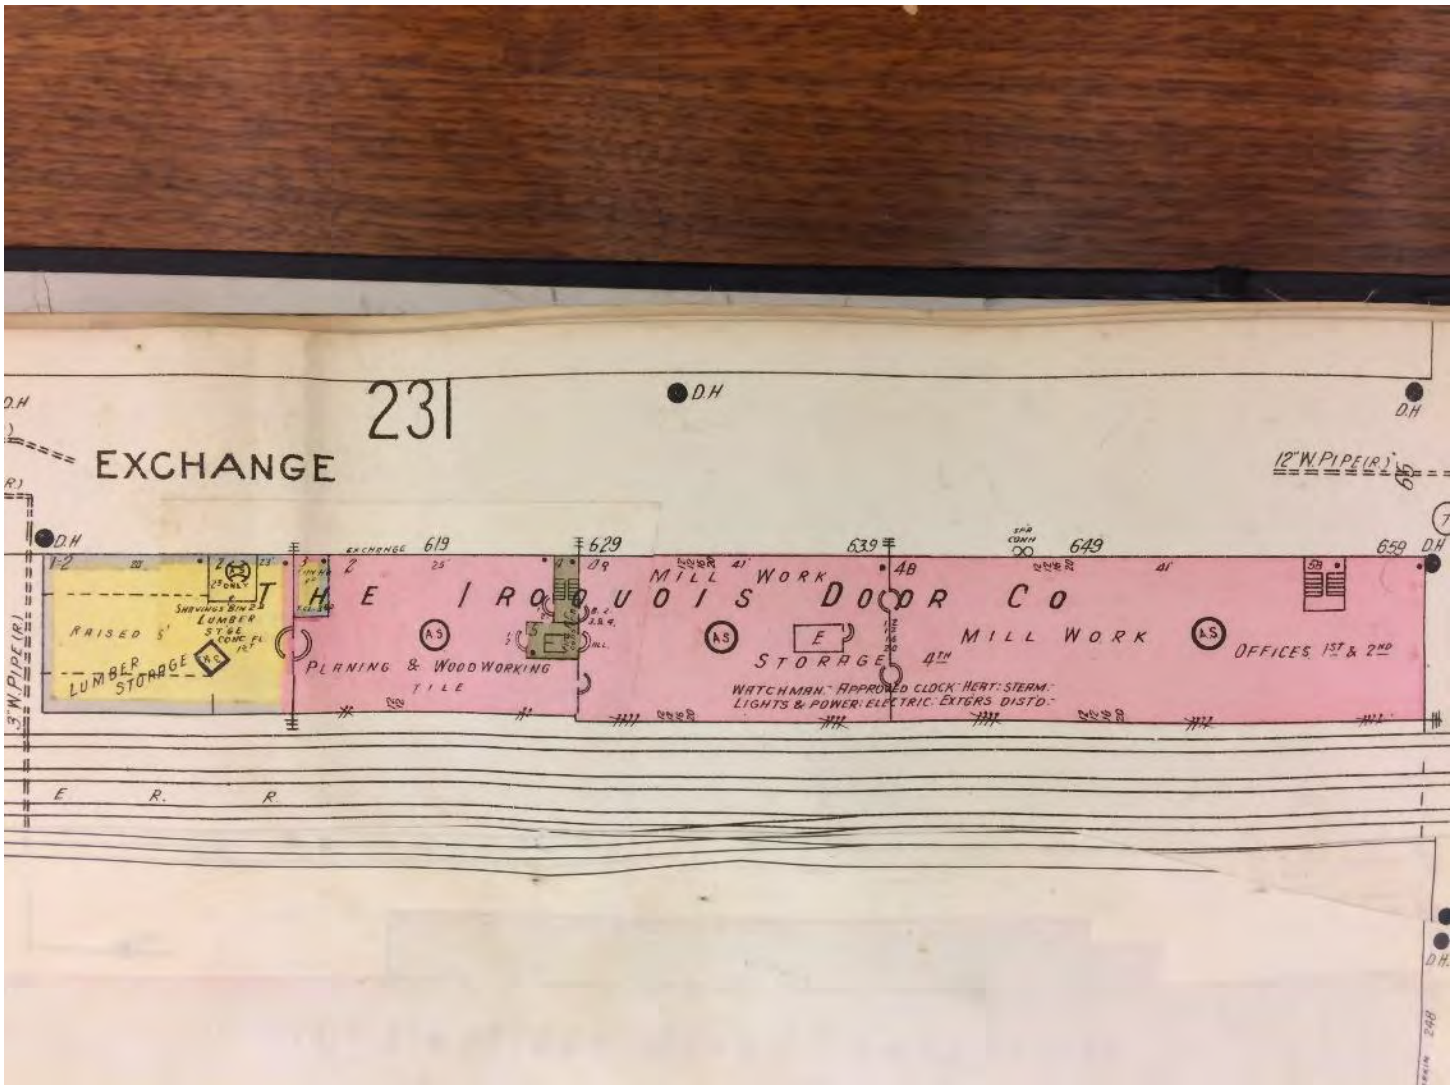
1926 Corrected to 1950 Sanborn Map

The 1950 Sanborn map is very similar to the 1925 map. The area of correction is to the 1925 Clay Tile addition and the western end of the 1925 Wood and Metal Clad addition.
