National Register of Historic Places Registration Form

historic name IROQUOIS DOOR COMPANY BUILDING

name of related multiple property listing Historic Resources of the Hydraulics/Larkin Neighborhood, Buffalo, Erie Co., NY

street & number 619-659 Exchange Street

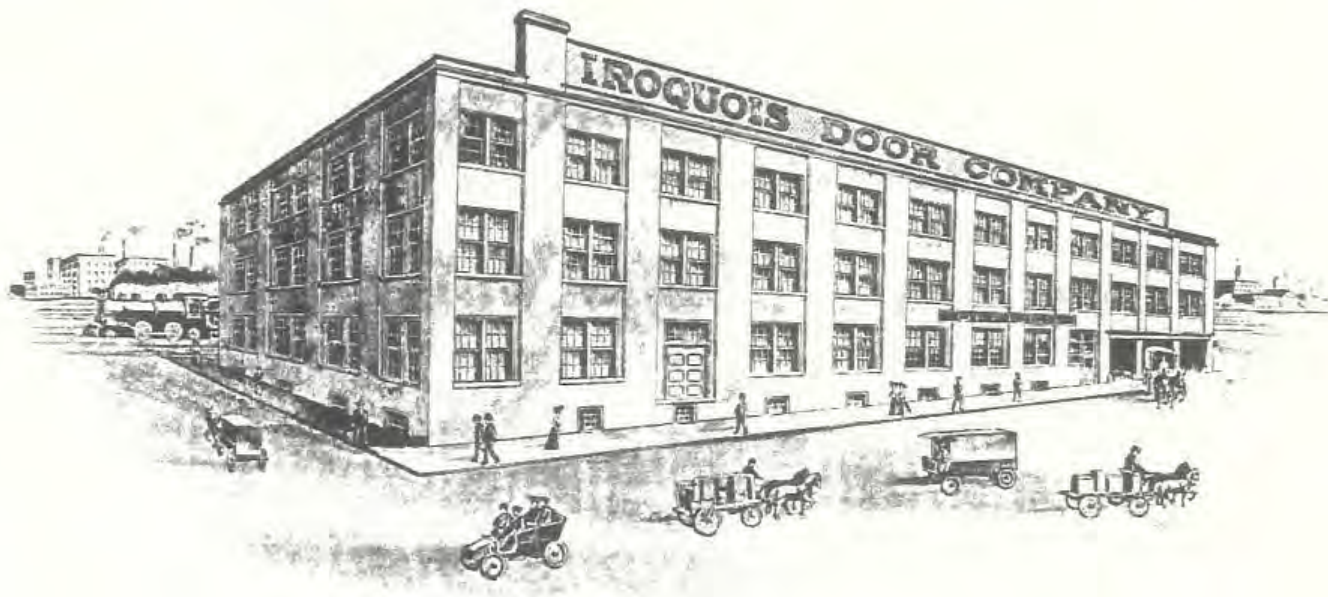
Illustration 1: The Iroquois Door Company Building, c1904.

The illustration rendered shortly after the completion of the Iroquois Door Company building shows Louise Blanchard Bethune's original work. The image was provided by Kelly Hayes MacAlonie FAIA LEED AP, Director of Campus Planning at the University of Buffalo as a part of the notes shared from a portion of a chapter she is writing on the architect Louise Blanchard Bethune.

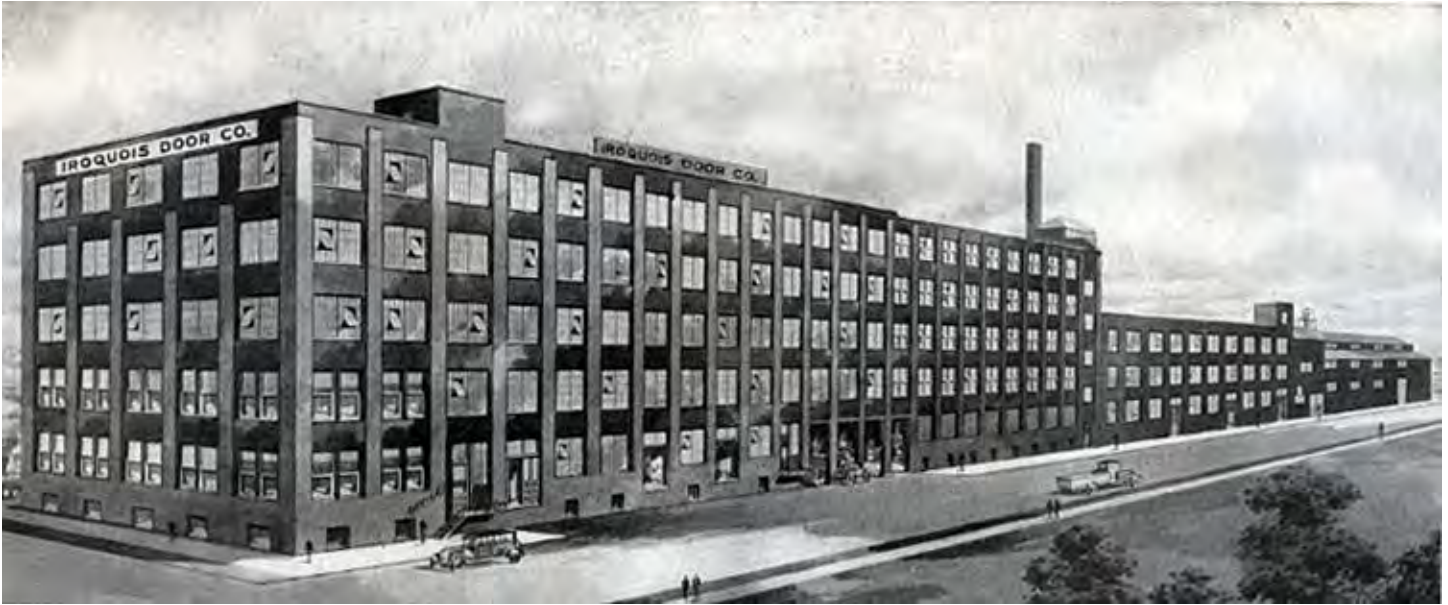
Illustration 2: The Iroquois Door Company ca. 1933.

The illustration shows the Iroquois Door Company's Buffalo location. Of particular interest are the inconsistencies between this illustration and competing historical documentation. In particular, the 5th bay along Larkin Street (Far left of image), the inclusion of a fifth floor, the addition of 4 bays along Exchange Street before the 1925 Clay Tile addition, and the third floor of the clay tile addition are contradicted by supporting historical sources.

It should be noted that between 1904-1940, inaccuracies appear in the illustrations of the Iroquois Door Company building published in customer catalogs. Illustrations from c1915, c1920, and c1933 show the building with five bays along Larkin Street (one more than actual), as well as a varying number of additional bays along Exchange Street and, in two instances, an additional fifth floor. These illustrations are contradicted by what architectural features remain on the existing building as well as by Sanborn/Century Atlas maps dated around the same time of the illustrations. It can be speculated that illustrations of the Iroquois Door Company published in customer catalogs attempted to portray the factory as larger and more industrious than it was, while Sanborn mapmakers strove for accuracy.
