Niagara Gorge Corridor Project

Draft Scoping Report

Appendix G - Visual Pavement Condition Assessment

Robert Moses Parkway-North Segment

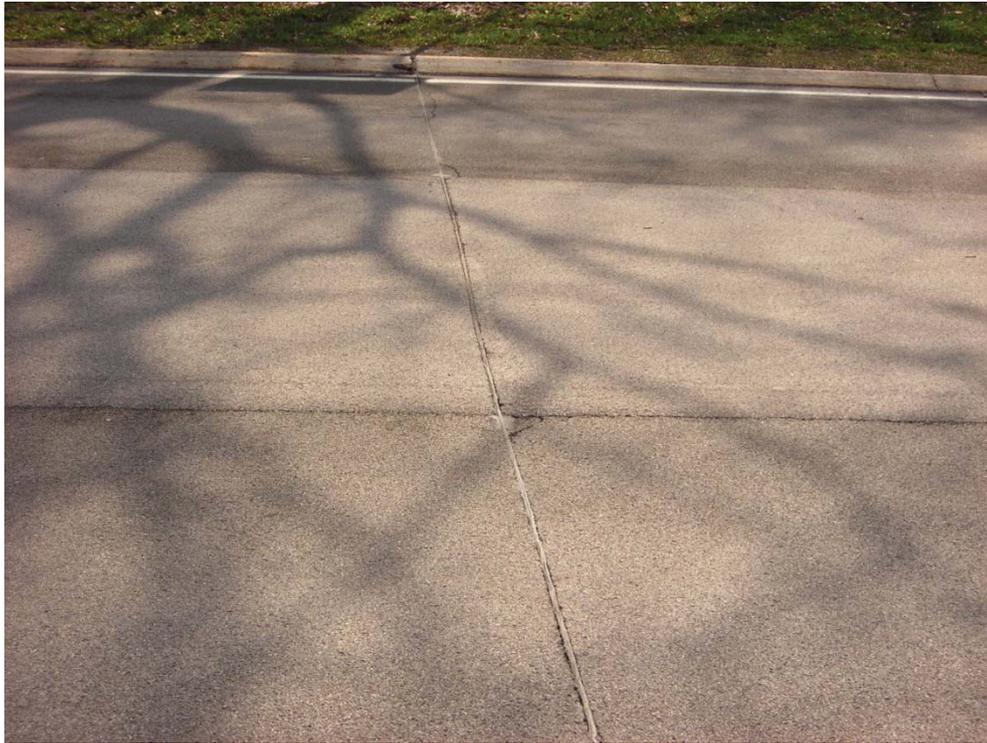
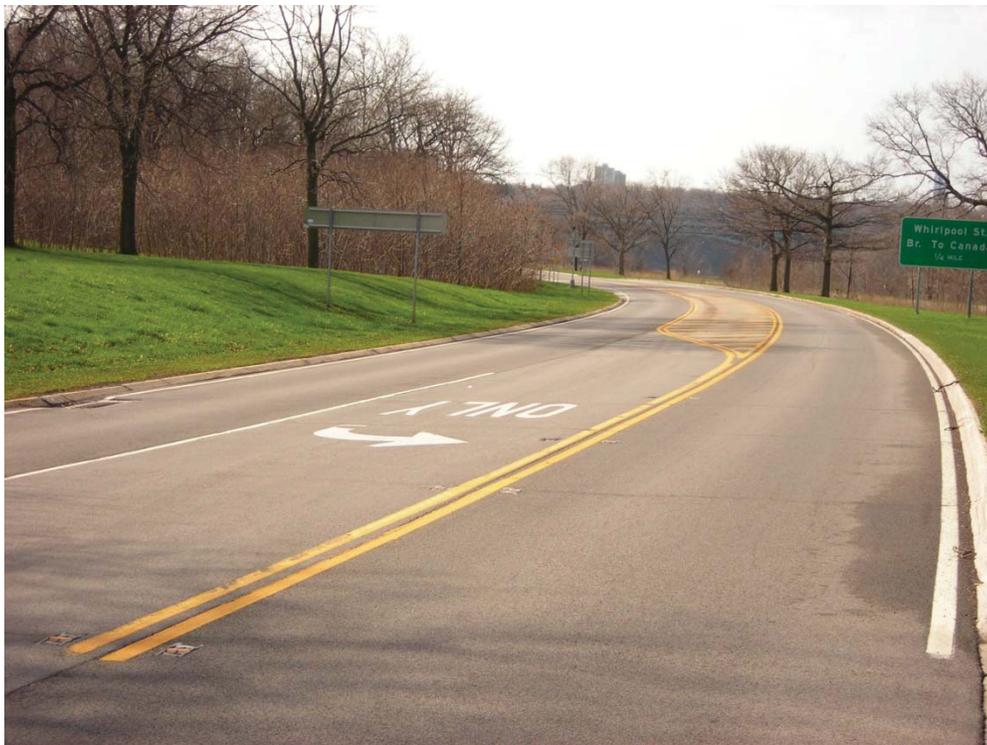
Milepost 2.2: Top photo close-up of a typical joint. Lower photo general view looking south from Whirlpool State Park

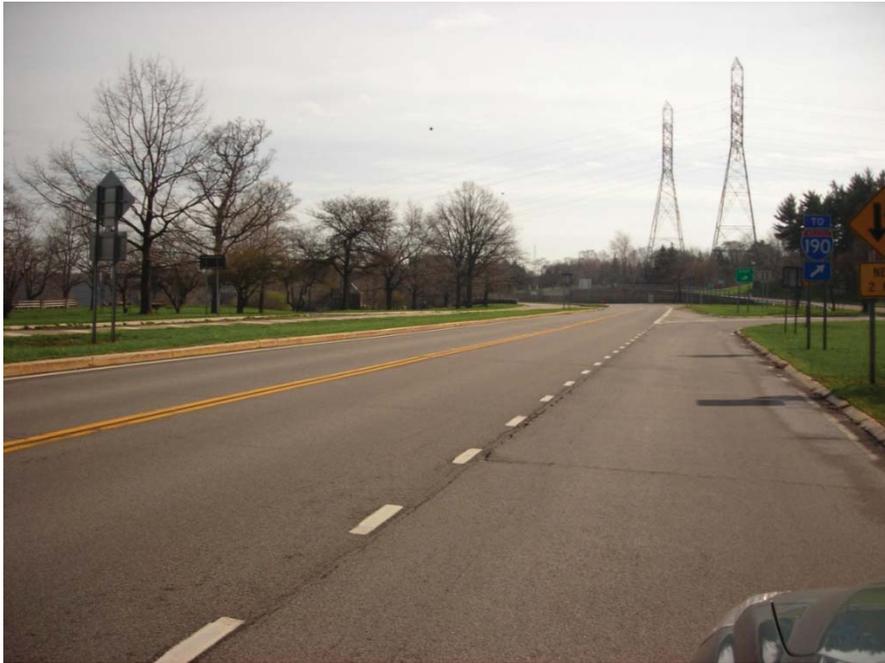
Segment 5 MP 2.2 to 3.6 (near Devils Hole State Park)	Pavement is in good condition rides well. Minor isolated random cracking, random, edge and centerline cracking. Cracks are still tight with little raveling.
	Segment 6 MP 3.6 to 4.1	Pavement is in fair to poor condition. Transverse cracks at joints are 6" to 1" wide with alligator cracking adjacent to the transverse joints. Pavement rides rough with numerous asphalt patches. Also, has longitudinal cracking along the centerline and edges. This section of pavement is adjacent to a tall retaining wall for NY104 and sits above a retaining wall for the Robert Moses Parkway Southbound. The stepped geometry in this section may be causing drainage problems, which have led to the pavement problems in this section.
	Segment 7 MP 4.1 to 4.4 (NYPA Niagara Power Project Bridge BIN 1068262)	NYPA Bridge BIN 1068262 bridge deck pavement in good condition.

Robert Moses Parkway
Segment 5 - approx. MP 3.4 looking north

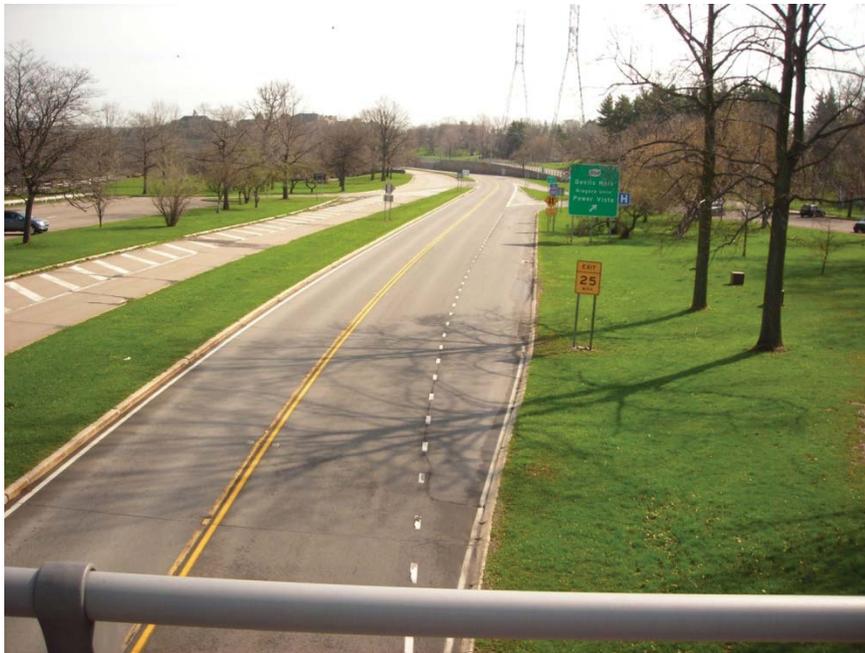
Robert Moses Parkway
Segment 5 - approx. MP 3.4 looking north from pedestrian overpass near Whirlpool Street Exit

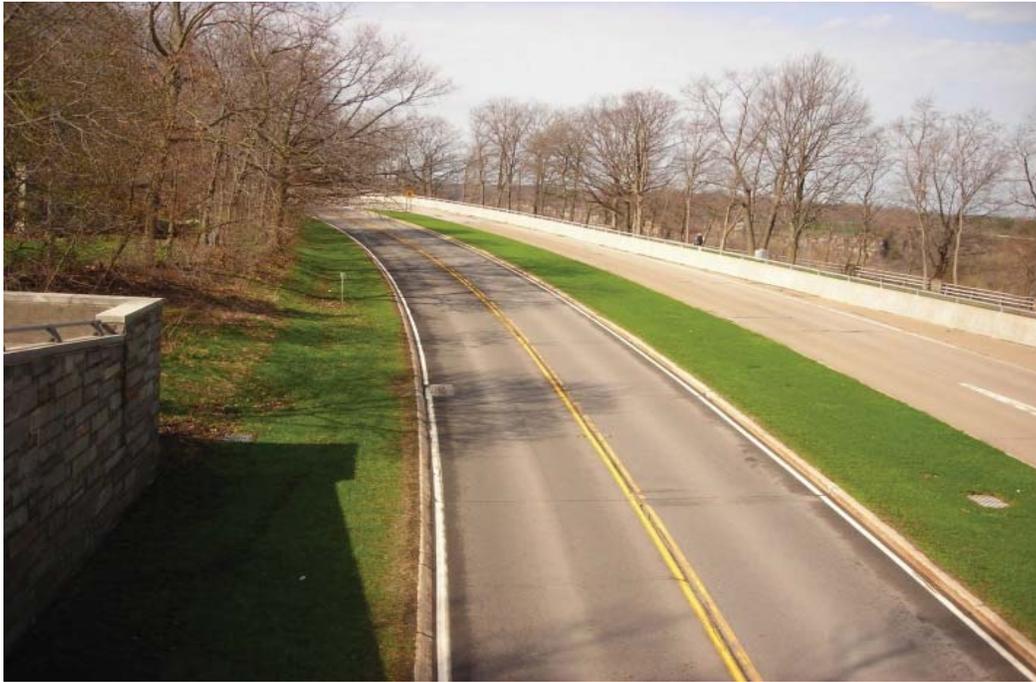
Segment 5 - approx. MP 3.4 looking south from pedestrian overpass (near Whirlpool Street Exit)

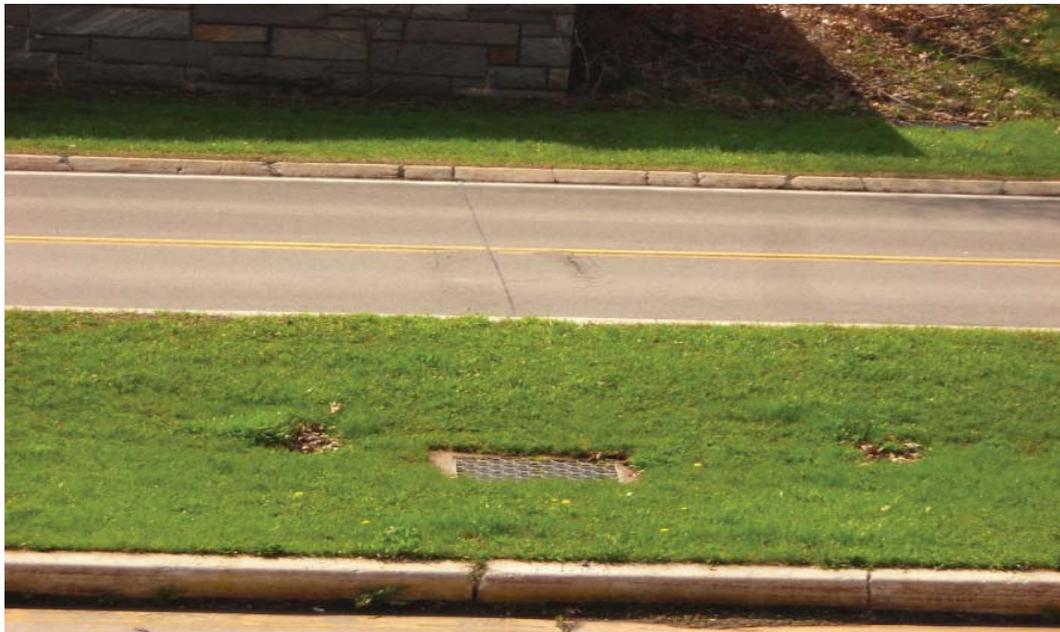
**Segment 5 - approx. MP 3.4 looking at typical joint from pedestrian overpass
(near Whirlpool Street Exit)**

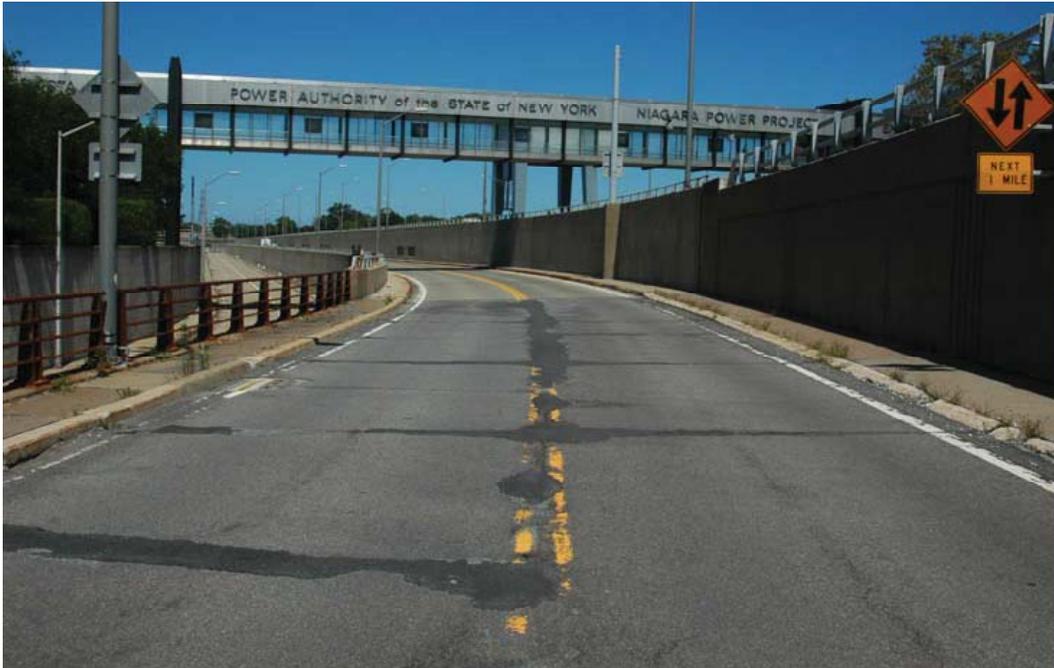
Segment 6 Photo courtesy of NYPA (photo is a few years old, pavement is in worse condition now)

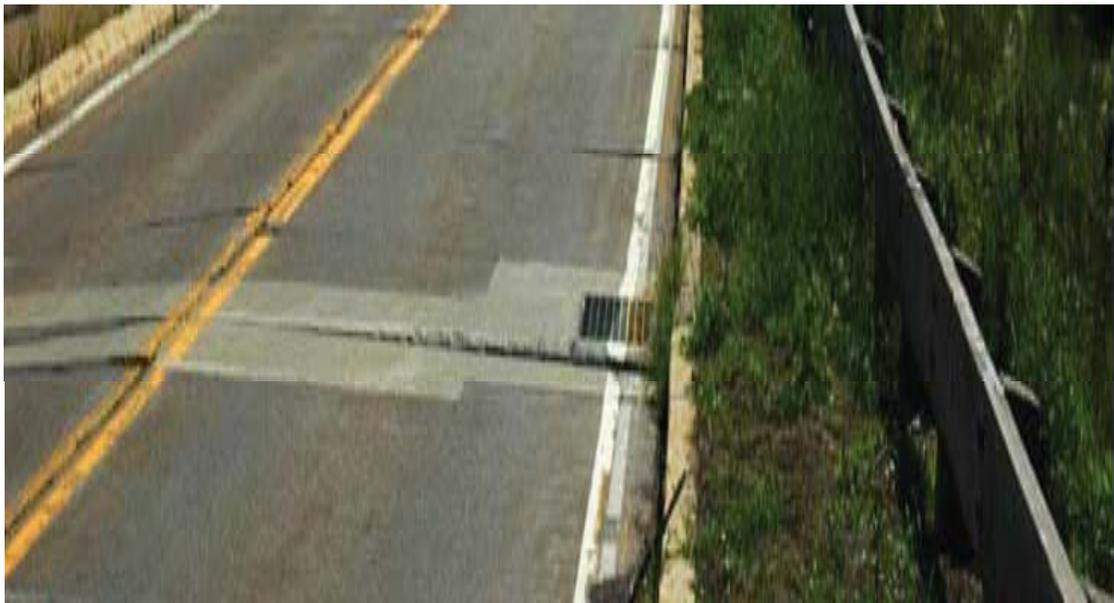
Segment 8 MP 4.4 to 4.8 (NYPA Niagara Power Project to just south of the Lewiston-Queenston International Bridge)	Similar to segment 6. Pavement is in fair to poor condition. Transverse cracks at joints. Pavement rides rough. Also, has longitudinal cracking along the centerline and edges.
	Segment 9 MP 4.8 to 5.0	Pavement is fair to good. Spalling of transverse joints, some longitudinal spalling along centerline. Pavement rides OK so far.
	Segment 10 MP 5.0 to 7.0 (Lewiston-Queenston International Bridge to project limits)	This segment includes the transition for 1-lane undivided traffic to a 2-lane divided highway. The pavement is in fair condition. There is spalling at transverse joints, some longitudinal spalling, asphalt patches along the lane line and transverse joints in approximately 5-10% of the segment. Isolated random cracking of the slabs (approx 5%), isolated wide asphalt patches, and isolated potholes.

Segment 8 Photo courtesy of NYPA (photo is a few years old, pavement is in worse condition now)

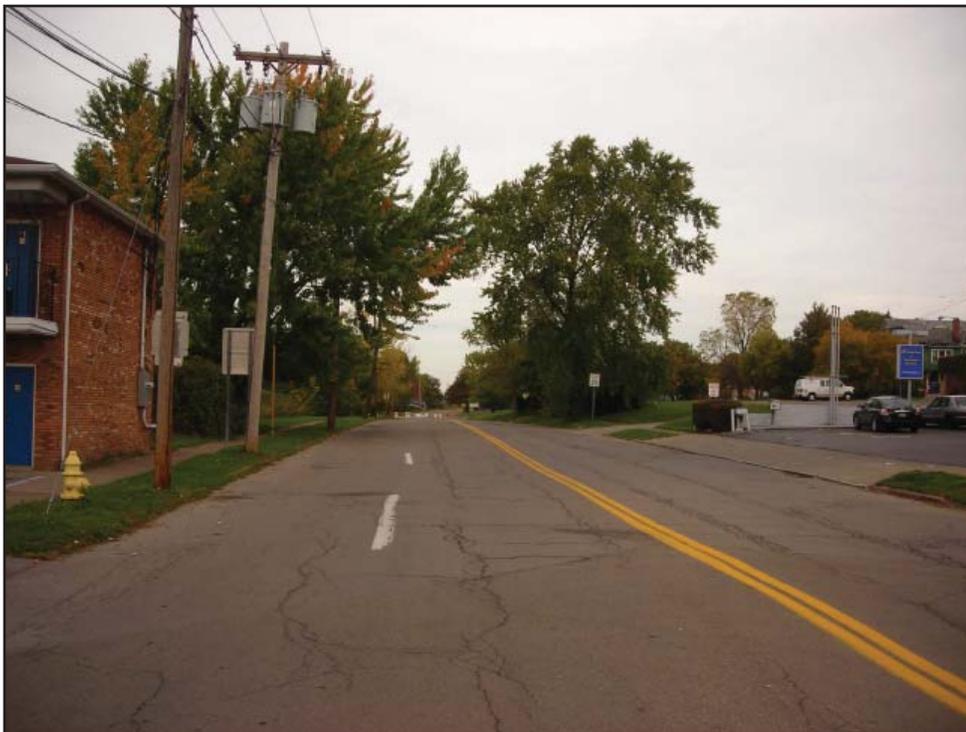
Sequence No. 2

Sequence No.	Photo #	Roadway	Notes
1	713	Whirlpool Street	Towards north from Main Street. Multiple longitudinal and transverse cracks were observed.
2	714	Whirlpool Street	Towards north from Main Street.
3	715	Whirlpool Street	Towards south near Main Street.
4	716	Whirlpool Street	Road Closed Ahead Sign
5	717	Whirlpool Street / Main Street	Pavement Condition
6	718	Main Street	Towards north near Whirlpool Street
7	719	Main Street	Near Whirlpool Street
8	720	Main Street	Towards south, near Whirlpool Street
9	721	Main Street	North of Whirlpool Street
10	722	Whirlpool Street	Towards north between Main Street and Walnut Street
11	723	Whirlpool Street	Towards north between Main Street and Walnut Street
12	724	Whirlpool Street	Towards north between Main Street and Walnut Street
13	725	Whirlpool Street	Towards north between Main Street and Walnut Street
14	726	Whirlpool Street	Towards north between Main Street and Walnut Street

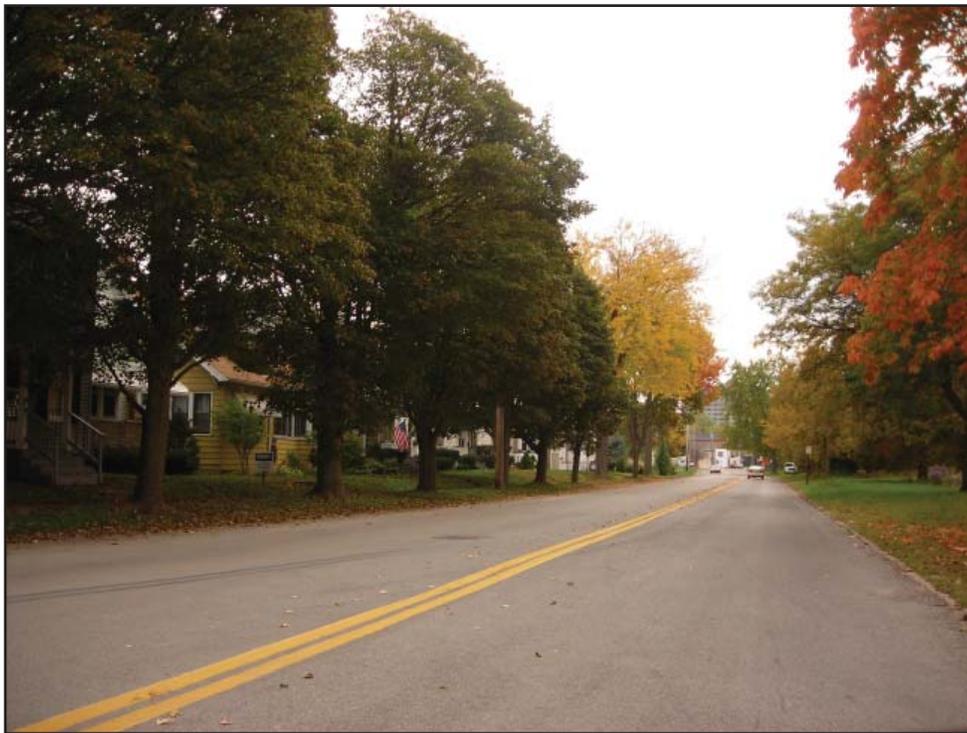
Sequence No. 24

24	736	Whirlpool Street	Towards south, between Chestnut Avenue and Chasm Avenue
25	737	Whirlpool Street	Towards south, between Chasm Avenue and Whirlpool Maintenance
26	738	Whirlpool Street	No Standing Any Time Sign
27	739	Whirlpool Street	Road Work Ahead Sign
28	740	Whirlpool Street	Towards south, between Chasm Avenue and Whirlpool Maintenance
29	741	Whirlpool Street	At Whirlpool Maintenance
30	742	Whirlpool Street	Road Closed to Main Street
31	743	Whirlpool Street	Towards south, under Whirlpool Rapids Bridge
32	744	Whirlpool Street	Towards south near Ontario Street
33	745	Whirlpool Street	Northbound approach near Ontario Street
34	746	Whirlpool Street	Road Closed Sign at Ontario Street
35	747	Whirlpool Street	Northbound approach near Ontario Street
36	748	Whirlpool Street	Northbound approach south of Ontario Street
37	749	Whirlpool Street	Towards south, between Ontario Street and Cleveland Avenue
38	750	Whirlpool Street	Northbound approach between Ontario Street and Cleveland Avenue

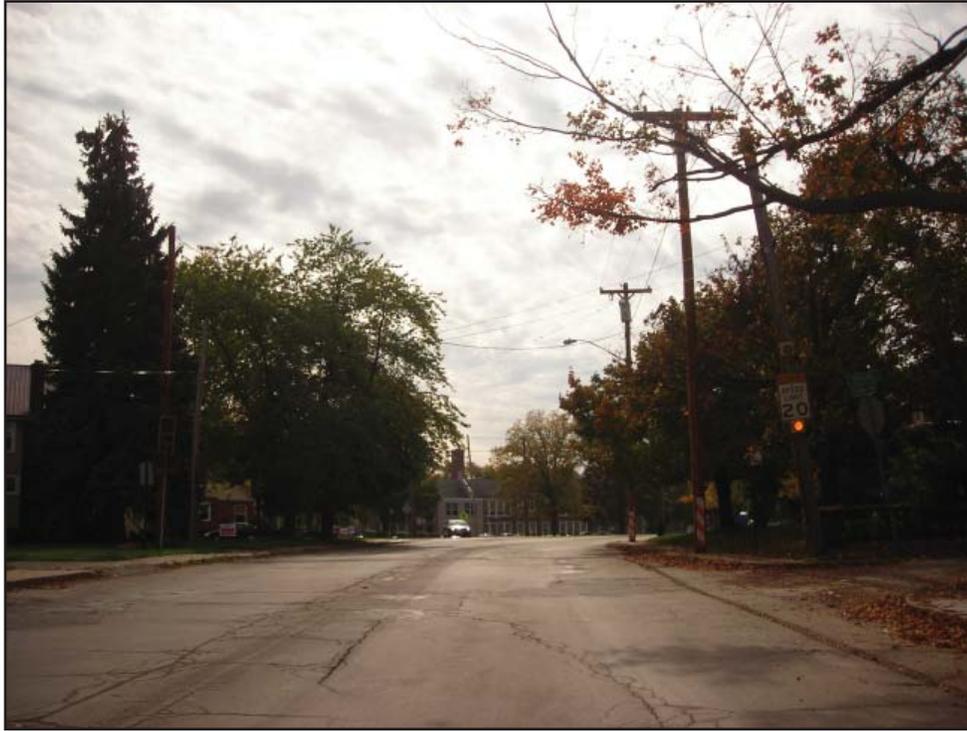
Sequence No. 62

62	774	Lewiston Road	Towards north near Garrett Avenue
63	775	Lewiston Road	Towards south near Garrett Avenue
64	776	Lewiston Road	Near Garrett Avenue
65	777	Lewiston Road	No Standing Any Time Sign
66	778	Lewiston Road	School Speed Limit Sign
67	779	Lewiston Road	Pavement condition near James Street
68	780	Lewiston Road	Towards south near James Street
69	781	Lewiston Road	Towards south near James Street
70	782	Lewiston Road	Utility cut patch near Morley Avenue
71	783	Lewiston Road	Towards south, between Morley Avenue and Maple Avenue
72	784	Lewiston Road	Pavement condition near Morley Avenue
73	785	Lewiston Road	Towards south, between Maple Avenue and College Avenue
74	786	Lewiston Road	Towards south, between College Avenue and Findlay Drive
